MANAGEMENT OF A MAJOR SLOPE FAILURE AT NCHANGA OPEN PIT,
CHINGOLA, ZAMBIA.

SDN Wessels, Head of Rock Mechanics, NOP
WA Naismith, Principal Consultant, SRK

Synopsis:

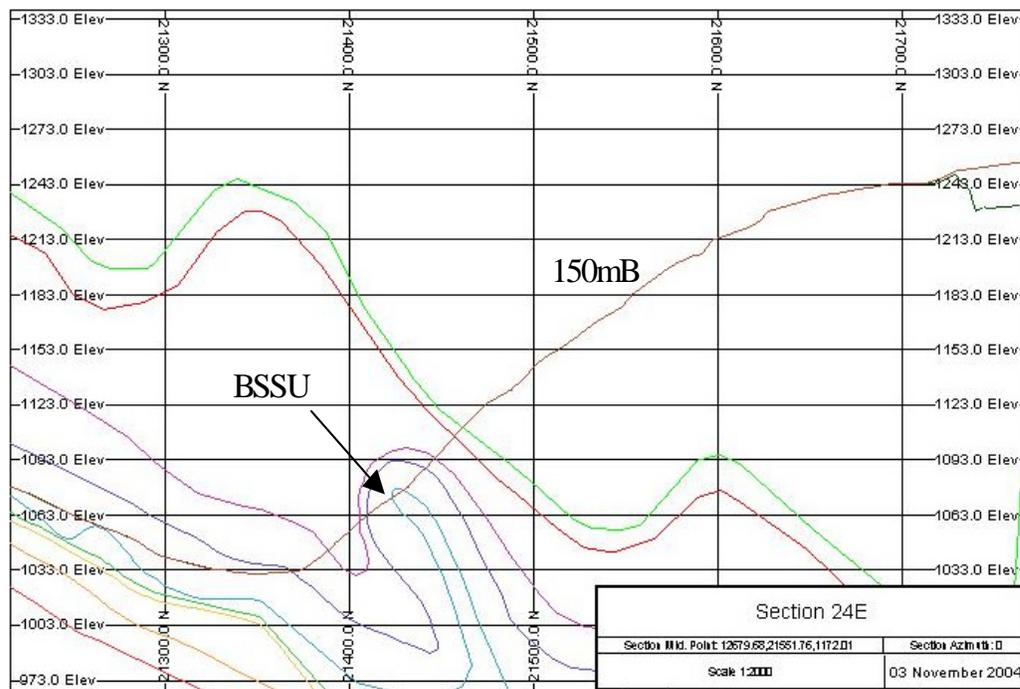
In July 2003, some monitoring points exhibited above average displacements and increases in movement rate. These lay in a specific area between 23E and 24E and from the 150m bench to the 225m bench. The increase in movement rates coincided with exposure of a small zone of Upper Banded Sandstone in the core of a tight fold structure on the 270m – 285m bench. Figure 1 shows a section through the slope at 24E illustrating the geological structure in the face. There was no obvious geological relationship between the elevation at which mining was taking place and the elevation at which deformation was occurring. It was surmised that displacement of vertical joint planes associated with the fold reduced confinement applied to the overlying Chingola Dolomite and subsequent compression of this strata was transferred to overlying strata as settlement.

Figure 1: A section through the AOC indicating the geology. Note the exposure of the Upper Banded Sandstone (BSSU) in the nose of the fold.

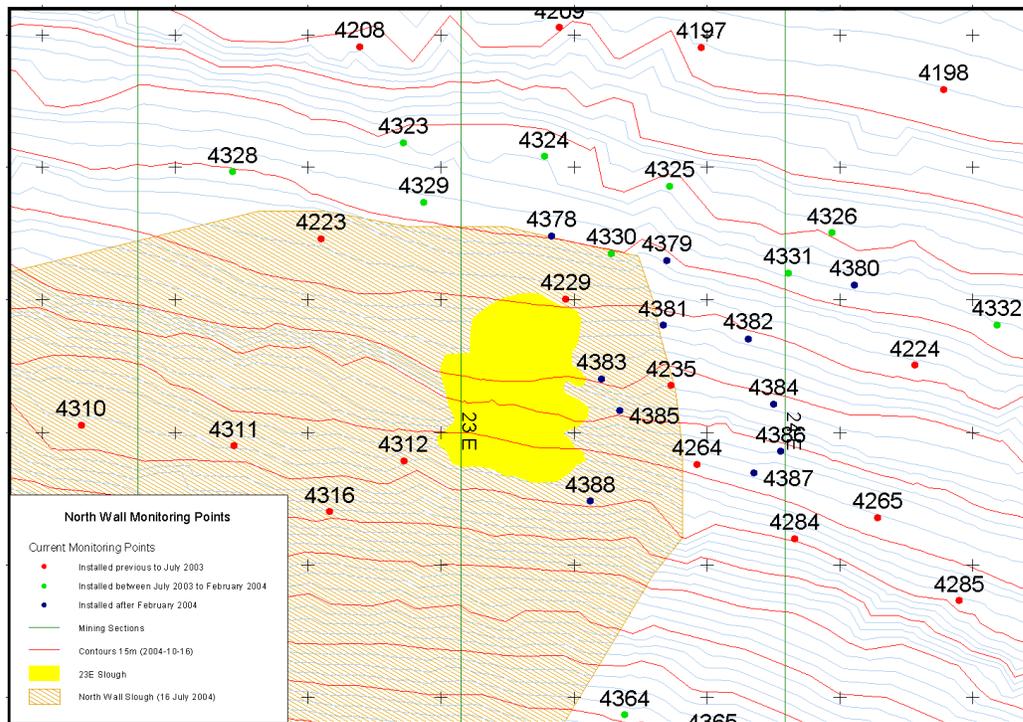
The location of monitoring points installed in the Area of Concern is indicated in figure 2. Shading indicates the position of the slough at the end of November 2003, and the hatched area the extent of the July 2004 failure. Unfortunately, no monitoring points were installed in the Area of Concern below 225m bench due to a combination of logistical and safety considerations.

Figure 2: Monitoring points installed on North Wall: up to MP4316- prior to July 2003; MP4323 to MP4332 - between July 2003 and February 2004; MP4380 to MP4388 - after February 2004

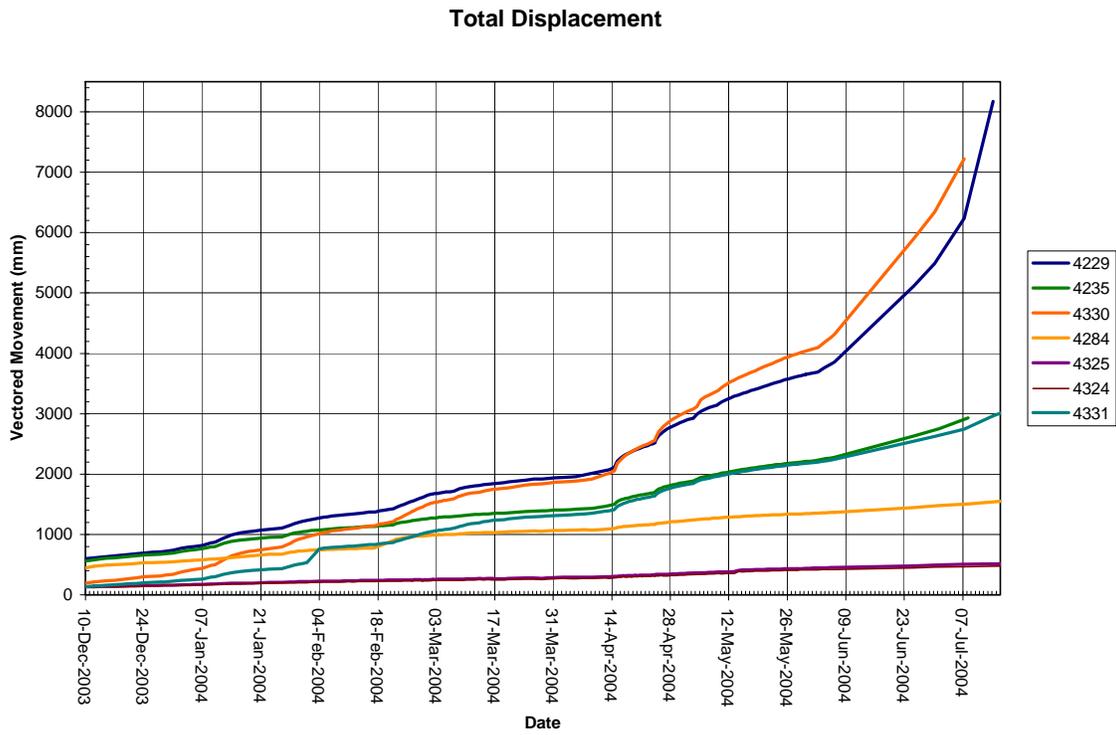
Figure 3 indicates the total displacement measured for a selection of monitoring points for the period from December 2003 to July 2004. Three groupings of points are evident: -

- MP4330 and MP4229 lie in the area of collapse and have undergone approximately 6500mm and 7500mm of movement respectively over the period. MP 4229 appears to approach its asymptote in the period following 7th July.

- MP4235 and MP4331 both exhibit over 2500mm of displacement. Whereas MP4235 lies on the margin of the collapsed zone and could be expected to move considerably, MP4331 lies some 60m from the margin and could be expected to exhibit movements of the same order as MP4325 which was installed at the same time. That it has not done so could be indicative of some local anomaly not associated with the main collapse.

- MP4325 and MP4284 lie outside the area of collapse and have remained relatively unaffected. MP4325 has undergone approximately 400mm of movement as would be expected with a background rate of 2mm/day over the period. MP4284 has undergone approximately 1000mm of deformation. This is far more than would be expected from the

background rate and it is probable that this point has been subjected to a local anomaly.

From examination of the selection of points shown in figure 3, it is clear that no unequivocal information regarding either the extent of the area of potential collapse or its likely time of collapse can be gleaned. The degree of uncertainty involved in making those predictions and in developing criteria by which to allow men and equipment to work safely is high and criteria must therefore err on the conservative side.

Figure 3: Total displacement of selected monitoring points from 10 December 2003 to 7 July 2004

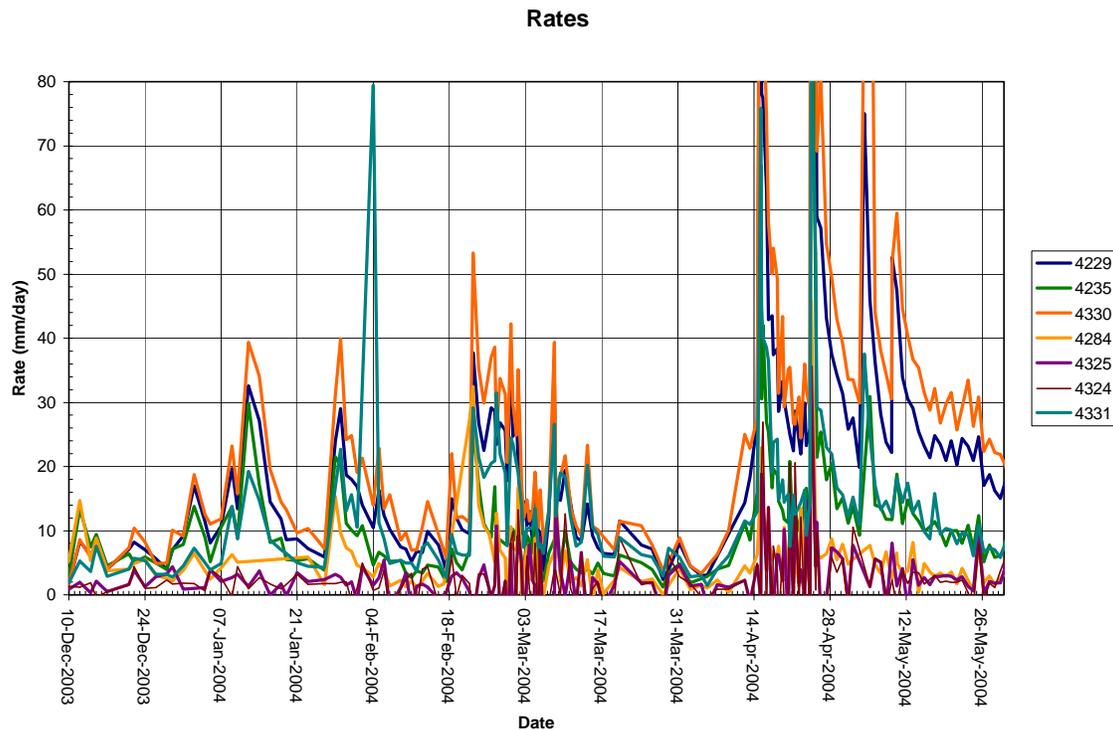
Figure 4 illustrates deformation data that has been converted into movement rates for the period December 2003 to May 2004. The response of deformation rate to blasting is clearly visible, particularly in April and early May when a series of blasts within the Area of Concern appear to have changed the longer term pattern of rate increase and decay. Prior to April, following a blast, rates would increase and then decay to pre blast levels. From the May blast, movement rates have taken much longer to decay and monitoring points lying within the collapse area, MP4229 and MP4330, have decayed to rates much higher than those pre blast. This is perhaps indicative of a change in strength characteristic of the slope from one of primarily peak shear strength to that approaching residual shear strength.

Figure 4: Movement Rates: 10 December 2003 - 19 May 2004

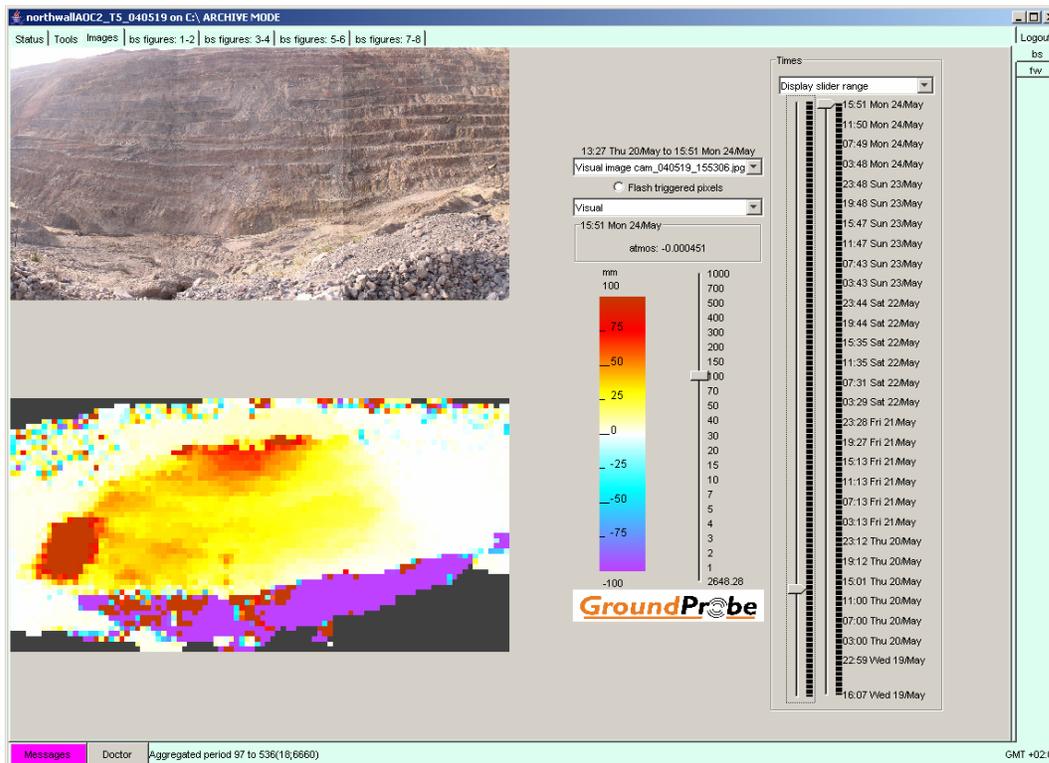
Figure 5: Initial Radar Survey Results-figure showing information that is relayed from the deployed unit to the central site. On screen, warmer (more dense) colours to the bottom right and upper central portions of the figure indicate greatest movements within the monitoring duration.

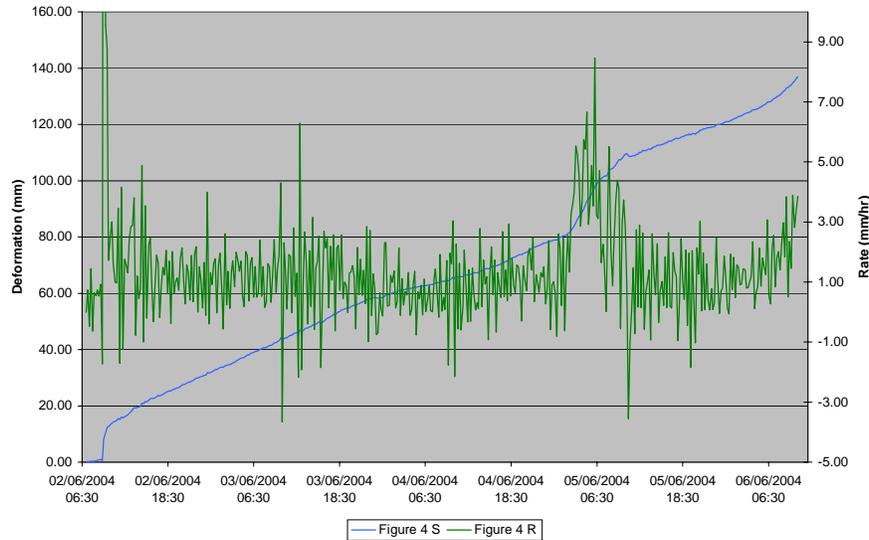
A combined displacement and movement rate graph is shown in figure 6.

Figure 6: Typical deformation and instantaneous movement rate plots derived from SSR data for a particular window. Note the variation in rate that often occurs between successive scans. A later variation to the software eased interpretation by smoothing the rate graph.

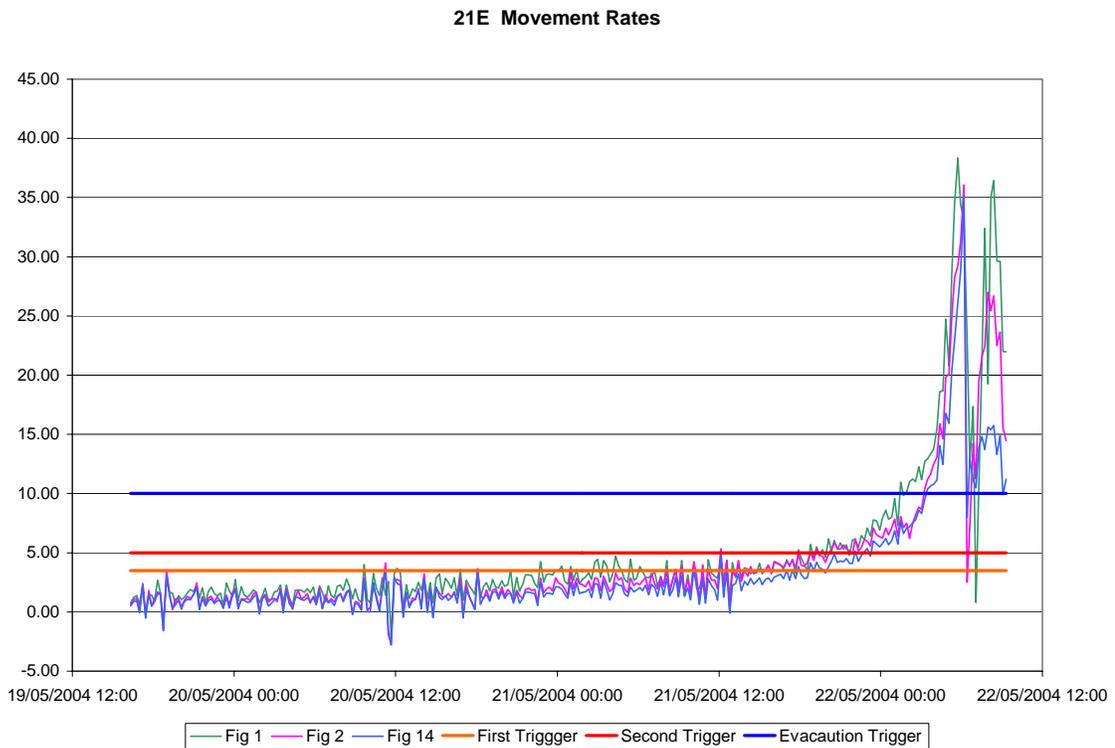
A back analysis was carried out on data obtained from an analysis window that was located retrospectively to cover the area of collapse. The displacement rates are indicated in figure 7. The following conclusions were drawn from the back analysis: -

- The increase in movement rates can clearly be seen in Figure 7. The change in rate of movement is a definite indicator of imminent collapse;
- There is no indication of the total amount of deformation that had taken place prior to collapse. Each time an SSR scan commences the displacement automatically starts from zero and there is no indication of previous displacements. Any predictive criteria based on deformation therefore is inappropriate;
- At approximately 12 hours prior to collapse an instantaneous rate of 3.5mm/hour was exceeded;
- At approximately 6 hours prior to failure an instantaneous rate of 5mm/hour was exceeded;
- At approximately 2 hours before failure an instantaneous rate of 10mm/hour was exceeded.

Figure 7: Back Analysis - 21E Failure figs 1, 2 and 14 refer to different windows placed retrospectively on the area. Trigger rates derived from the analysis are indicated by horizontal lines.

As these time intervals were considered acceptable in order to successfully evacuate men and equipment from the area of concern, they were adopted as “alert”, “alarm” and “scram” warning levels with associated management responses as indicated in Table 1: -

Trigger Level	Response
3.5mm/hour	ALERT: Increase frequency of rate calculations to every 30 minutes
5.0mm/hour	ALARM: Increase frequency of rate calculations to every 15 minutes Inform Control Tower of Alarm status. Inform Geotechnical Engineer on duty.
10mm/hour	SCRAM: Immediate evacuation from Area of Concern

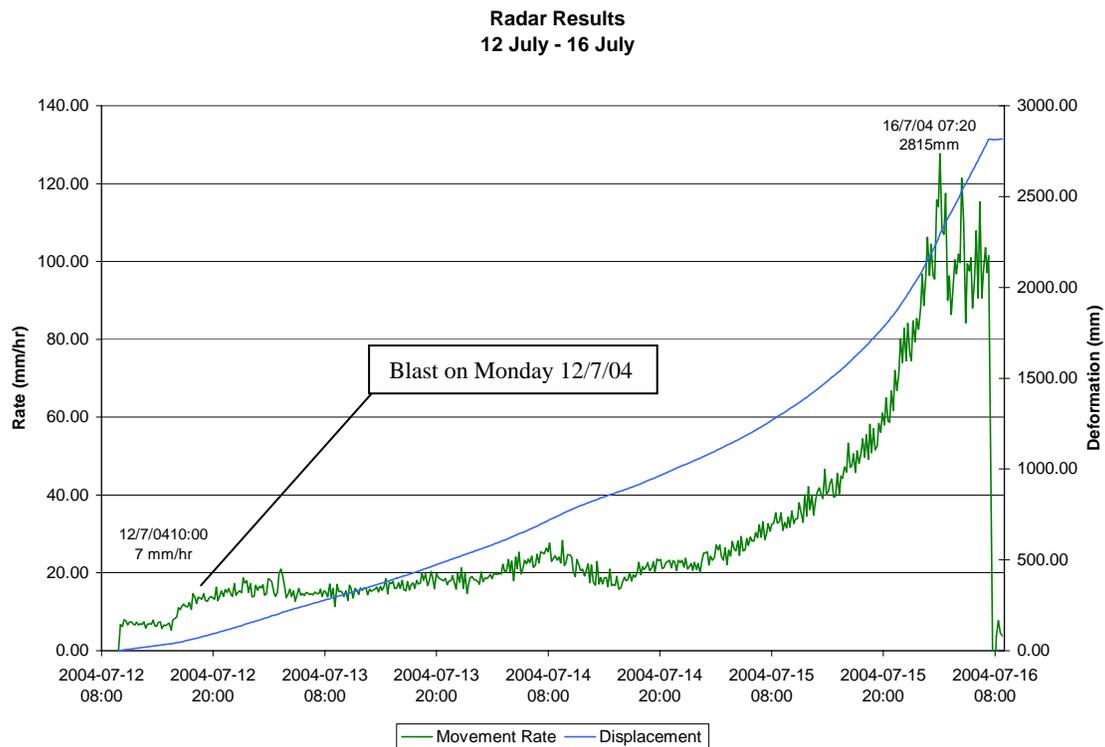
A constant displacement rate averaging 2-3mm/hour was observed until the 9th July, when it started to increase. The reason for this change is unclear. By Sunday 11th July the rates had increased to between 5 and 10mm/hr. On Monday 12th July the rates suddenly

increased to 20mm/hr following blasting during the afternoon and continued at between 20 – 30mm/hr until early in the morning of Thursday 15th July (about 02:00). This continuing increase had not been observed previously and was considered indicative of a change in condition within the slope. Rates continued to accelerate throughout Thursday and a decision was made at 20h00 to withdraw men and equipment from mining operations lying between 20E and 21E and relocate them further West. At 06h30 on Friday 16th July, rates had increased to 70mm/hr, all operations within the pit were suspended and remaining men and equipment withdrawn although they were working over 200m West of the Area of Concern. Final collapse of the slope commenced at about 06h50 with sloughing and collapse of benches on 150-165m levels. The main collapse followed at 0710 when an estimated 4.5 million tons of rock moved and completely inundated the 330m bench from 21E to 23E. The change in movement rates in the days and hours leading up to collapse can be seen clearly in Figure 8. The maximum movement rate immediately prior to failure exceeded 100mm/hr.

Figure 8: Movement rates and displacement in the four days prior to collapse.
