# Satellite Synthetic Aperture Radar for Mine and Tailings Dam Monitoring

Neil Pendock

DIRT Exploration, Cape Town, South Africa

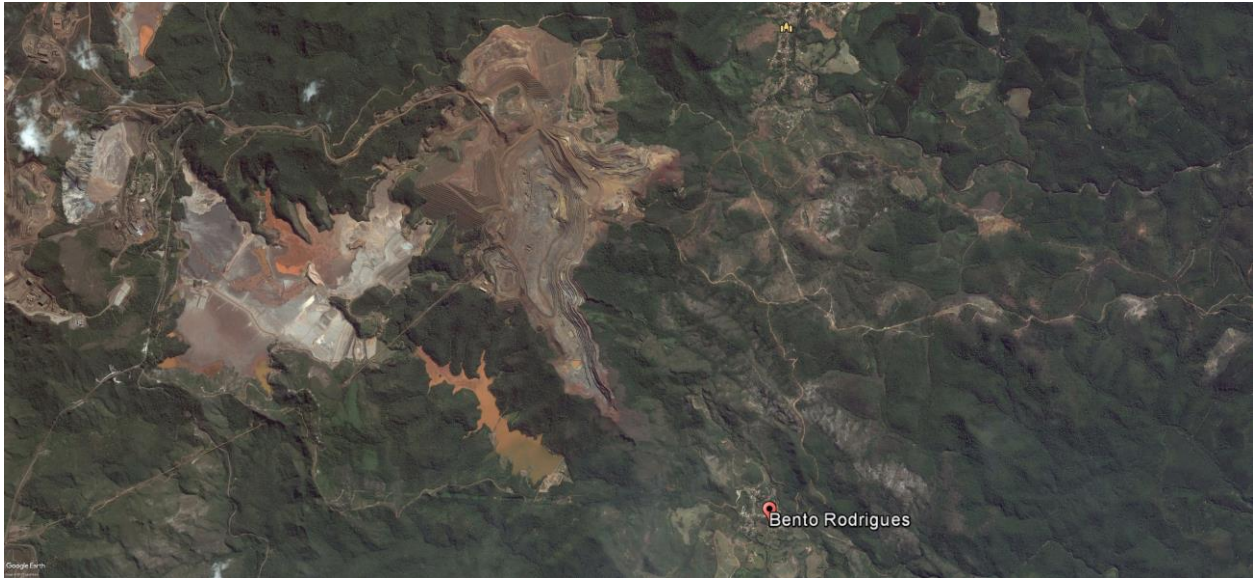
*Figure 1: Fundão tailings dam from Google Earth before collapse.*

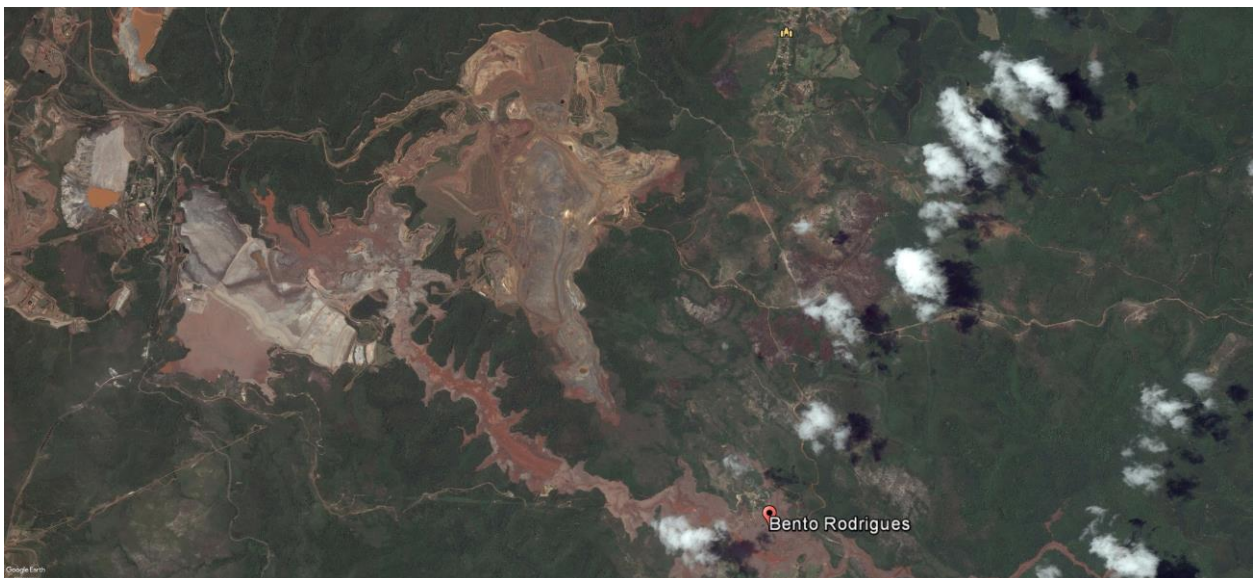
*Figure 2: Fundão tailings dam from Google Earth immediately after collapse.*

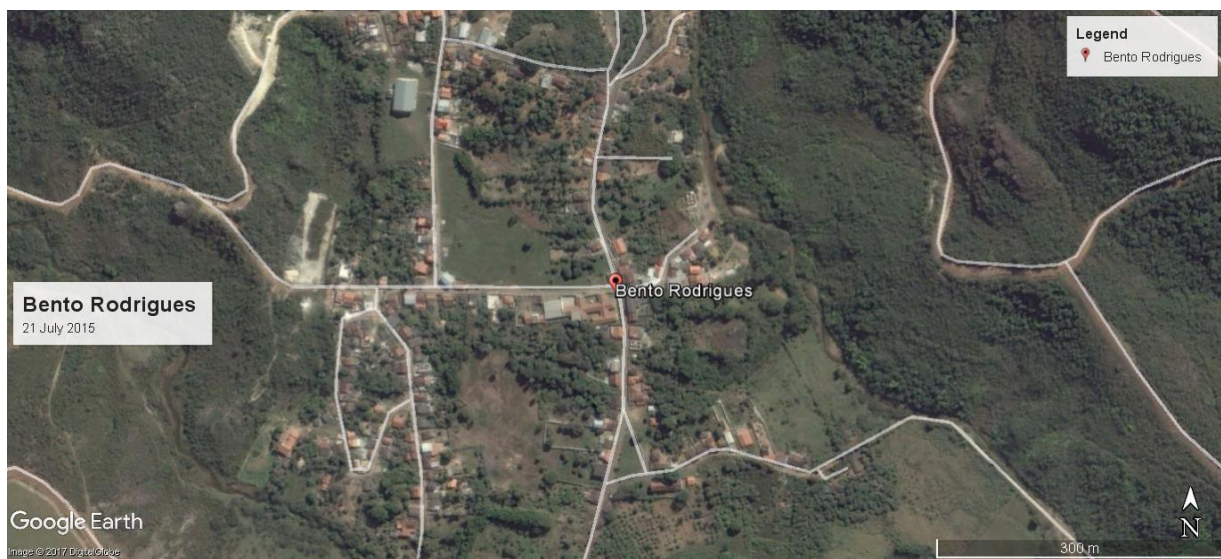
Figure 3: The village of Bento Rodrigues on 21 July 2015.

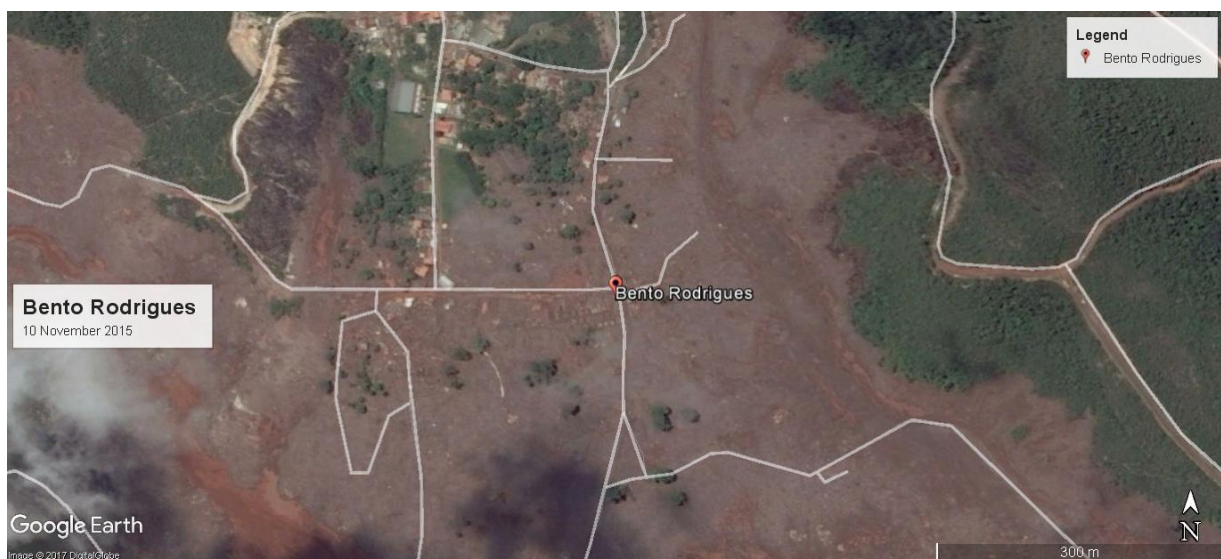
Figure 4: The village of Bento Rodrigues on 10 November 2015.

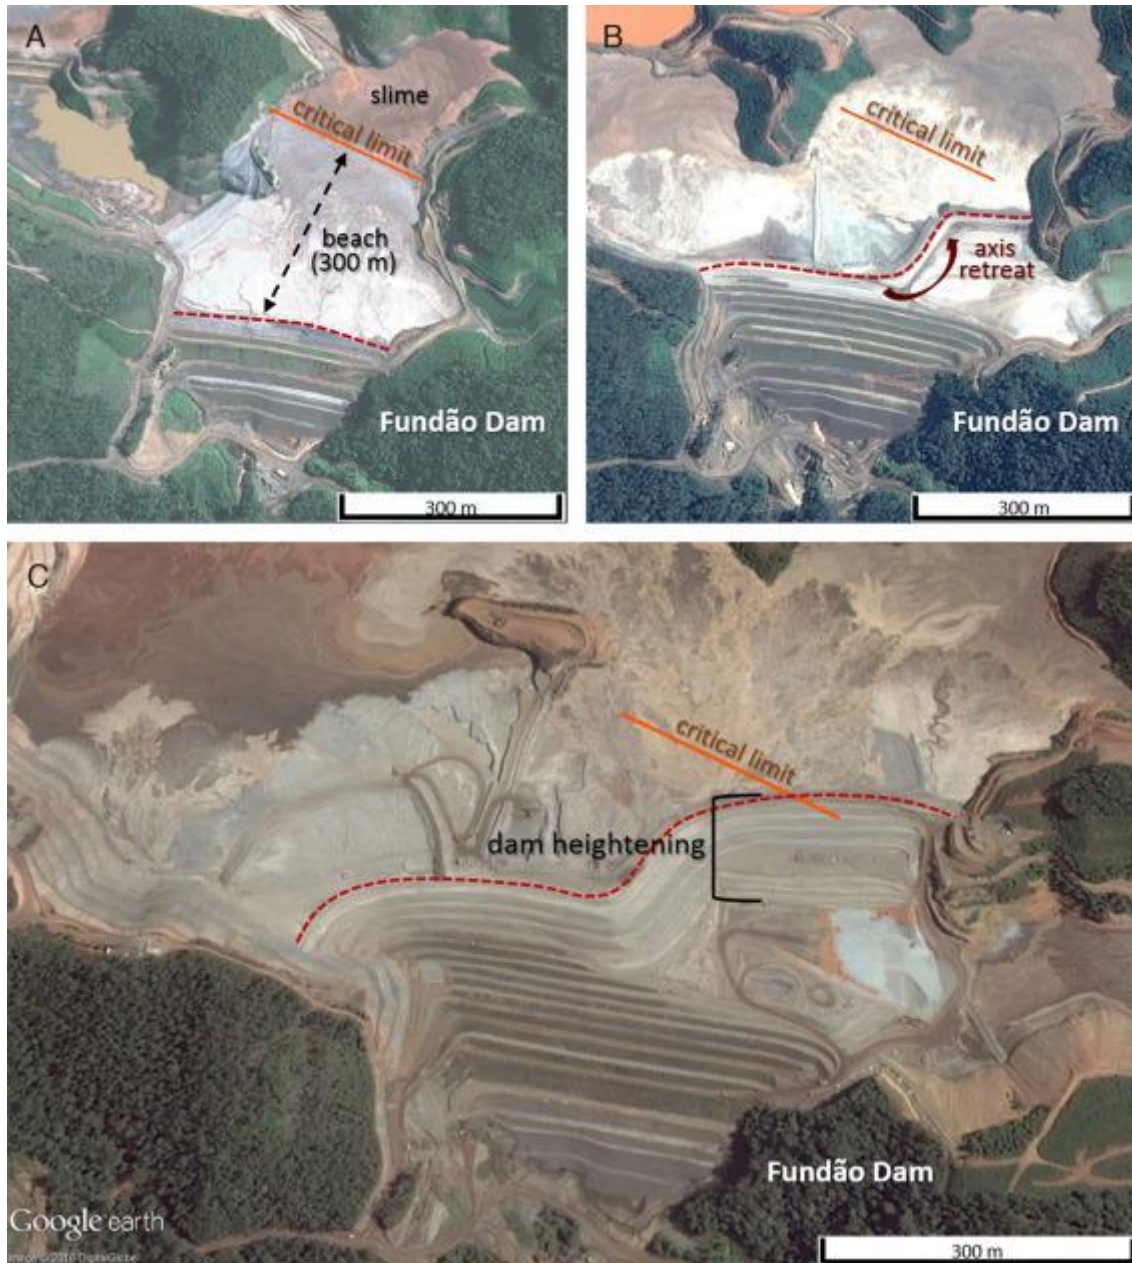
Figure 6: Detail of the Fundão tailings dam.

The dam wall that failed is shown in Figure 6, taken from Fonseca do Carmo *et al.* (2017). The Fundão tailings dam started operation in 2008 and, right from the start, saturation of sandy material was a problem. Figure 6(a) shows the state of the dam in 2011. There was a sandy tailings beach 300 m wide with the critical limit of contact between sandy tailings and sludge (labeled slime) denoted by an orange line.

Figure 6(b) shows the result of an engineering intervention: realignment of the left shoulder of the dam by moving it behind the section of a gallery filled with concrete, to allow the continuation of the landfill embankment. This retreat moved the crest of the dam closer to the water in the reservoir and the mud contained within it. The saturated mass of sandy tailings continued to grow, and by 2015, the critical limit had reached the dam crest, as is clear from Figure 6(c).

The question we pose is whether SAR may be used to monitor the saturation of sandy tailings in this situation because a technical report on the disaster (Morgenstern *et al.*, 2016) concluded that the collapse was due to liquefaction of the sandy tailings, a phenomenon that occurs when solid materials lose their mechanical resistance and behave like fluids.

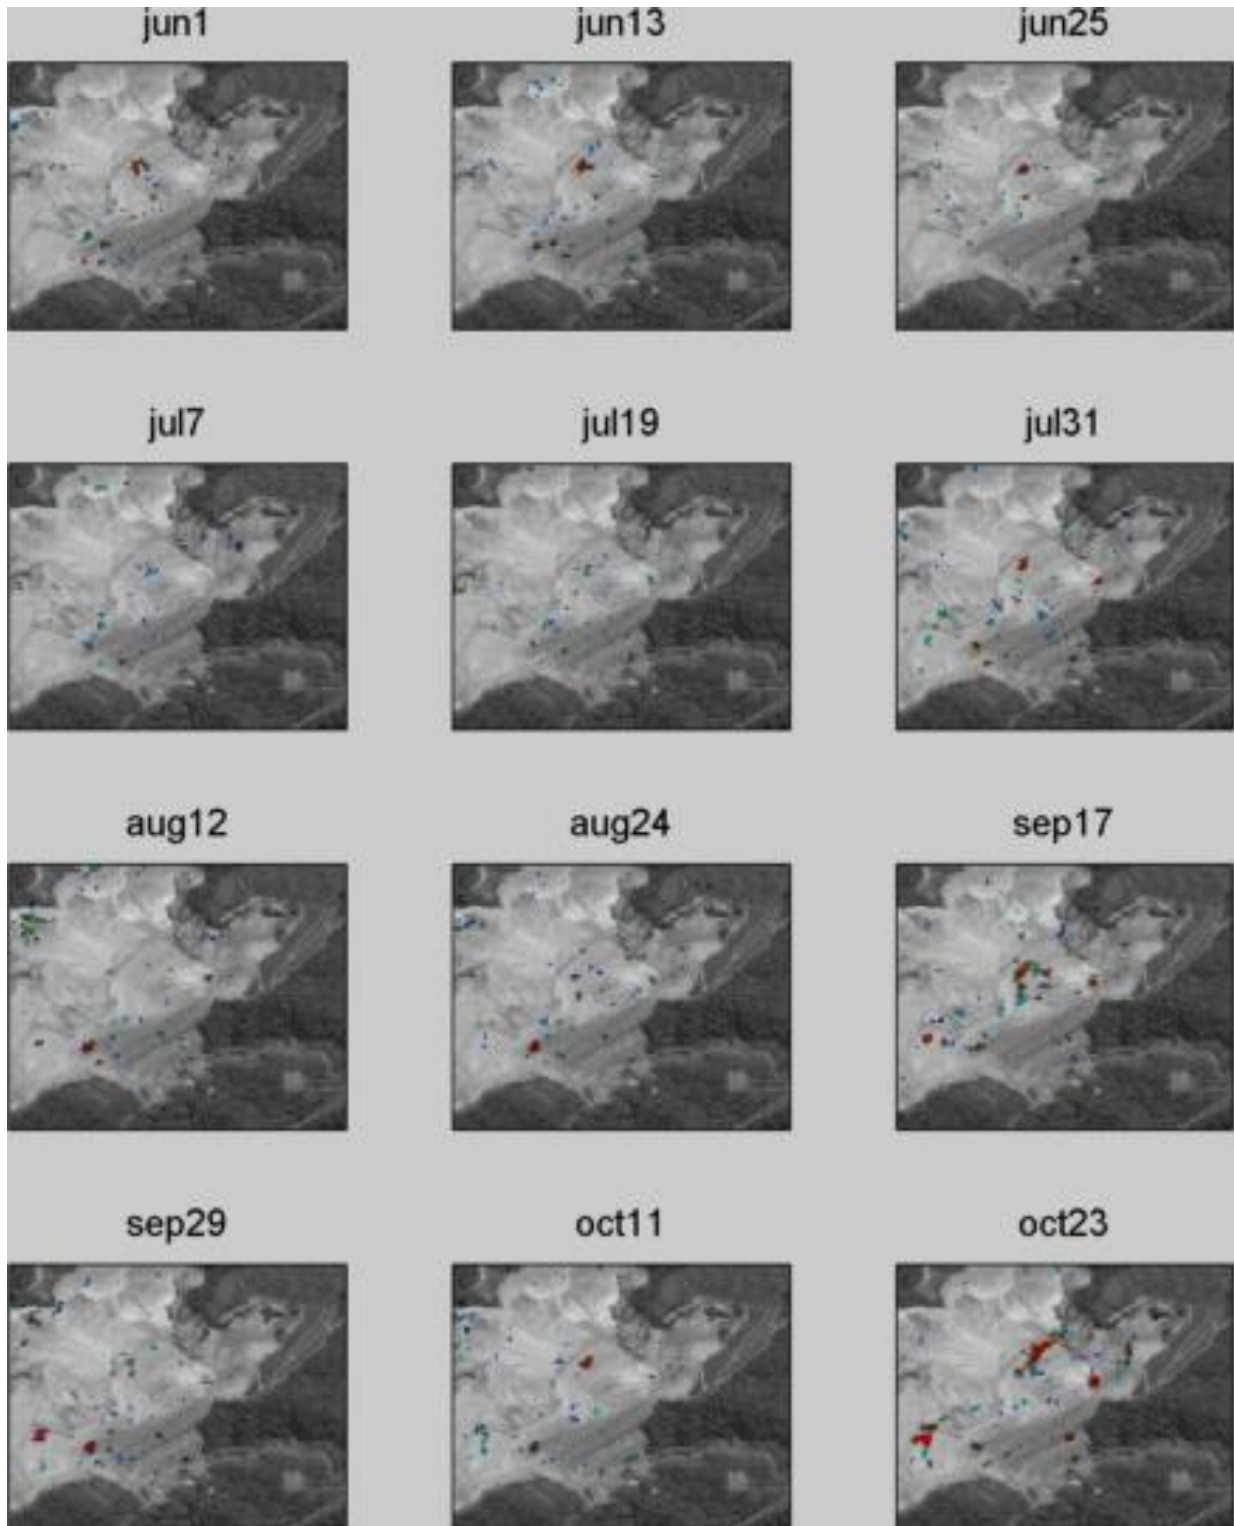
Dielectric constants were then estimated for each scene from the VH and VV polarized images. The largest 1% dielectric constants were coloured on the images in Figure 7, with red being the largest dielectric constants, corresponding to the wettest tailings dam slurry.

Figure 7: Moisture estimates for 12 SAR scenes before the dam broke.

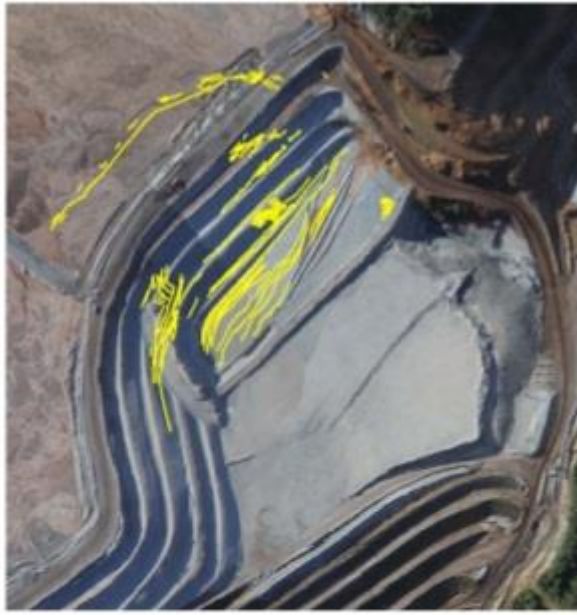
**Figure 2-14 August 27, 2014 cracking at left abutment setback**

The report into the collapse of the dam commissioned by owner Samarco (Morgenstern *et al.*, 2016), released in August 2016, notes that cracks appeared in the left abutment setback of the dam wall in 2014 (Figure 8). These cracks were repaired. The report is available on a dedicated website (<http://fundaoinvestigation.com>) and registration is required to access it. Eye-witness accounts confirm that the dam failed at the left abutment setback. Dielectric constant estimates confirm moisture build-up in the vicinity of the repaired cracks prior to the catastrophic collapse (Figure 9).

*Figure 8: Cracks mapped at the left abutment setback over a year before collapse.*

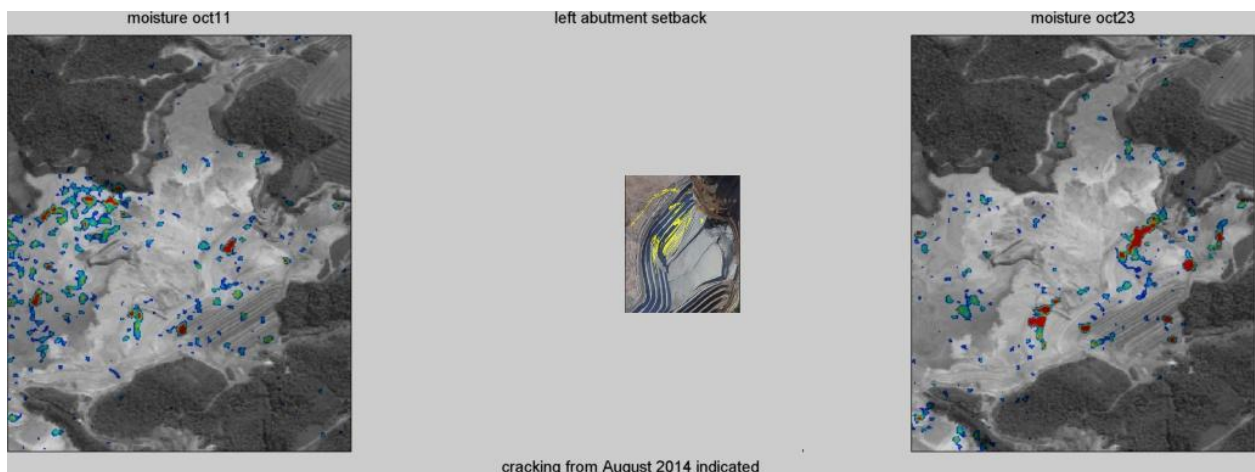
*Figure 9: Moisture starts to build up in the vicinity of the 2014 cracks.*

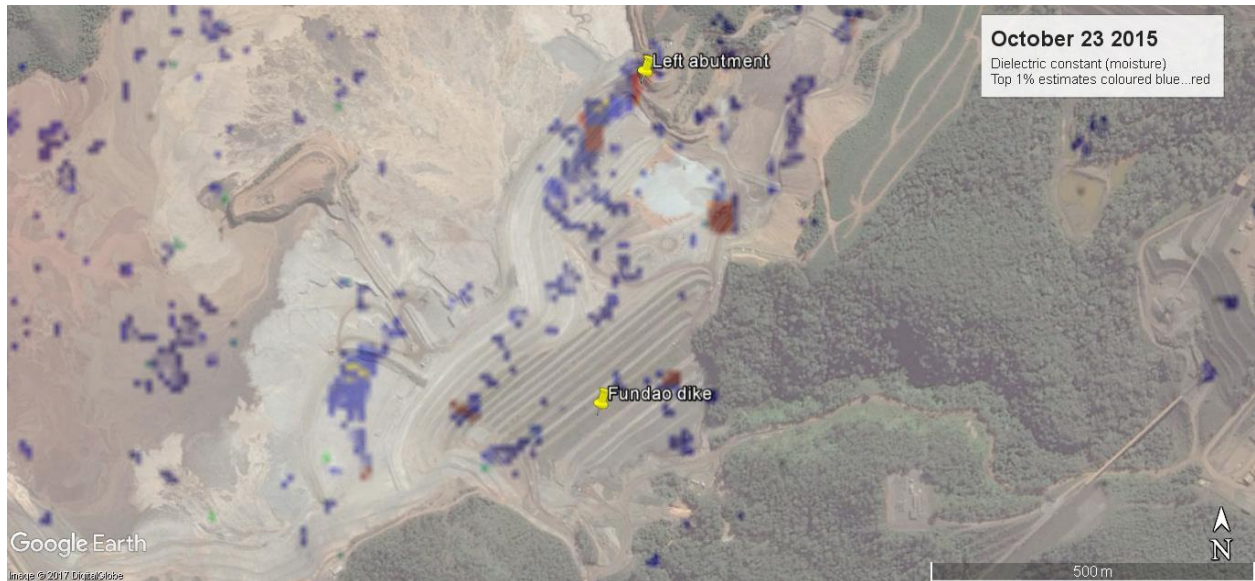
In this case, the Figure 10 is clearly worth a thousand words. Arguments for monitoring moisture are quite persuasive, although work still needs to be done to convince the technical community. We

Figure 10: Two weeks before the left abutment failed, moisture is clearly an issue.
