## GROUND CONTROL AT LEINSTER NICKEL OPERATIONS

J Cahill and M Lee  
 BHP Billiton, Leinster Nickel Operations

Leinster Nickel Operations, located in Western Australia, consists of an underground and three open pit mines in relatively adverse ground conditions. This paper reviews our ground control practices in the open pits, covering aspects of ground support, wall control and monitoring. These methods have been effective in allowing mining operations to continue beneath unstable slopes. In particular, the use of Groundprobe's Slope Stability Radar has enabled the Harmony Open Pit to safely operate for months following indication of failure from traditional methods. This case study highlights the benefits of investing in appropriate slope stability monitoring systems.

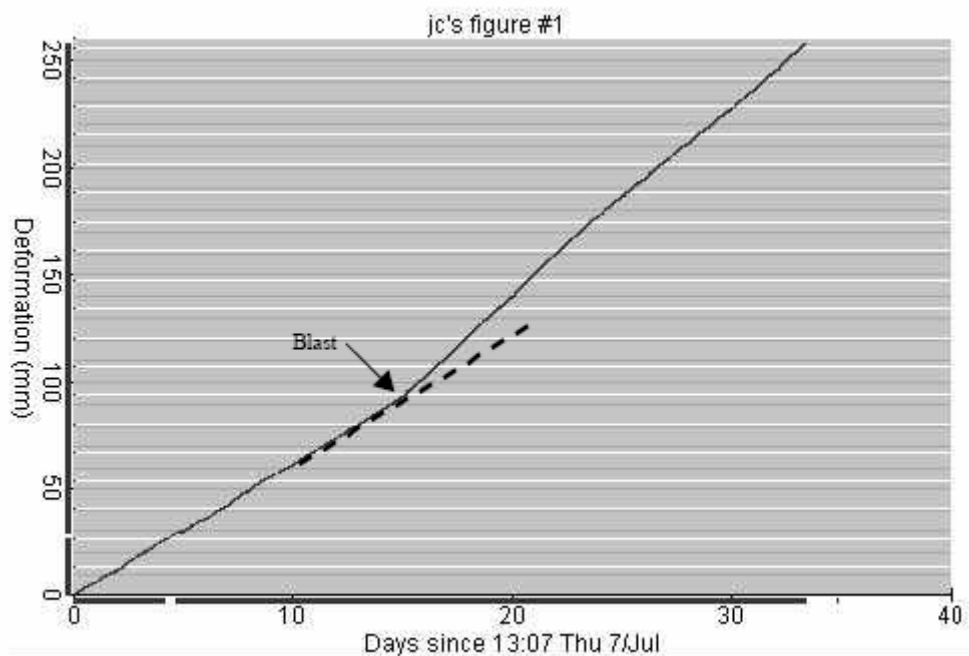
Figure 3 shows the increased rate of movement following blasting. Accelerated movement was monitored until a steady rate was established prior to blast clearance.

**Figure 3 Accelerated wall movement due to blasting.**

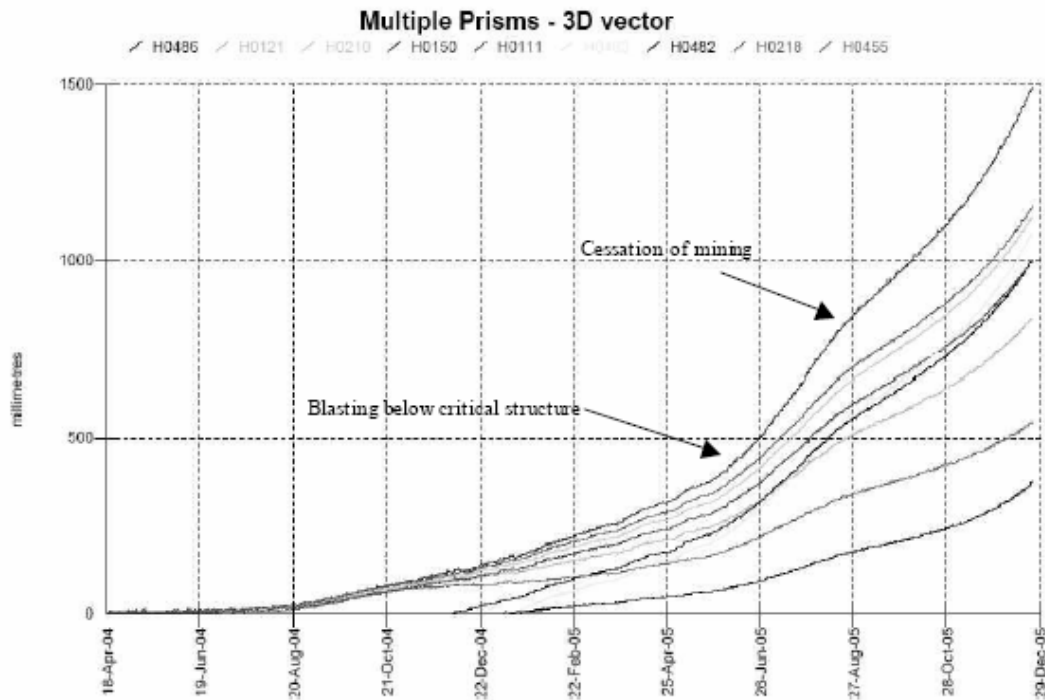
Figure 4 shows typical prism movement in the south east corner, where readings were taken every 24hrs. Prism rates accelerated after blasting below the critical structure. Rates decreased for a short time following cessation of mining, but continued to increase in the long term.

Figure 4 Prism movement data represented in Quikslope's graphing tool.

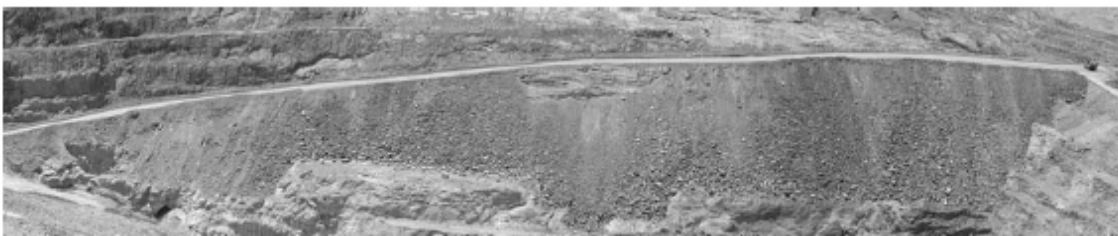
Ground control was also implemented by using backfill to buttress against unstable sections of wall (Figure 6). Fill buttressing was proven effective in stabilising a major ramp, where relative movement within the ramp was halted.

**Figure 6** Rock fill buttress placed to increase stability of the main haulage ramp.

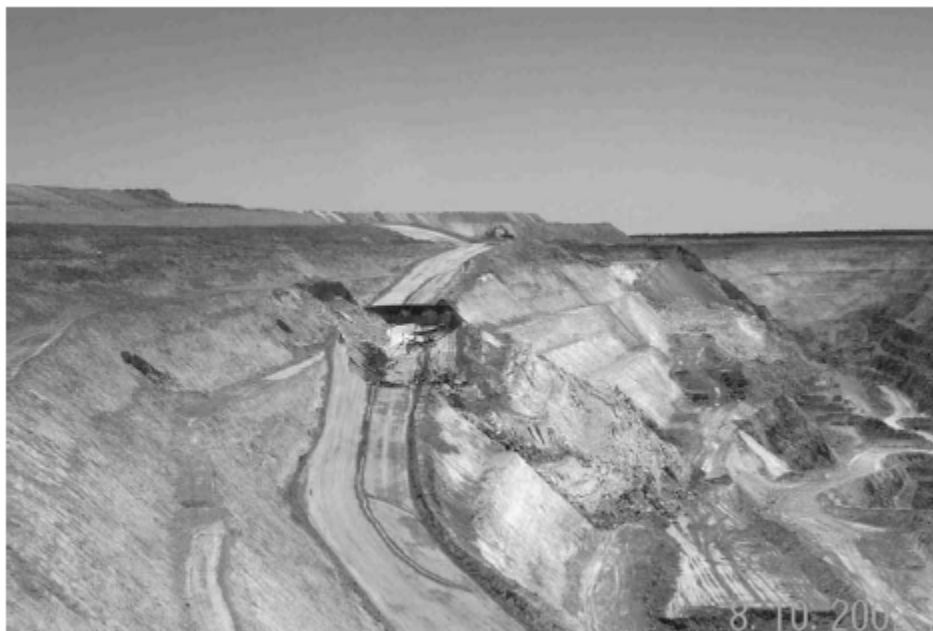
A major failure to occur in the Harmony pit was that of the Komatsu Ramp 8/10/02. The structurally controlled failure occurred in weathered material and was predicted by prisms and crack gauges, giving adequate warning to remove the crew from the pit.

**Figure 7 The Komatsu Ramp failure, Harmony Open Pit**

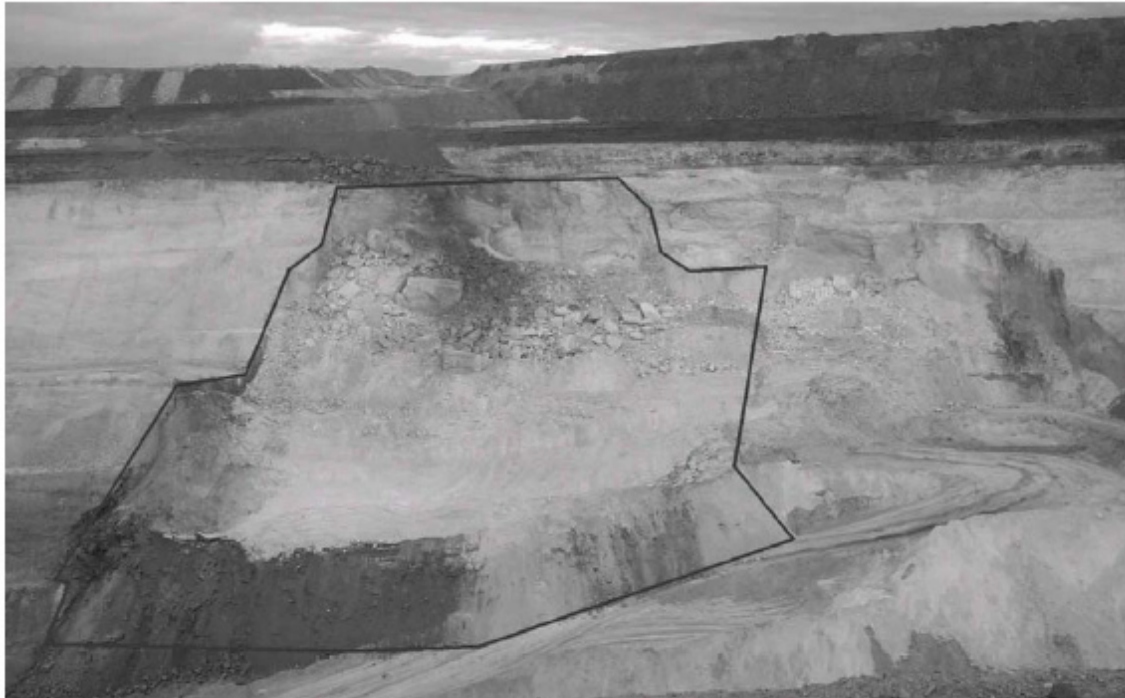
The 1C slip was an extension to a previous failure. It occurred on 23<sup>rd</sup> June 2003 while a clean-up was being undertaken to re-establish mining in the area following the initial failure.

**Figure 8 Harmony 1C Slip, showing existing failure to the right, with extension outlined.**

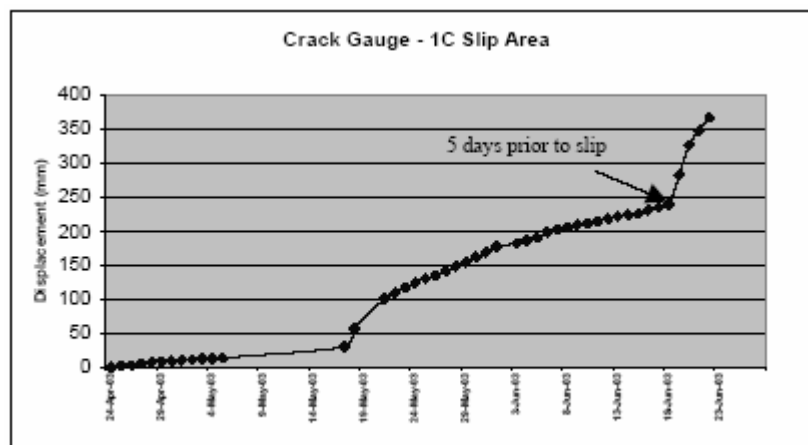
The failure was anticipated from the 18<sup>th</sup> June due to movement observed in prisms and crack gauges. Figure 9 shows the crack gauge data, with distinct acceleration of movement.

**Figure 9 Crack gauge data from the 1C slip.**

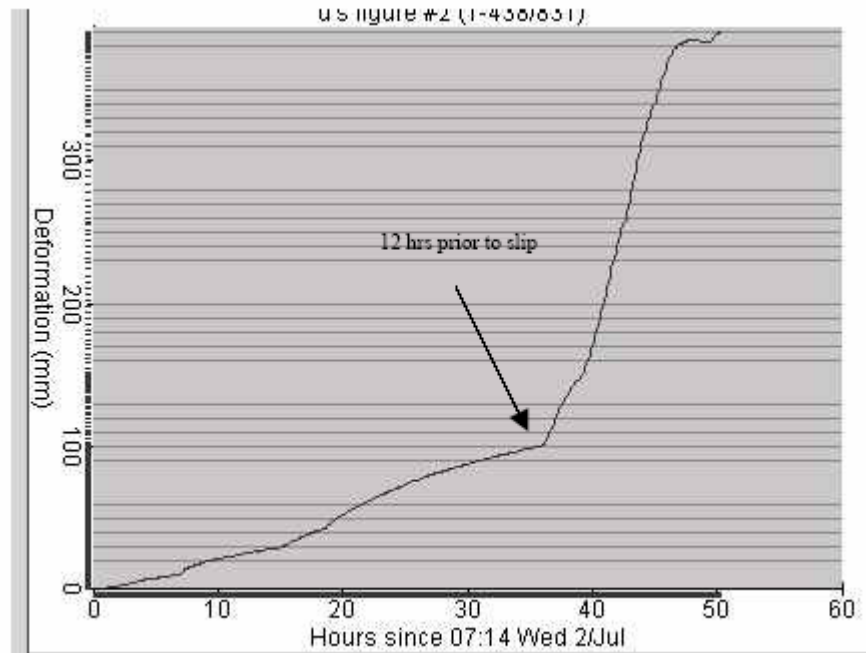
Monitoring of area continued by radar, which showed significant acceleration approximately 12hrs prior to failure (Figure 10).

**Figure 10 Radar data of the IC Slip extension failure.**

Monitoring of this failure gave confidence that prisms and crack gauges would give adequate warning of impending failure in similar ground conditions. Furthermore, the radar monitoring showed that once the prisms and crack gauges indicated failure, there

was still a significant amount of lead time prior to the onset of wall failure. This data clearly showed the benefits of radar monitoring, when working under unstable walls.

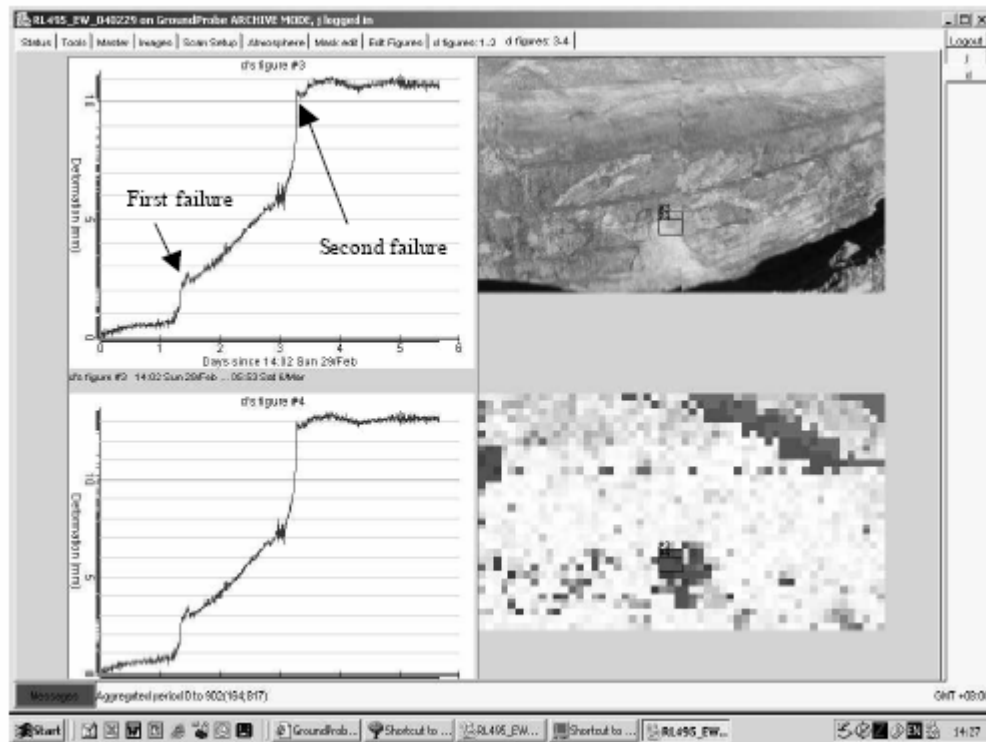
The north east wall fresh rock failure occurred as an extension of a previous failure. Due to the recognised potential for further instability, the radar was used to monitor the area whilst work was occurring nearby. The prism system was inoperative, since no new prisms could be installed on the batter face. The radar detected movement prior to slab failure then movement continued until a second slab failed approximately two days later.

Figure 11 shows wall data as seen on the radar screen. The plot bottom right is a heat map of wall movement over the section in the photo top right. The two figures on the left show movement over time for selected areas of the wall.

**Figure 11 Radar data of two slab failures in fresh rock,**

The monitoring of this failure gave confidence in the radar's ability to give forewarning for failures that occur in hard rock. Initial failure occurred within a period less than the average time between prism readings. It also demonstrated the ability to determine if further failure was likely to occur.

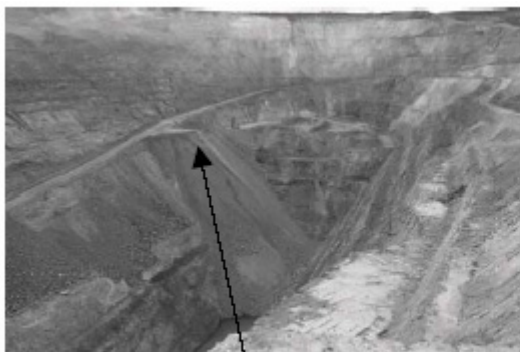
Figures 12 through 14 shows the progression of the constructing, and then excavating the fill ramp. Figure 12 shows waste rock being placed to access upper benches. Placement of the fill temporarily slowed wall movement rates. Figure 13 shows excavation a further 30m in depth. All geotechnical analysis to date indicated major wall failure if mining continues past this point. The final pit, a further 43m past.

**Figure 12 Construction of the fill ramp.**

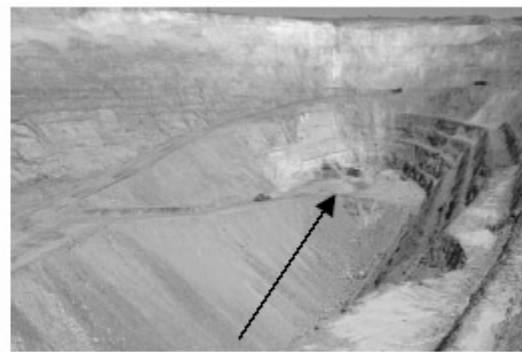
**Figure 13 Excavation has advanced 30m in depth.**

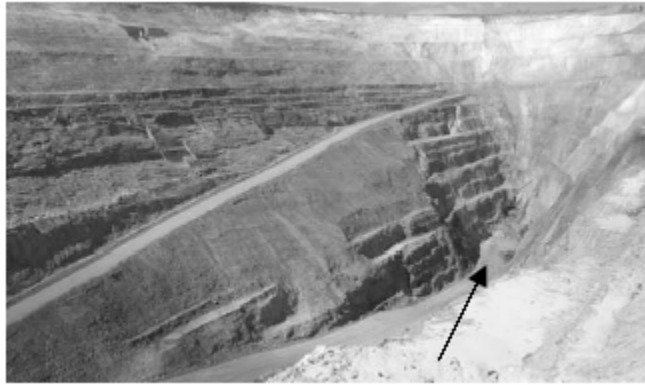
**Figure 14** The final result a further 43m in depth.

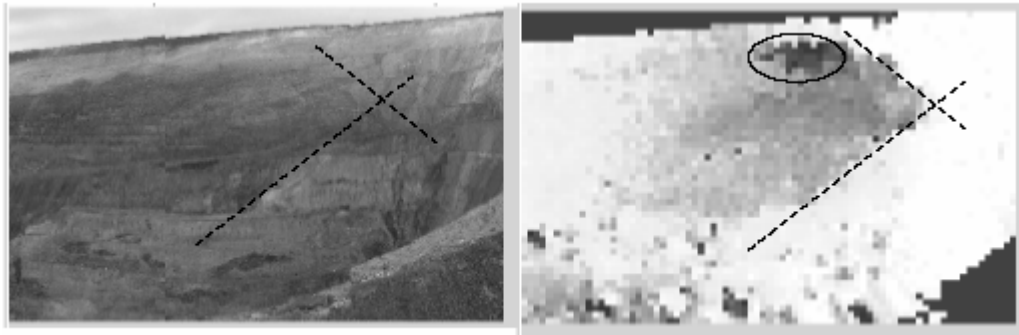
In the later stages of mining there were movements of up to 20mm per day recorded on the batter faces by the radar, indicating that they were starting to buckle. Figure 16 shows radar data of the south east wall. The structural boundaries of the movement are clearly

visible on the movement heat map on the right. Circled in Figure 16 and photographed in Figure 17 is the uppermost berm, which showed extensive cracking and slumping.

**Figure 16 Radar data of south east wall.**

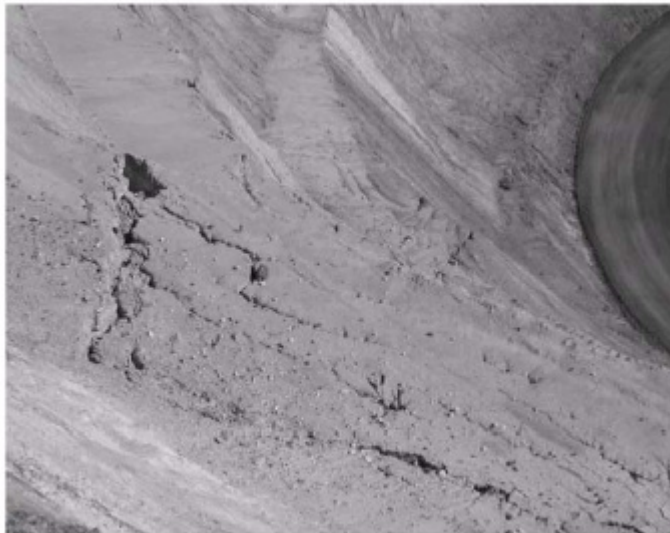
**Figure 17 Cracking and slumping of a berm above the ramp.**
