Winning paper: Analysis of strike gully stability at TauTona Mine

by J. Thompson* Paper written on project work carried out in partial fulfilment of B.Eng (Mining Engineering) degree

Synopsis

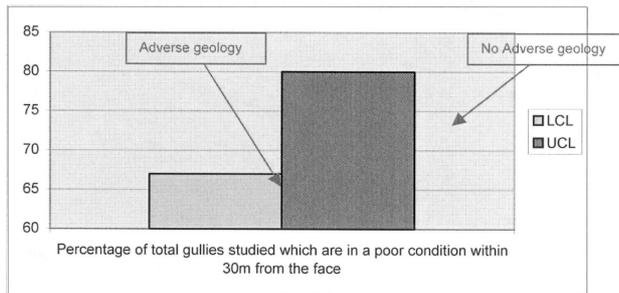
An even more interesting point brought to light in Appendix 1 is shown in Figure 2. 67% of gullies in the LCL are mining under adverse geology and all of these gullies were in a poor condition within the first 30 m, the remaining 33% (not mining adverse geology) were less inclined to deteriorate as quickly. Surprisingly in the UCL, where no real adverse geology was found and ground stresses are less, 80% of the gullies were found to deteriorate quickly. Thus it could be argued that should adverse conditions not have existed in the LCL (as was the case in the UCL) then,

Figure 2—Percentage of gullies in a poor condition within 30 m from the face

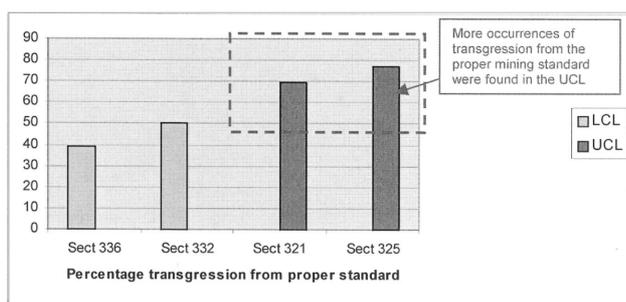
- 74% of the tabulated transgression groups take place
- Not as deep nor as influenced by 'adverse' geology or high stress as is the LCL (thus is a 'less hazardous' area)
- Greater tendency of non-adherence to proper mining standard
- Early gully deterioration in most cases due to these transgressions.

Figure 3—Recorded sectional transgression from mine standard

- This is a 'more hazardous**' area due to ultra depth as well as 'adverse' conditions
- Early gully deterioration most likely more as a result of the adverse geology than transgression

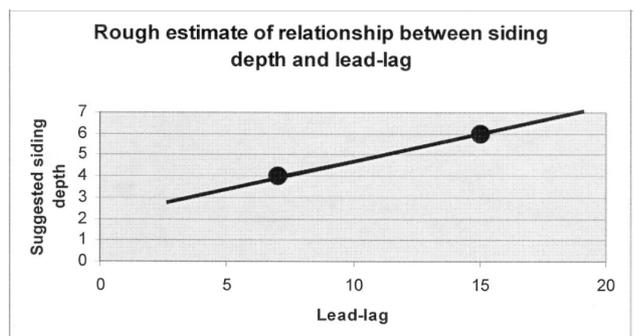
There appears to be a relationship between siding depth and panel lead-lag. When the panel lead lag is well below 10 m (7 m or less), a siding depth of 4 m is more than adequate. Yet a gully with a panel lead-lag above 7 m can be characterized with flat hanging fractures even if a siding depth in excess of 4 m is carried.

Figure 4—Estimation of the relationship between lead-lag and siding depth

Figure 4. suggests that the TauTona standard of <10 m lead-lags may require the required siding depth to be increased to roughly 5 m. However, Figure 4 is not based on substantial evidence and thus it is enough to suggest that for a siding of 4 m a lead-lag <7 m should be carried, else the siding depth is to be adjusted accordingly.

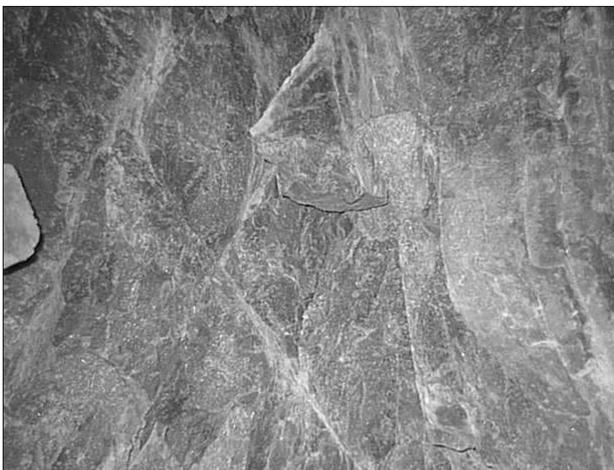
A 'criss-cross' fracture/jointing pattern is evident in the hangingwall.

This is believed to be partially due to the reduced middling (between reef and Green Bar) of this area. It was also noted that the reef was carried low down in the panel face, thus effectively reducing the already below average middling even further.

Photograph 1—Adverse geology—'Criss-cross' fracture pattern in gully hanging

Applying shotcrete to the gully hanging seems to be the most logical solution and will most certainly prevent this key block initiated hanging failure. TauTona is currently investigating the use of various skins to provide areal coverage in gullies.

- ▶ Investigate and implement the use of shotcrete or other super skins on the hangingwalls of gullies situated in adverse ground conditions. Special attention should be paid to the 'stick side' from which failure tends to originate.

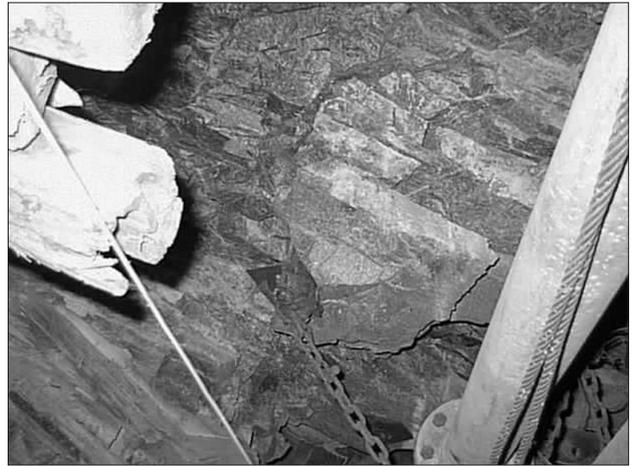
The result is that 'key blocks' fall out of the hanging. Once a key block has fallen, horizontal-clamping forces in the hanging can no longer be maintained and the failure propagates outward over the entire hangingwall. The failure usually begins in the siding or 'stick-side' area and then propagates out towards the gully hanging.

Photograph 2—Adverse geology—typical 'key block' failure in gully hanging

Another possibility, which is successfully implemented at neighbouring mine Savuka, is the application of backfill in the stick side. This will certainly prevent the initial key block failure in the siding from propagating into the strike gully, but holds both advantages and disadvantages over the shotcrete system.

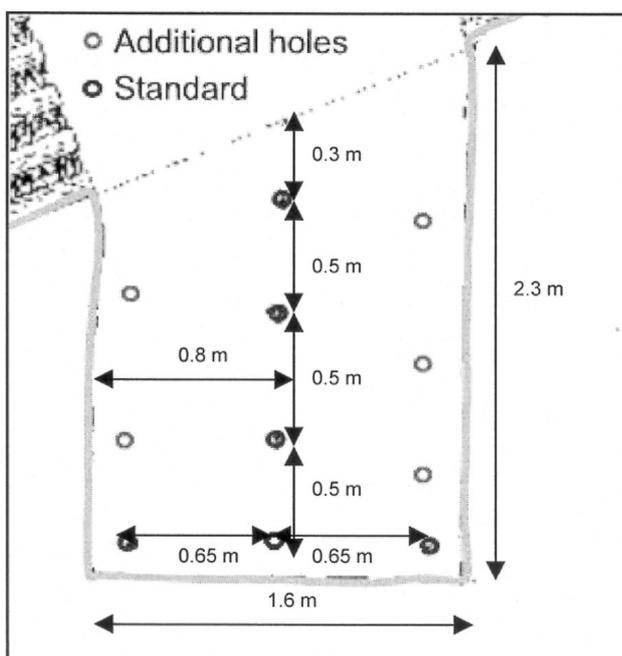
Figure 5—Placement of the problematic side blast holes

these holes is believed by many to assist in creating a smoother break of the gully shoulder, but management has stressed that these holes should not be charged up. These side holes, however, need to be spaced closely together (about 30 cm) in order to have this desired effect.

- Drillers drill these additional side holes, which have been requested for by management, but the temptation to charge these holes is simply too great and the gully shoulder, on which a timber packs is to rest, is consequently damaged by the induced blast fractures.
- The spacing between consecutive side holes was, in general, noted to be so great that it is unlikely that their use will have any significant effect on the smoothness of the induced break. In fact, the mine standard makes no mention of these side holes in the first place and it has been shown on numerous occasions during AEL demonstrations that the current standard (without these side holes) works well when the correct burden, spacing and timing is used.

- It begins with the education and continual coaching of the entire stope team so that confidence is restored in the original mine standard. Workers need to be convinced that the standard does work if the correct timing sequence and spacing of holes are used.
- The next step is to completely discourage the drilling of the additional side holes in the gully face. Unless an impractical number of them are drilled, they will serve no beneficial purpose. What they do however, is waste valuable time that could be used to a much better avail. It should also be noted that if these side holes are not drilled, then it removes the temptation to charge them up and the subsequent damage to the gully shoulder is also prevented.

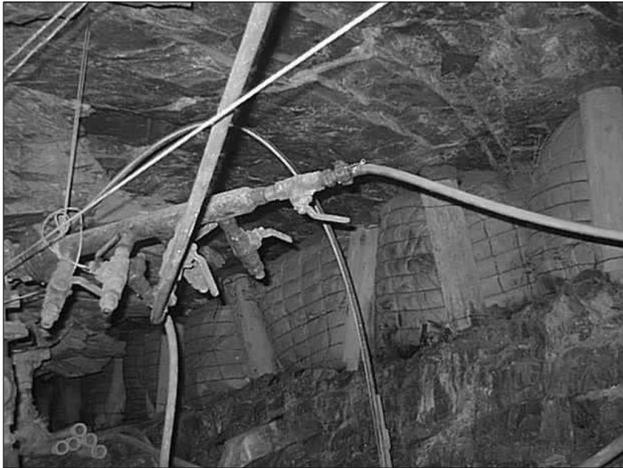
Photograph 3—Split sets installed in cubbies only after initial failure has occurred

- ▶ 90 % of all split set related transgressions were due to the split sets not being installed within 1 m behind the gully face (Appendix 1). On average over the 11 studied gullies the first row of split sets were installed 4.2 m behind the gully face. This relates to roughly 5 blasts, or assuming 3 blasts a week, almost 2 weeks worth of extra time in which the gully hanging is not supported. A direct result of this is the irreversible opening up of mining-induced extension fractures within the hanging. Opening of fractures results in a decrease in the horizontal clamping forces within the hanging, and thus a greater possibility of a key block falling loose results.
- ▶ Another very common form of malpractice takes place in the winch/water jet cubbies as well as at strike/dip gully intersections.

- ▶ The initial fall could damage equipment in the cubby
- ▶ Horizontal clamping forces in the hanging have been lost.

- ▶ Implement an INCENTIVE programme in which the team is rewarded should their split sets be up to date and to standard. This is a controversial issue; where on the one hand it makes sense that in order to get people to act a certain way, they will require incentive, it must be said that the reward (if monetary) should not be large enough so as to blind the workers from the importance of face advance. Perhaps the incentive should be driven by the creation of awareness of the dangers and consequences of not installing tendon support to standard or by the creation of an additional use for the split set as proposed later.
- ▶ Note that the suggestion to discourage the drilling of side holes in the gully face (see blasting section) could

- ▶ Ensure split sets are installed 1 m behind the gully face so as to prevent opening up of fractures. Make use of the additional time made available by point 2 above and the use of an incentive programme should be investigated.

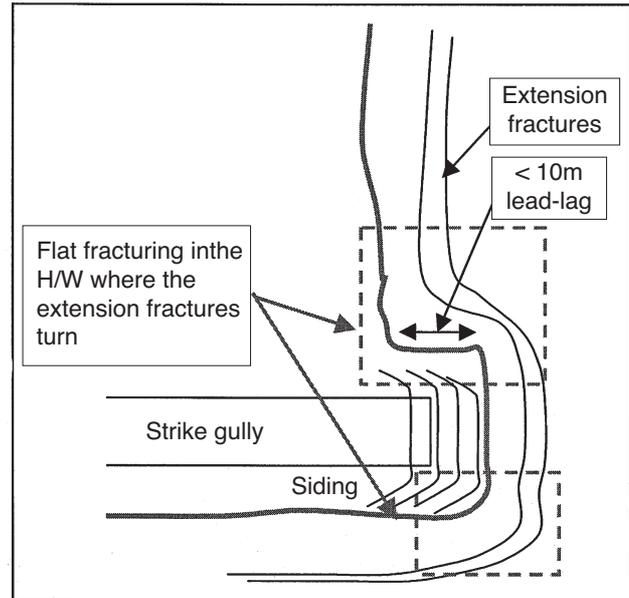
Figure 6—The flattening of extension fractures as they bend into the abutment (pillar)

Basic rock engineering principles state that an extension fracture will flatten when it is forced to bend. This is one of the drawbacks to the leaving of strike stability pillars. The bending of the fractures around the top and bottom of the mini-longwall as they concentrate in the pillar, results in the development of flat hangingwall fracturing (Figure 6.). The carrying of a siding thus attempts to remove the strike gully (and subsequently, the workers) from the area prone to these flat-dipping extension fractures and the potential FOG threat they pose.

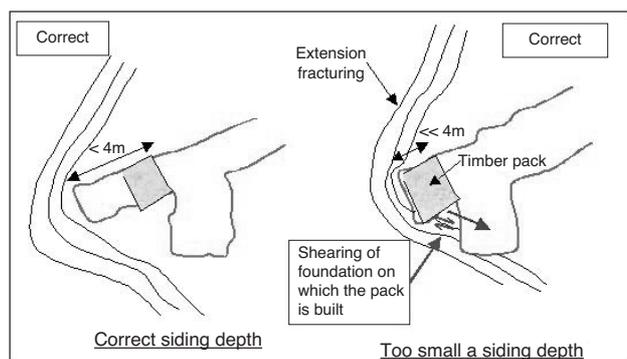
Figure 7—The deterioration of the gully shoulder due to the carrying of too small a siding depth

The effects of carrying too small a siding depth can be serious and the problem is well illustrated in Figure 7. The section through a typical reef excavation, shows how if too small a siding is carried and the strike gully is deep, the extension fractures bending around the excavation may cut into the gully shoulder (on which the timber pack rests) causing the rock to wedge and shear out.

- ▶ Maintain lead-lags well below 10 m. A lead lag of 7 m or less with a 4 m siding depth will ensure steep-dipping hanging extension fractures and it is suggested

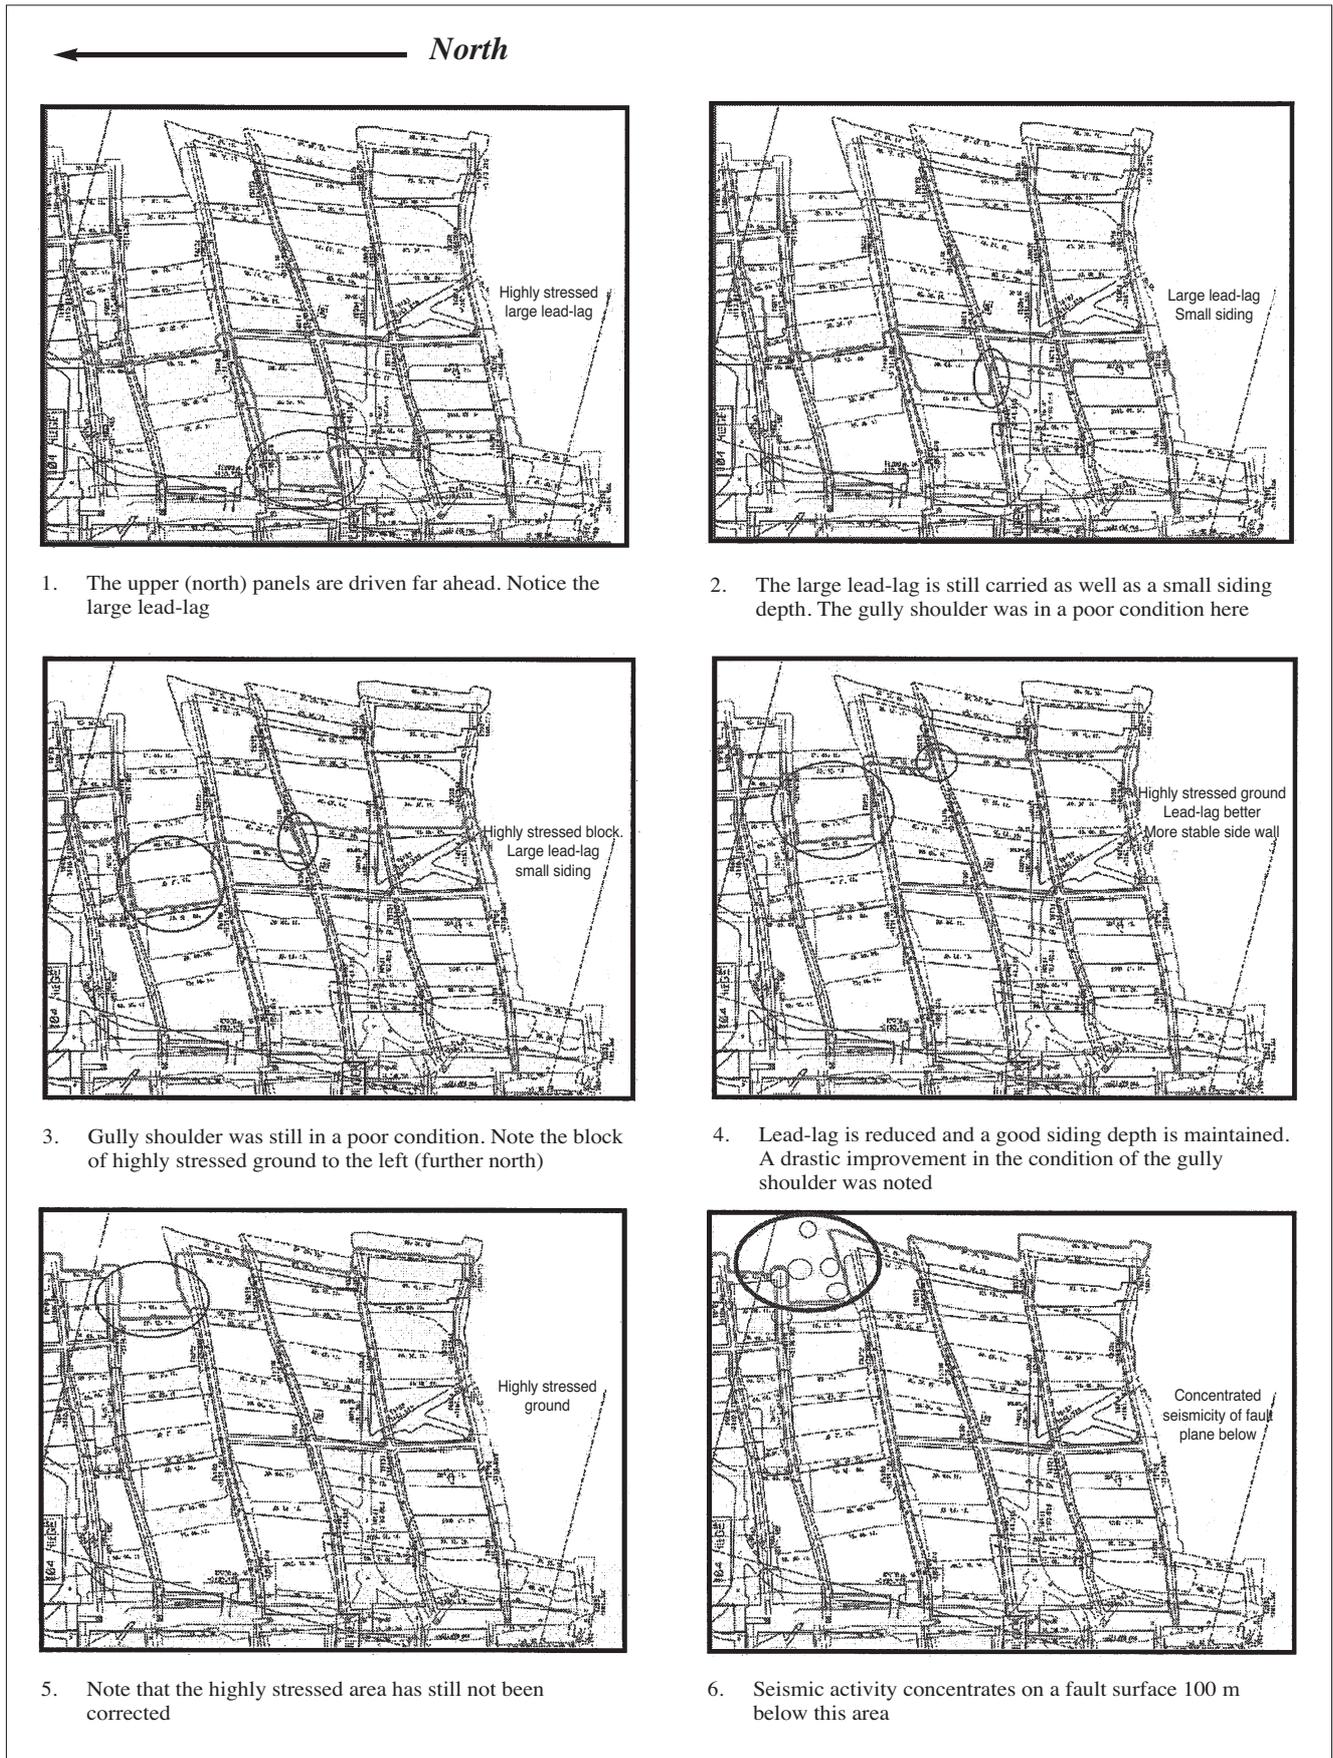
Figure 8—Series showing how the carrying of an incorrect face shape can affect mining

The effects of carrying an incorrect face shape are severe. The practice can result in induced seismicity, poor ground conditions and failure of timber pack support.

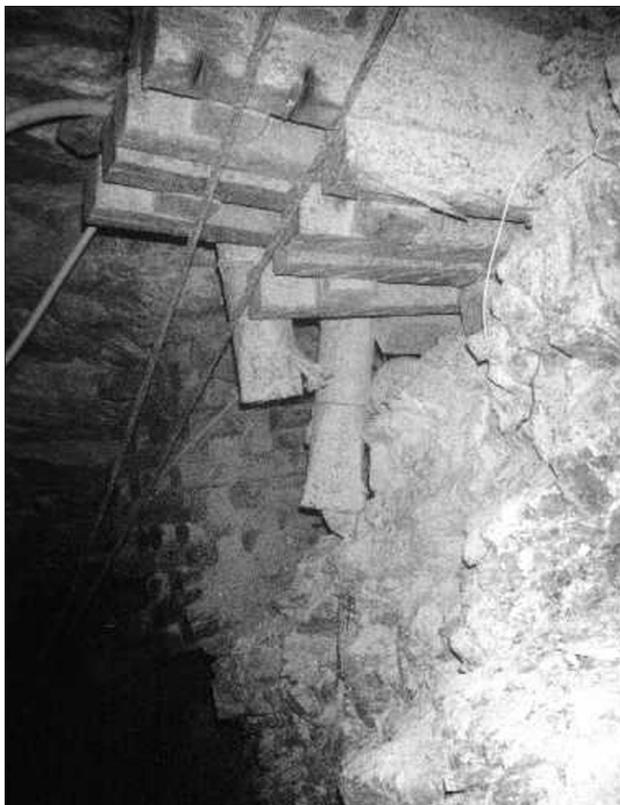
Photograph 4—Typical undermining of timber packs due to off-line gully development

It is clear in the picture that the timber pack is offering less than half the areal coverage it should and a fire hazard is also created as the scraper cable cuts into the timber.
