Management of a major slope failure at Nchanga Open Pit, Chingola, Zambia

by W.A. Naismith* and S.D.N. Wessels†

On 16 July 2004, at 07:10 a collapse of about 1.8 million m³ (about 4 1/2 million tons) took place on the north wall on Nchanga Open Pit.

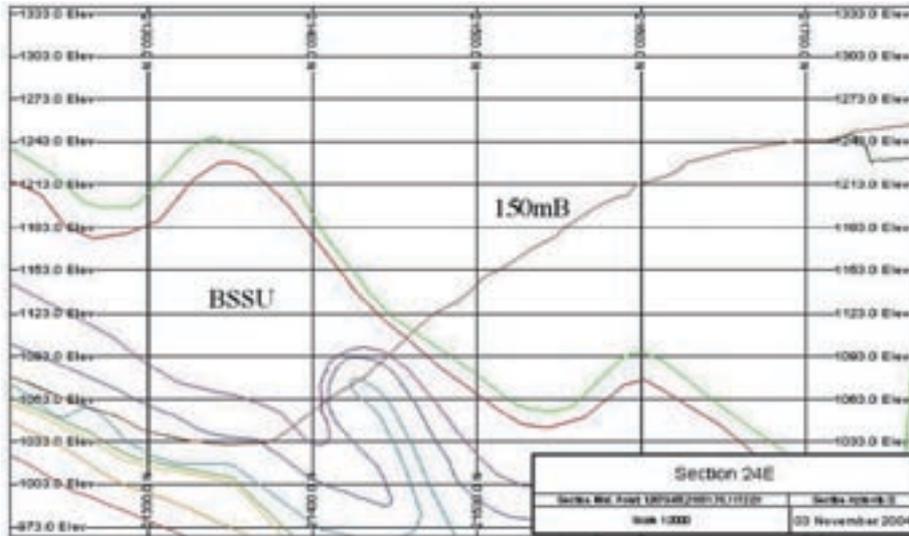
In July 2003, some monitoring points exhibited above average displacements and increases in movement rate. These lay in a specific area between 23E and 24E and from the 150 m bench to the 225 m bench. The increase in movement rates coincided with exposure of a small zone of upper banded sandstone in the core of a tight fold structure on the 270 m–285 m bench. Figure 1 shows a section through the slope at 24E illustrating the geological structure in the face. There was no obvious geological relationship between the elevation at which mining was taking place and the elevation at which deformation was occurring. It was surmised that displacement of vertical joint planes associated with the fold reduced confinement applied to the overlying Chingola dolomite and subsequent compression of this strata was transferred to overlying strata as settlement.

Figure 1—A section through the AOC indicating the geology. Note the exposure of the upper banded sandstone (BSSU) in the nose of the fold

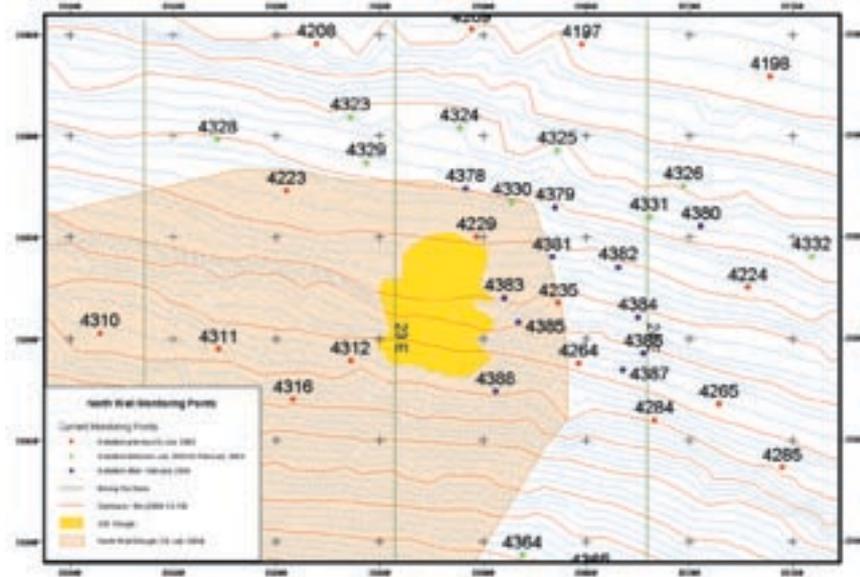
The location of monitoring points installed in the area of concern is indicated in Figure 2. Shading indicates the position of the slough at the end of November 2003, and the hatched area the extent of the July 2004 failure. Unfortunately, no monitoring points were installed in the area of concern below 225 m bench due to a combination of logistical and safety considerations.

Figure 2—Monitoring points installed on the north wall: up to MP4316—prior to July 2003; MP4323 to MP4332—between July 2003 and February 2004; MP4380 to MP4388—after February 2004

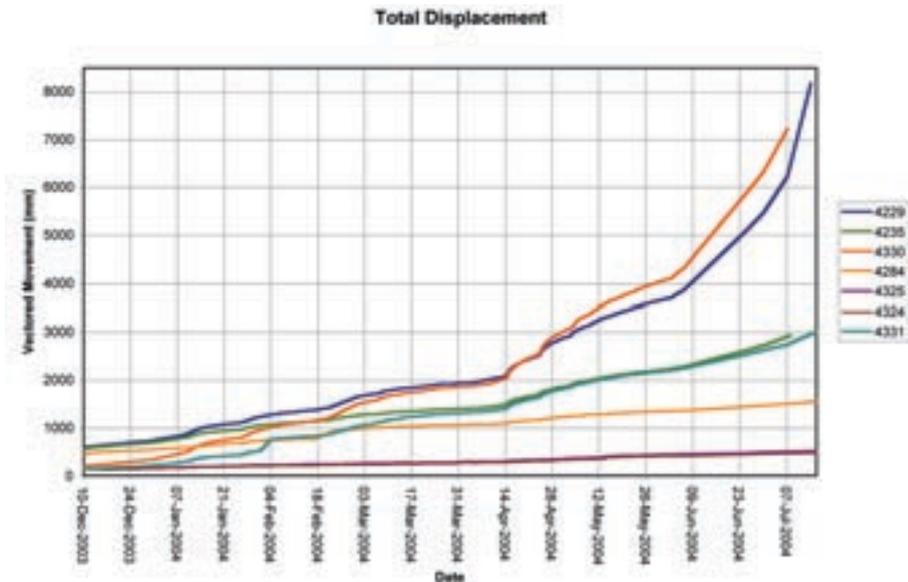
Figure 3 indicates the total displacement measured for a selection of monitoring points for the period from December 2003 to July 2004. Three groupings of points are evident:

MP4330 and MP4229 lie in the area of collapse and have undergone approximately 6500 mm and 7500 mm of movement, respectively, over the period. MP 4229 appears to approach its asymptote in the period following 7th July

MP4235 and MP4331 both exhibit over 2500 mm of displacement. Whereas MP4235 lies on the margin of the collapsed zone and could be expected to move considerably, MP4331 lies some 60 m from the margin and could be expected to exhibit movements of the same order as MP4325, which was installed at the same time. That it has not done so could be indicative of some local anomaly not associated with the main collapse

MP4325 and MP4284 lie outside the area of collapse and have remained relatively unaffected. MP4325 has undergone approximately 400 mm of movement, as would be expected with a background rate of 2 mm/day over the period. MP4284 has undergone approximately 1000 mm of deformation. This is far more than would be expected from the background rate and it is probable that this point has been subjected to a local anomaly.

From examination of the selection of points shown in Figure 3, it is clear that no unequivocal information regarding either the extent of the area of potential collapse or its likely time of collapse can be gleaned. The degree of uncertainty involved in making those predictions and in developing criteria by which to allow men and equipment to work safely is high, and criteria must therefore err on the conservative side.

Figure 3—Total displacement of selected monitoring points from 10 December 2003 to 7 July 2004

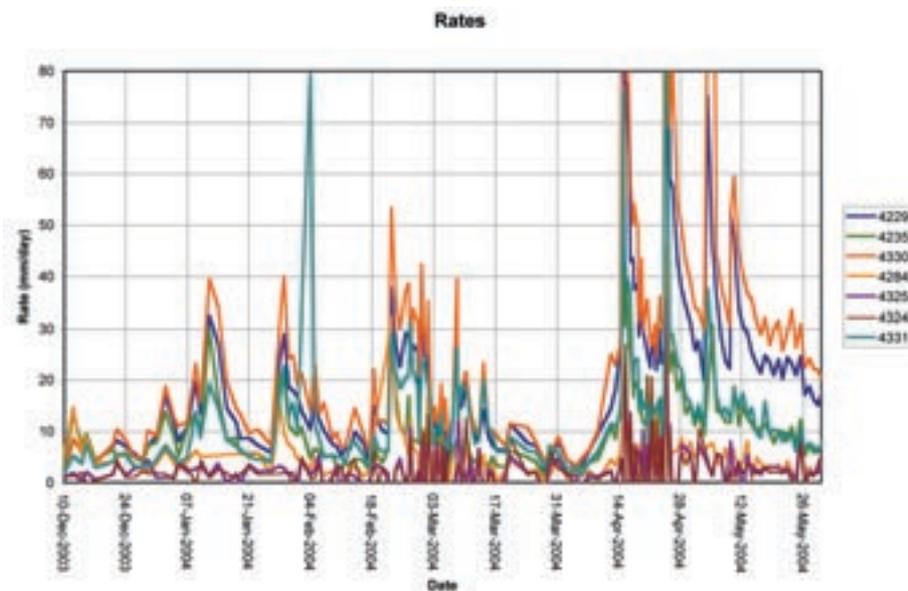
Figure 4 illustrates deformation data that been converted into movement rates for the period December 2003 to May 2004. The response of deformation rate to blasting is clearly

visible, particularly in April and early May when a series of blasts within the area of concern appear to have changed the longer-term pattern of rate increase and decay. Prior to April, following a blast, rates would increase and then decay to pre-blast levels. From the May blast, movement rates have taken much longer to decay and monitoring points lying within the collapse area, MP4229 and MP4330, have decayed to rates much higher than those pre blast. This is perhaps indicative of a change in strength characteristic of the slope from one of primarily peak shear strength to that approaching residual shear strength.

Figure 4—Movement rates: 10 December 2003 to 19 May 2004

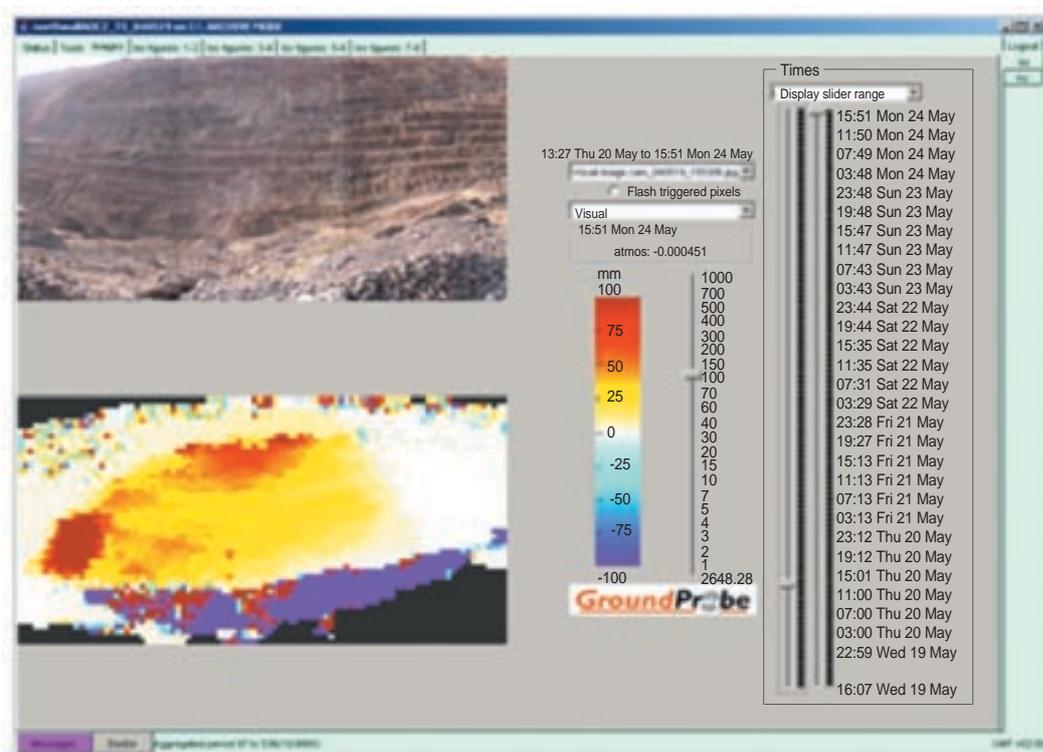
Figure 5—Initial radar survey results showing information that is relayed from the deployed unit to the central site. On screen, warmer (more dense) colours to the bottom right and upper central portions of the figure indicate greatest movements within the monitoring duration

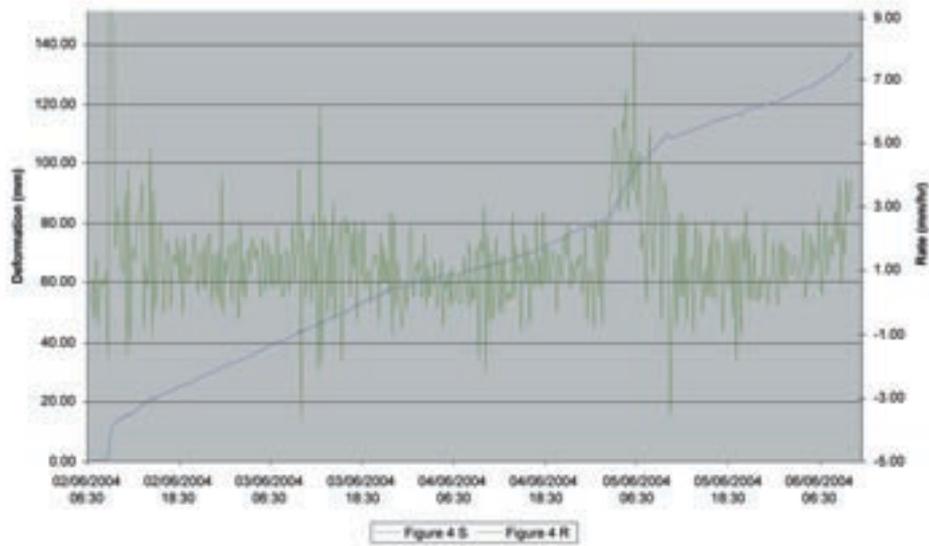
A combined displacement and movement rate graph is shown in Figure 6.

Figure 6—Typical deformation and instantaneous movement rate plots derived from SSR data for a particular window. Note the variation in rate that often occurs between successive scans. A later variation to the software eased interpretation by smoothing the rate graph

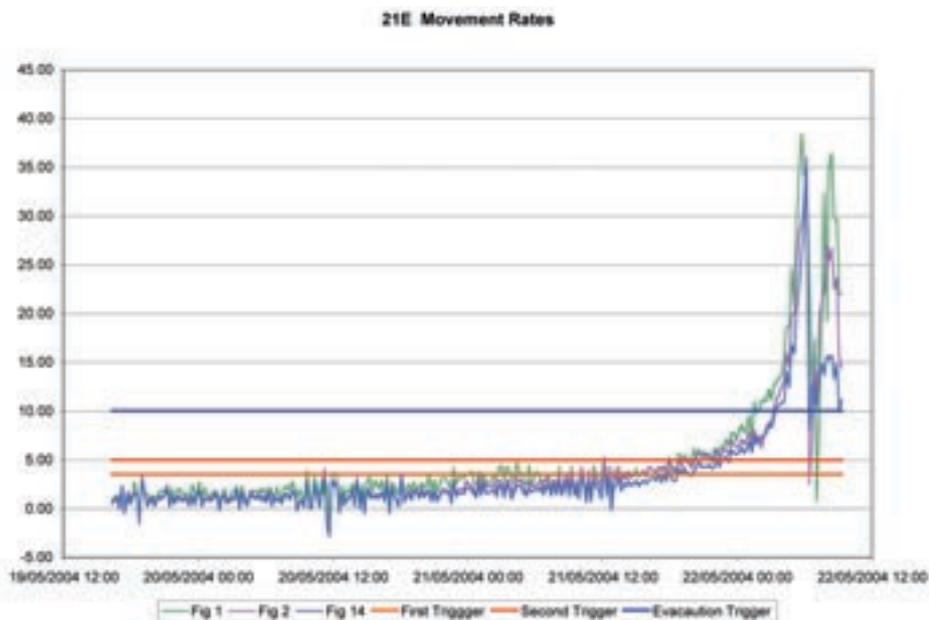
Figure 7—Back analysis of 21E. failure Figures 1, 2 and 14 refer to different windows placed retrospectively on the area. Trigger rates derived from the analysis are indicated by horizontal lines

A back analysis was carried out on data obtained from an analysis window that was located retrospectively to cover the area of collapse. The displacement rates are indicated in Figure 7. The following conclusions were drawn from the back analysis:

The increase in movement rates can clearly be seen in Figure 7. The change in rate of movement is a definite indicator of imminent collapse
There is no indication of the total amount of deformation that had taken place prior to collapse.
Each time an SSR scan commences the displacement

At approximately 12 hours prior to collapse an instantaneous rate of 3.5 mm/hour was exceeded

At approximately 6 hours prior to failure an instantaneous rate of 5 mm/hour was exceeded

At approximately 2 hours before failure an instantaneous rate of 10 mm/hour was exceeded.

time. From a back analysis of deformation rates immediately preceding the collapse, trigger levels of 3.5, 5.0 and 10 mm/h were derived that could be expected to give advance warning of 12, 6 and 2 hours respectively. These intervals were considered acceptable in order to successfully evacuate men and equipment from the area of concern and were adopted as 'alert', 'alarm' and 'scram' warning levels. These are shown on Figure 7.

As these time intervals were considered acceptable in order to successfully evacuate men and equipment from the area of concern, they were adopted as 'alert', 'alarm' and 'scram' warning levels with associated management responses as indicated in Table I.

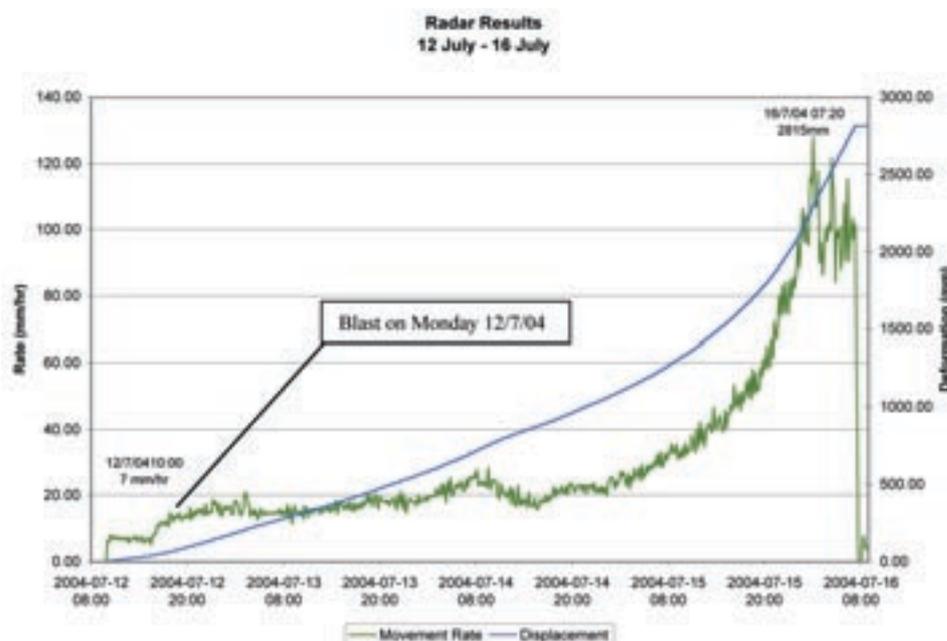
A constant displacement rate averaging 2–3 mm/hour was observed until 9 July, when it started to increase. The reason for this change is unclear. By Sunday 11 July the rates had increased to between 5 and 10 mm/h. On Monday 12 July the rates suddenly increased to 20 mm/h following blasting during the afternoon and continued at between 20–30 mm/h until early in the morning of Thursday 15 July (about 02:00).

This continuing increase had not been observed previously and was considered indicative of a change in condition within the slope. Rates continued to accelerate throughout Thursday and a decision was made at 20h00 to withdraw men and equipment from mining operations lying between 20E and 21E and relocate them further west. At 06h30 on Friday 16 July, rates had increased to 70 mm/h, all operations within the pit were suspended and remaining men and equipment withdrawn, although they were working over 200 m west of the area of concern. Final collapse of the slope commenced at about 06h50 with sloughing and collapse of benches on 150–165 m levels. The main collapse followed at 07h10 when an estimated 4.5 million tons of rock moved and completely inundated the 330 m bench from 21E to 23E. The change in movement rates in the days and hours leading up to collapse can be seen clearly in Figure 8. The maximum movement rate immediately prior to failure exceeded 100 mm/h.

Figure 8—Movement rates and displacement in the four days prior to collapse
