Sutherland, J.J. and Gous, J.P. Managing the tap-hole life-cycle at five submerged arc furnace producing silicomanganese at Transallovs.

Synopsis

This paper gives a review of SAF operation, furnace and tap-hole design, daily tapping operation, and maintenance practices for repairing tap-holes.

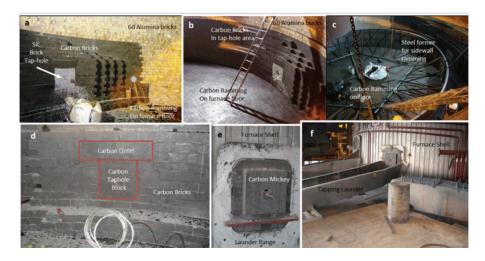
Figure 5—(a) Inside of tap-hole showing the staggered design of graphite bricks and a SiC brick tap-hole; (b) sacrificial carbon ramming on hearth and carbon tap-hole wall before sidewall ramming is installed; (c) former for sidewall ramming installed; (d) carbon tap-hole showing carbon tap-hole block and carbon lintel; (e) outside view of carbon tap-hole showing carbon mickey installed; (f) water cooling channels on furnace shell, front mickey, and launder flange with curved launder design

Figure 5a shows the staggered design on the sidewalls of furnace 3, allowing for optimal contact between the sidewall carbon ramming (Figure 5c) and the carbon bricks surrounding the tapblock. In the semi-freeze lining design the tapblocks, lintels, and mickeys are surrounded by carbon bricks (Figures 5b and d), allowing for maximum heat removal through external water cooling channels as shown in Figure 5f. The outside of a carbon tap-hole showing the installed mickey and the launder flange is shown in Figure 5e.

Figure 5b shows the installed carbon ramming on the furnace floor (800 mm thick). The carbon ramming is taken up to 200 mm below the tap-hole. When completed, a sidewall ramming is installed (800 mm wide) as shown in Figure 5c, covering the tap-hole graphite bricks. A drill depth of 2 m is required to open a tap-hole.

Figure 5f shows the tapping launder installed in position; notice a slight bend 2 m from the tap-hole. This allow for the tappers to lance and poke the tap-hole in a direct line with the

tap-hole to prevent unnecessary damage to the carbon block. Figure 5d shows the front sacrificial mickey and flange as installed. The tapping launder is bolted onto the tap-hole flange.

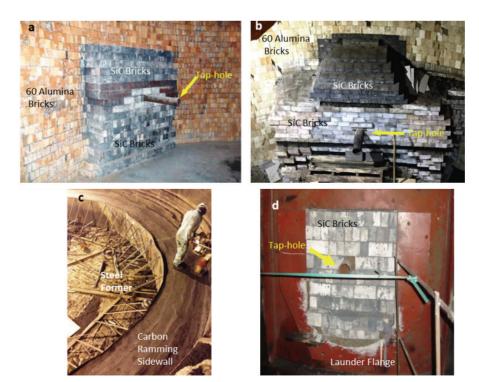
Figure 7a shows the square block tap-hole design (furnace 1). The tapblock area consists of SiC bricks, whereas the rest of the furnace wall consists of SiO₂/Al₂O₃ bricks. Figure 7b shows

Figure 7—(a) Square SiC tap-hole design inside carbon bricks; (b) inside of tap-hole showing the staggered design of SiC bricks; (c) sidewall carbon ramming being installed; (d) outside view of SiC bricked tap-hole

a staggered design of the bricks on the sidewall of Furnace 6, allowing for improved contact between the sacrificial carbon ramming wall (not yet installed) and the SiC bricks around the tap-hole.

Figure 7b shows the sacrificial carbon ramming on the furnace floor (600 mm thick). The ramming is taken up to 200 mm below the tap-hole. A steel pipe is inserted into the tap-hole in order to keep the tap-hole free from any obstructions and to facilitate the opening of the first tap after start-up. When completed, a sacrificial sidewall ramming is installed (600 mm wide) as shown in Figure 5c covering the SiC bricks forming the tapblock. A drill depth of at 1.8 m is required to open a tap-hole.

Figure 7d shows configuration of bricks on the outside of the tap-hole. The face plate and tap-hole flange where the tapping launder will be bolted onto are shown.

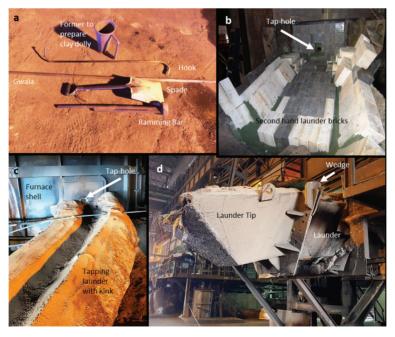
Figure 10a shows some of the typical launder cleaning tools used on a tap floor. A bent oxygen pipe is used to remove alloy and slag buildups after they have been loosened with a steel roundbar. In the case of the claygun not being operational a dolly is used to close the tap-hole manually. Figure 10a also shows a former used to create a tap-hole clay plug to be used when closing the tap-hole.

The steel launder is normally lined with used refractory bricks of any quality used at Transalloys (alumina, SiC, or carbon bricks, Figure 10b), then covered with carbon ramming material and finally covered with a layer of sand (see Figure 10c). The sand makes the cleaning of the launder easier in that it is easier to insert a steel 'gwala' below the metal/slag scull through the sand layer and lift the skull out of the launder.

Figure 10—(a) Tap-hole clay former. hook bend from redundant oxygen lance, poker bar, shovel, and dolly to close tap-hole manually; (b) redundant refractory bricks used on base of launder; (c) river sand used to dress launder; (d) removable launder tip

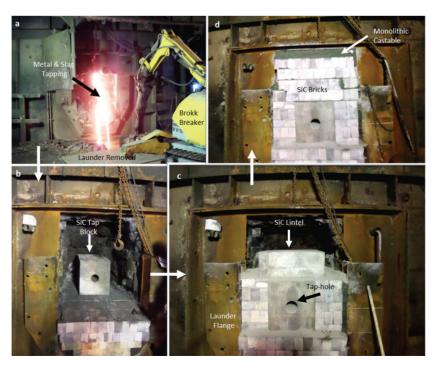
Figure 11 shows the steps in the rebuilding of a SiC tap-hole. A rebuild is completed in four days (from furnace switch-out to first tap), including the warming up of the tap-hole refractories.

Figure 11—(a) Brokk machine breaking out tap-hole; (b) placing of first SiC block; (c) two SiC blocks with SiC lintels; (d) repaired face plate and tap-hole flange

down for 12 hours, removal of tapping launder, installation of a working platform in front of the tap-hole, removal of tap-hole face plate to expose tap-hole refractories, breaking out of tap-hole refractories with a Brokk machine, and allowing the remaining molten slag and metal to drain from the furnace (see Figure 11a). During the breaking out of the refractory and removal of loose burden and solidified slag, water cooling is applied to increase the rate at which the tap-hole area is cooled down. Final breaking out of tap-hole bricks is done carefully with a jackhammer to expose undamaged tap-hole bricks to establish a clean surface to tie-in the new refractory bricks.

Figures 11b, 11c, and 11d show the installations of the SiC –blocks, lintels, and SiC bricks in furnace. The bricks below the block are started from a solid foundation or good floor. After the rebuild of the tap-hole is completed, the faceplate and launder flange are replaced. A steel pipe is placed in the tap-hole and only plugged with a small piece of tap-hole clay at the hot face of the pipe to assist with the opening of the first tap after start-up. After the launder is replaced, the tap-hole bricks are extended into the launder and then rammed with carbon material. It is of utmost importance to check the alignment of the claygun and drill after a tap-hole rebuild.

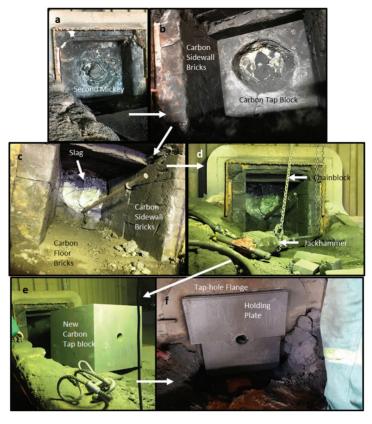
Figure 12—(a) Breaking out of front graphite mickey with jackhammer; (b) installing new mickey; (c) steel plate over mickey holding it in position; (d) repairing launder with carbon ramming material

Under normal conditions, repairing a graphite tapblock entails only the replacement of the front sacrificial mickey. This can be done on an eight-hour planned shutdown. The launder sand and refractory materials in the launder are cleaned out with a jackhammer and shovel to expose the full mickey.

The old mickey is then removed by breaking it out with a jackhammer (Figure 12a) and replaced with a new micky (see Figure 12b). Removal of the first mickey allows for inspection of the second mickey and if required it can also be replaced.

After the mickey has been replaced, a 20 mm steel plate is installed over the mickey to keep it in position (see Figure 12c). Carbon ramming material is then used to line the launder up to the tap-hole again (see Figure 12d). A new mickey does not require warming-up before it can be used.
