Bindura Nickel Smelter - from decommissioning, care and maintenance, to plant re-start

A. Mboma and K.D. Chitaukire

Bindura Nickel Corporation, Bindura, Zimbabwe

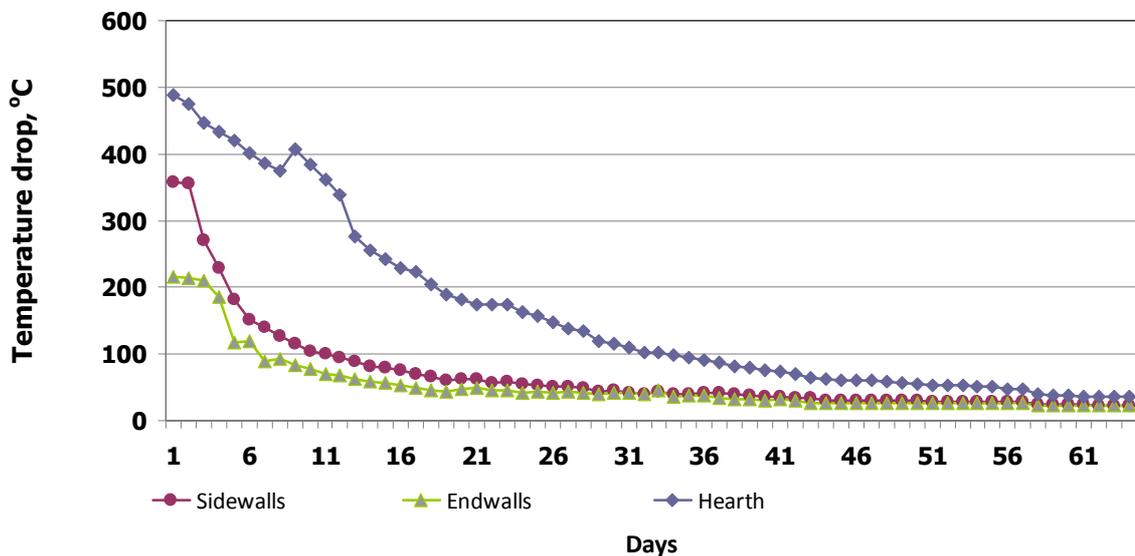
Figure 2: Refractory temperature drops during decommissioning

- On the side-walls, the greatest decrease in temperature was on thermocouple T3, revealing the melt dynamics during shutdown.
- For the end-wall thermocouples, the matte-end placed thermocouple T23 dropped the most, due to the furnace burn-down that aimed at removing the build-up in the furnace.
- The matte-end hearth thermocouple T18 dropped the most due to the furnace burn-down.

After switching the furnace power off, the temperature drop resulted in the contraction of refractory, and subsequently the furnace structure. A sharp increase in the hearth temperature occurred on Day 9, after switching off the hearth cooling fans, and this resulted in a rise in the hearth temperature (see Figure 2) as more energy was conducted from the hot hearth build-up through the refractory bricks.

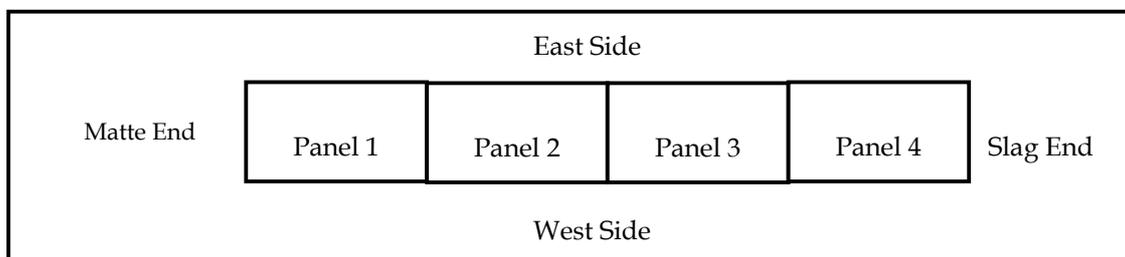
Figure 3: Furnace roof panels arrangement

The furnace roof moved upwards right from switching off, as a result of the drop in the temperature of the refractory bricks and their subsequent contraction. Of the four panels, panels 2 and 3 had the greatest movement, much higher than the normal 50 mm. Roof movements were then controlled by limiting the tonnage decrease on top cross springs to 17 t (normal working tonnage) and top long spring to 15 t (maximum working tonnage) from 9 March.

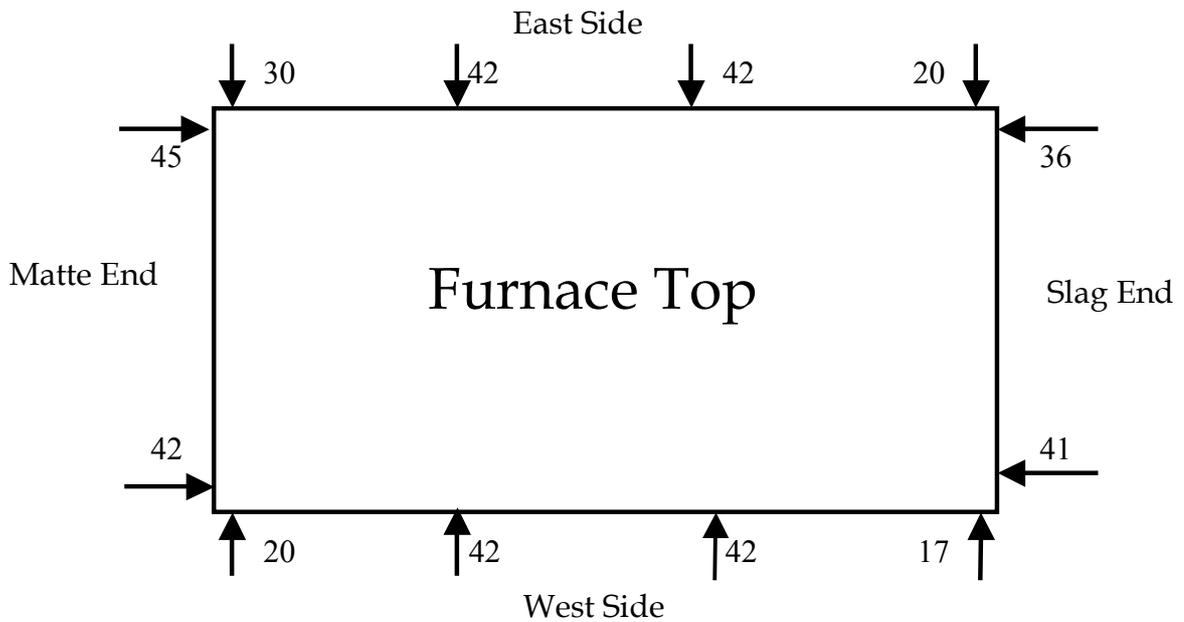
Figure 4: Lateral movements at the Furnace Top (upper section) in mm

Furnace Top: Contraction on the end-walls was relatively uniform, although the eastern matte-end side contracted the most by 45 mm. The side-walls contracted the most at the centre, where panels 4 and 5 contracted by 42 mm, as shown in Figure 4.

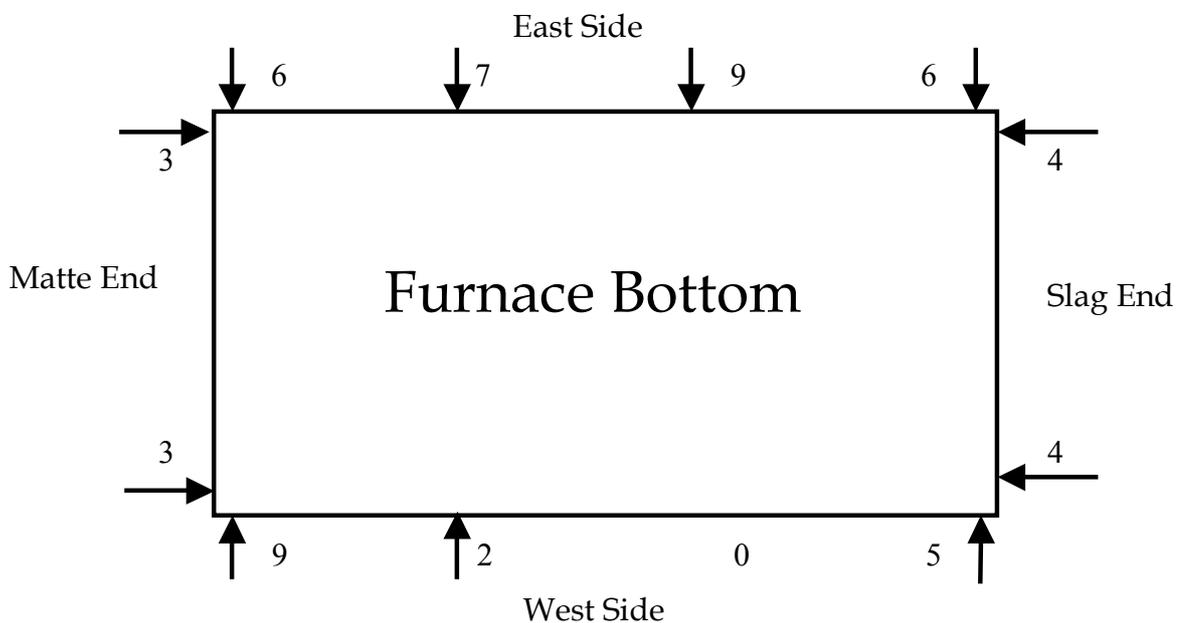
Figure 5: Furnace Bottom lateral movements (bottom section) in mm

Furnace Bottom or Hearth-end: The furnace contracted more at the slag-end than at the matte-end. The furnace bottom (hearth) had the least contraction on the side-walls, with a maximum of 9 mm, indicating the relative stability of the hearth during the furnace cooling period, as shown in Figure 5.

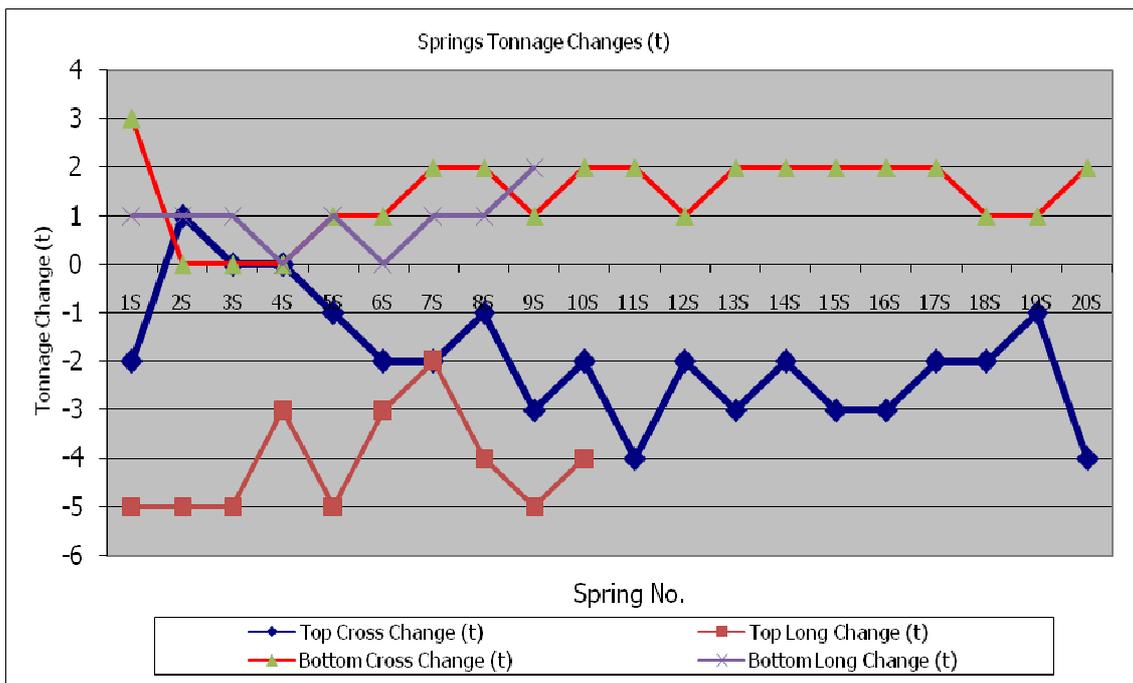
Figure 8. Tensional force changes for individual springs

Top Cross Springs: Major decreases in tensional forces were recorded on springs 11 and 20, which decreased by 4 t each at 21 t, as shown in Figure 8.

Top Long Springs: The biggest drops were on springs 1, 2, 3, 5, and 9, which dropped by 5 t each.
