An operational review of the belt-filtration plant at Chemwes Limited

by J. L. TAYLOR*, B.Eng. (Hons.), M.I.M.M., C.Eng. M.I.M.,
F.S.A.I.M.M.

The belt-filtration plant at Chemwes Limited has been in operation for three years. The plant design is discussed. Operational and engineering problem areas are reported, and where possible the modifications or practices that led to their solution are mentioned.

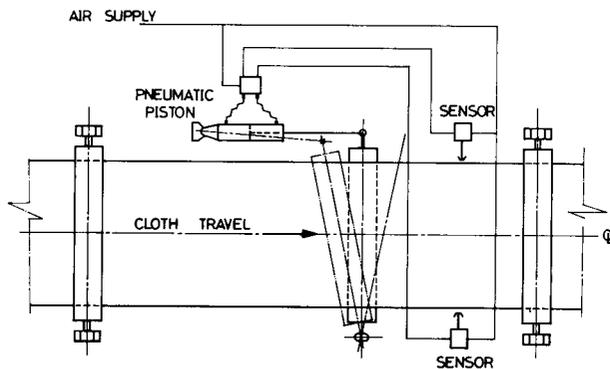
Fig. 3—The cloth-tracking system

The cloth-tracking arrangement is still maintenance-intensive. As described earlier, the cloth is constantly tracked from side to side between the limits set by limit switches. On some filters this can result in the activation several times a minute of the switches and cloth-tracking roller, which is moved pneumatically. This area is also subject to dripping acidic solutions, which adds to the problem of maintenance. Improvements must still be made in this area.

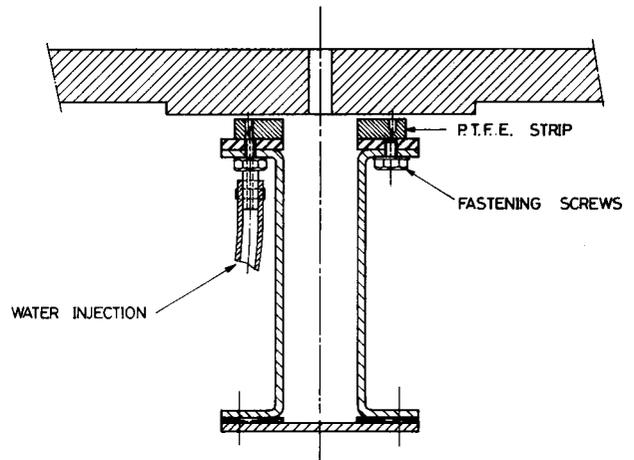
Fig. 4—A vacuum box

This area has been the subject of much attention, experimentation, and development, which are still continuing. The filters were commissioned with the standard rubber wear strips attached to the underside of the belts sliding against P.T.F.E. wear strips bonded to stainless-steel backing plates. The backing plates were

bolted to the top of the vacuum boxes. The filters were commissioned at low vacuum (approximately 40 kPa) to give a low torque for a period of approximately 12 days to allow the filters to bed in; theoretically, a layer of P.T.F.E. is worn off the wear strips and coated onto the rubber wear belt. This never really occurred to the extent that the predicted lower torques were achieved. The

Experiments with vacuum-seal water consumption indicated that improved wear-strip life would be achieved if the number of addition points and the water flowrate were increased. The water flowrate was increased from 5 to 10 m³/h, and the number of addition points was increased twelvefold—from one every 3 m to one every 250 mm. From this point onwards, the guaranteed wear-strip lives began to be achieved.

Recently, a more successful combination of materials⁸ was tested. These tests involved changing of both the wear-strip material attached to the belt and the wear strips on top of the vacuum box. The new wear-belt material still had a rubber base but with layers of polyester fabric in the rubber matrix (marketed as *flat transmission belting*). The vacuum-box wear-strip material was changed to high-density polyethylene (H.D.P.E.), and the number of water addition points was reduced to the

original number of 1 every 3 m. Several designs of H.D.P.E. wear strip are on test. All look promising at this stage with regard to wear and torque. Lives for H.D.P.E. wear strip (20 mm) and polyester rubber wear belt of about 30 000 hours are predicted, and the torque has been reduced by approximately 40 per cent for the same equivalent vacuum. H.D.P.E. has a lower ~~the cone-wash zone, running behind the cloth into the~~ belt grooves to join the filtrate. Folding in of the cloths at the edges also led to wear and, finally, failure at the crease. Also, if the cloth edge remained folded on the cloth return, the edges could not be sensed accurately, leading to severe tracking problems. Problems were also experienced with fraying of the cloth edges.

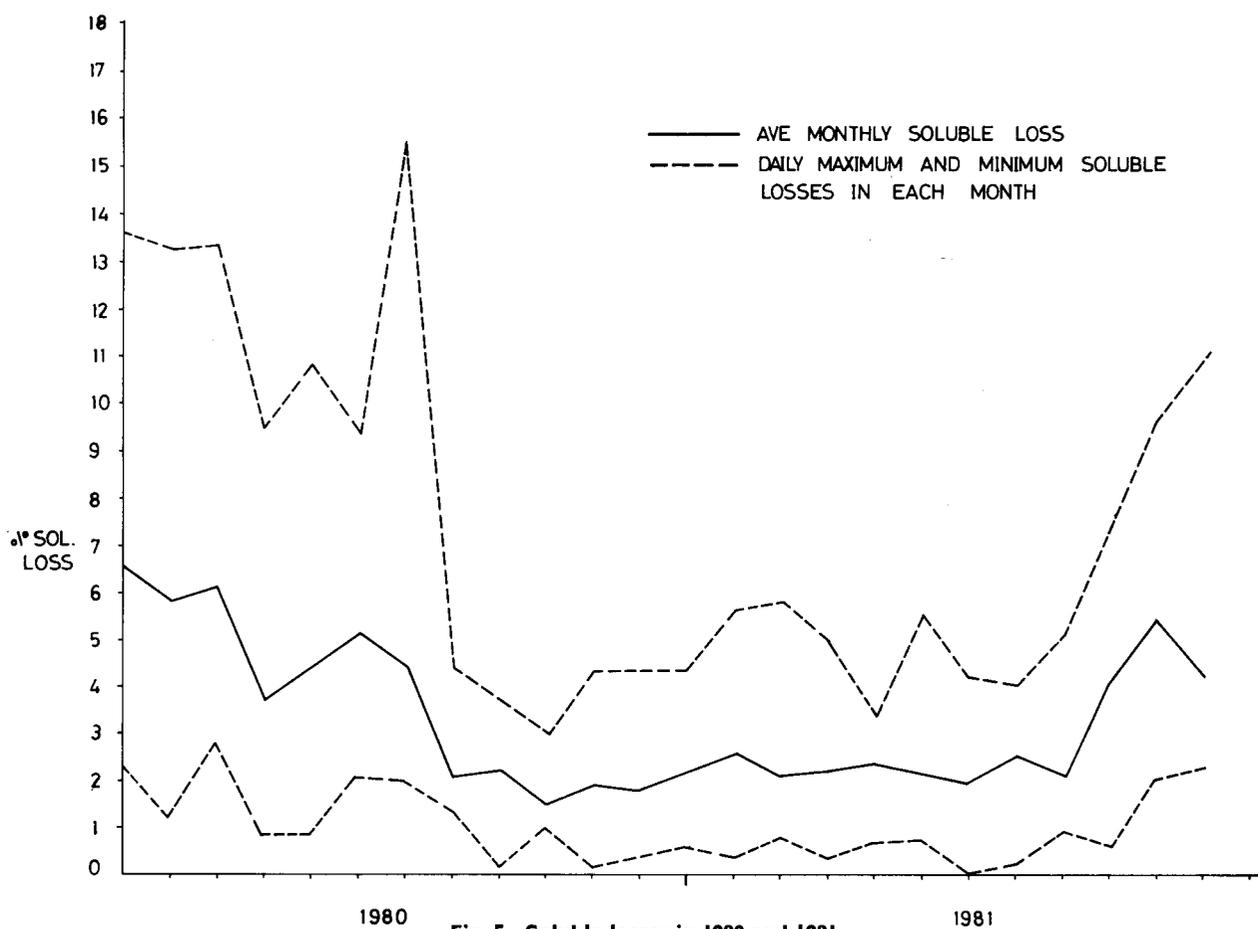
Fig. 5—Soluble losses in 1980 and 1981

The loss of dissolved uranium has been an intermittent problem. For long periods, acceptable losses (close to the 2 per cent design figure) were achieved. However, at other times losses as high as 6 per cent for a month or more were experienced. These high losses seem to be associated with periods when very fine slime (as fine as 45 per cent smaller than 10 μm) is being filtered. The correlation, however, was not consistent.

Sampling problems were also experienced in that it was not possible for the high soluble losses found in repulper samples to be correlated with the soluble losses in the filter-cake discharge. Frequently, negligible soluble losses were found in the filter-cake discharge when significant values were found in the repulper, and these differences could not be correlated with any known solutions entering the repulper. It was thought that residual filtrate in the filter-belt grooves and filter cloth could be falling into the repulper at the head pulley after the cake discharge. Trays were constructed to collect these drippings, and their values were found at times to be high (similar to those of the pregnant solution), but high unexplained discrepancies still remained between the soluble losses in the repulper and those in the cake, even after most of these drippings had been removed. A satisfactory explanation of the problem is still being sought. Fig. 5 gives the results for the years 1980 and 1981, indicating the monthly average soluble loss, to-
