Torn-corner defect in billets rolled from continuously cast blooms

by L. W. HELLE* and W. F. SMITH†

SYNOPSIS

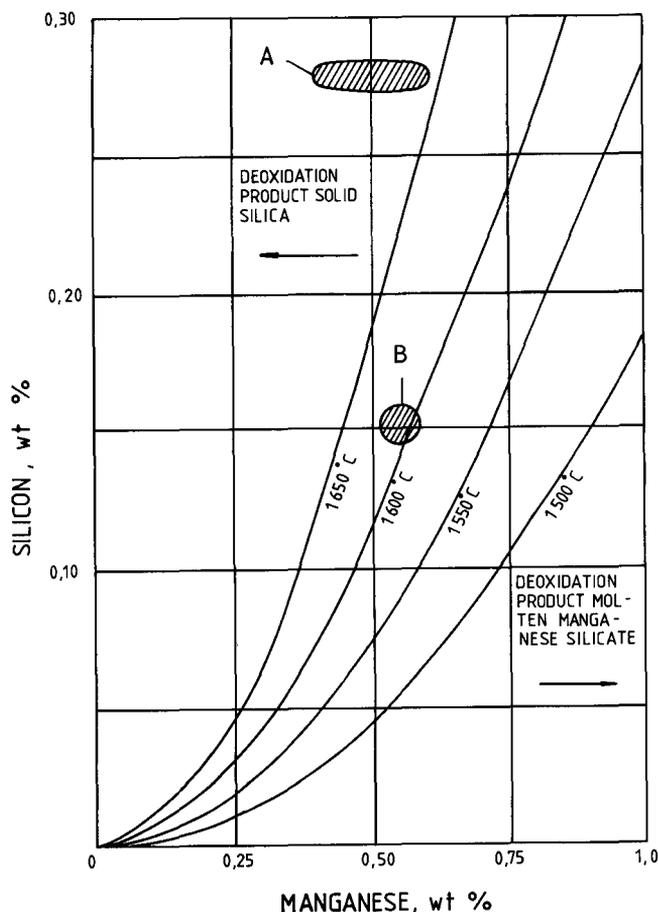
Fig. 1 gives the critical silicon and manganese contents of iron in equilibrium with silica-saturated manganese silicate at various temperatures. To avoid the formation of silica (area A), the manganese: silicon ratio would have to be adjusted so that liquid manganese silicates would form as the primary deoxidation product. So that this could be achieved at Newcastle, it was decided that the

Fig. 1—Critical silicon and manganese contents of iron in equilibrium with the silica-saturated deoxidation product, which is almost pure manganese silicate (after Turkdogan¹).

silicon level of the low-manganese steels should be reduced to an aim level of 0,15 per cent and the manganese level raised to an aim level of 0,55 per cent (area B).

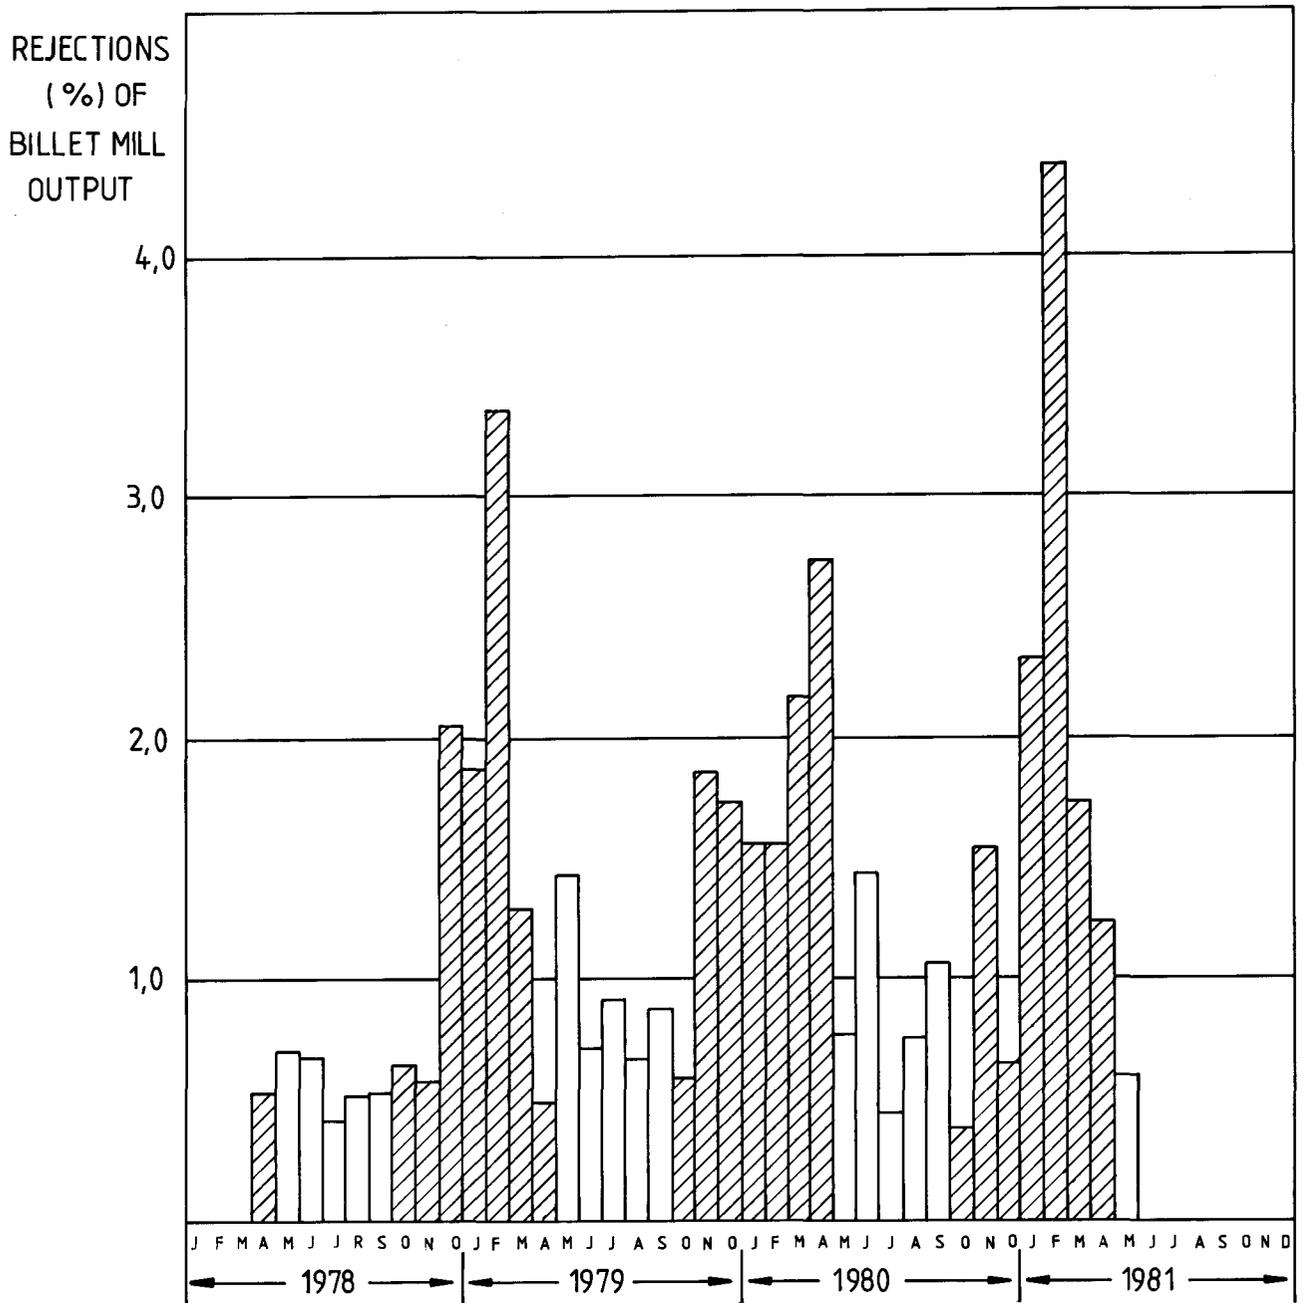
After some time, it was noticed that there were intervals when high rejections due to torn corners could be expected, and these were then followed by low rejections (Fig. 2). It was also apparent that the periods of high rejections occurred in summer, when most of the rain falls in the region.

Fig. 2—Rejections because of the torn-corner defect, the shaded months representing the rainy season in the Newcastle area.

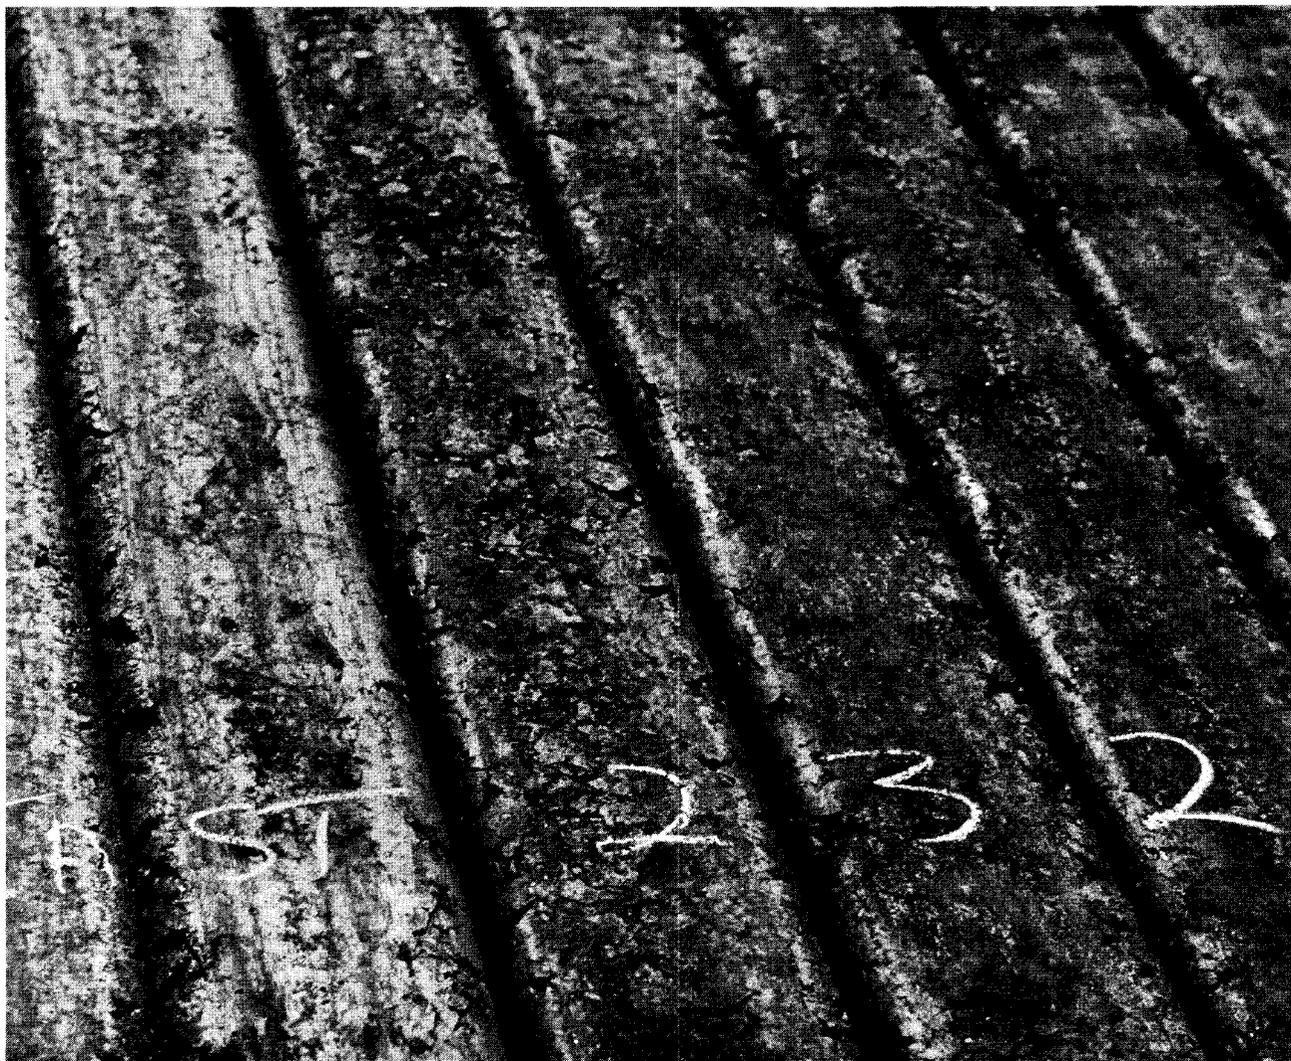
A typical feature of the corner defect is that the defect is not readily apparent in the as-cast bloom. The defect shows only during rolling to billet. Fig. 3 represents the typical appearance of the defect in rolled billets laid out for inspection. A close-up of a defect is shown in Fig. 4.

Fig. 3—Torn-corner defect in billets laid out for in-line inspection.

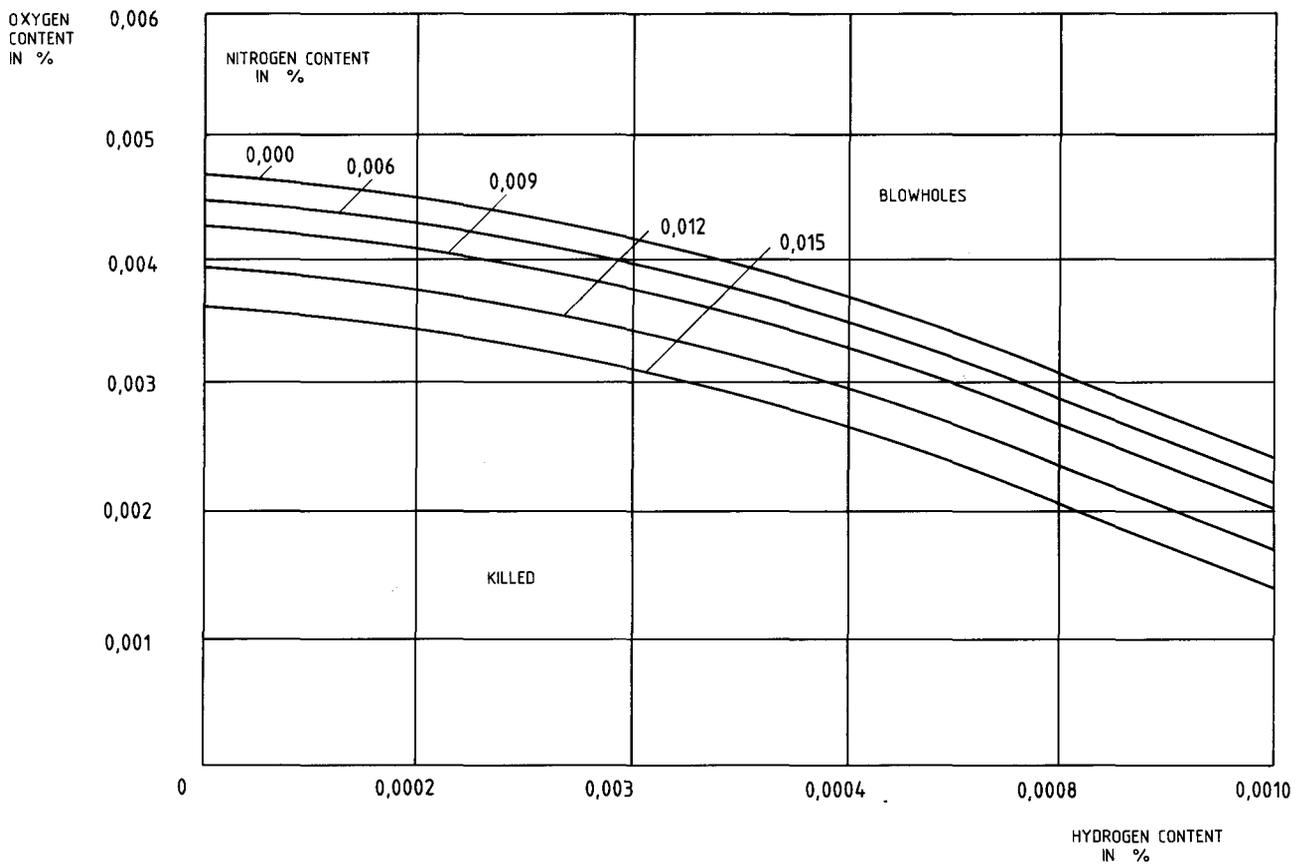
To illustrate the total effect of these three gases on the formation of blowholes in continuously cast steel, a graph given by Oeters *et al.*² was redrawn to correspond to the extremely rapid solidification conditions at the mould wall. This graph (Fig. 5) confirms the initial assumption that the gases are interrelated, and any combination of the three will indicate whether the critical total concentration is exceeded and whether blowholes will form.

Fig. 5—Influence of nitrogen and hydrogen on the critical oxygen content for the formation of blowholes (after Oeters et al.²)

Although no measurements were made (because of a lack of suitable equipment), it is believed that the hydrogen content of the higher-carbon steels is lower than that of the lower grades owing to the strong inhibiting effect of carbon on the solubility of hydrogen⁶. Further, as was established earlier, the nitrogen content in the higher-carbon steels was correspondingly greater. It is suggested that the torn-corner defect is caused by the combined effect of the oxygen, hydrogen, and nitrogen. In the low-carbon steels (containing less than 0,20 per cent carbon), the major contribution to the total pressure is made by the partial pressure of hydrogen, and, in the high-carbon steels, by the partial pressure of nitrogen. Fig. 5 clearly demonstrates the combined effect of these three gases.

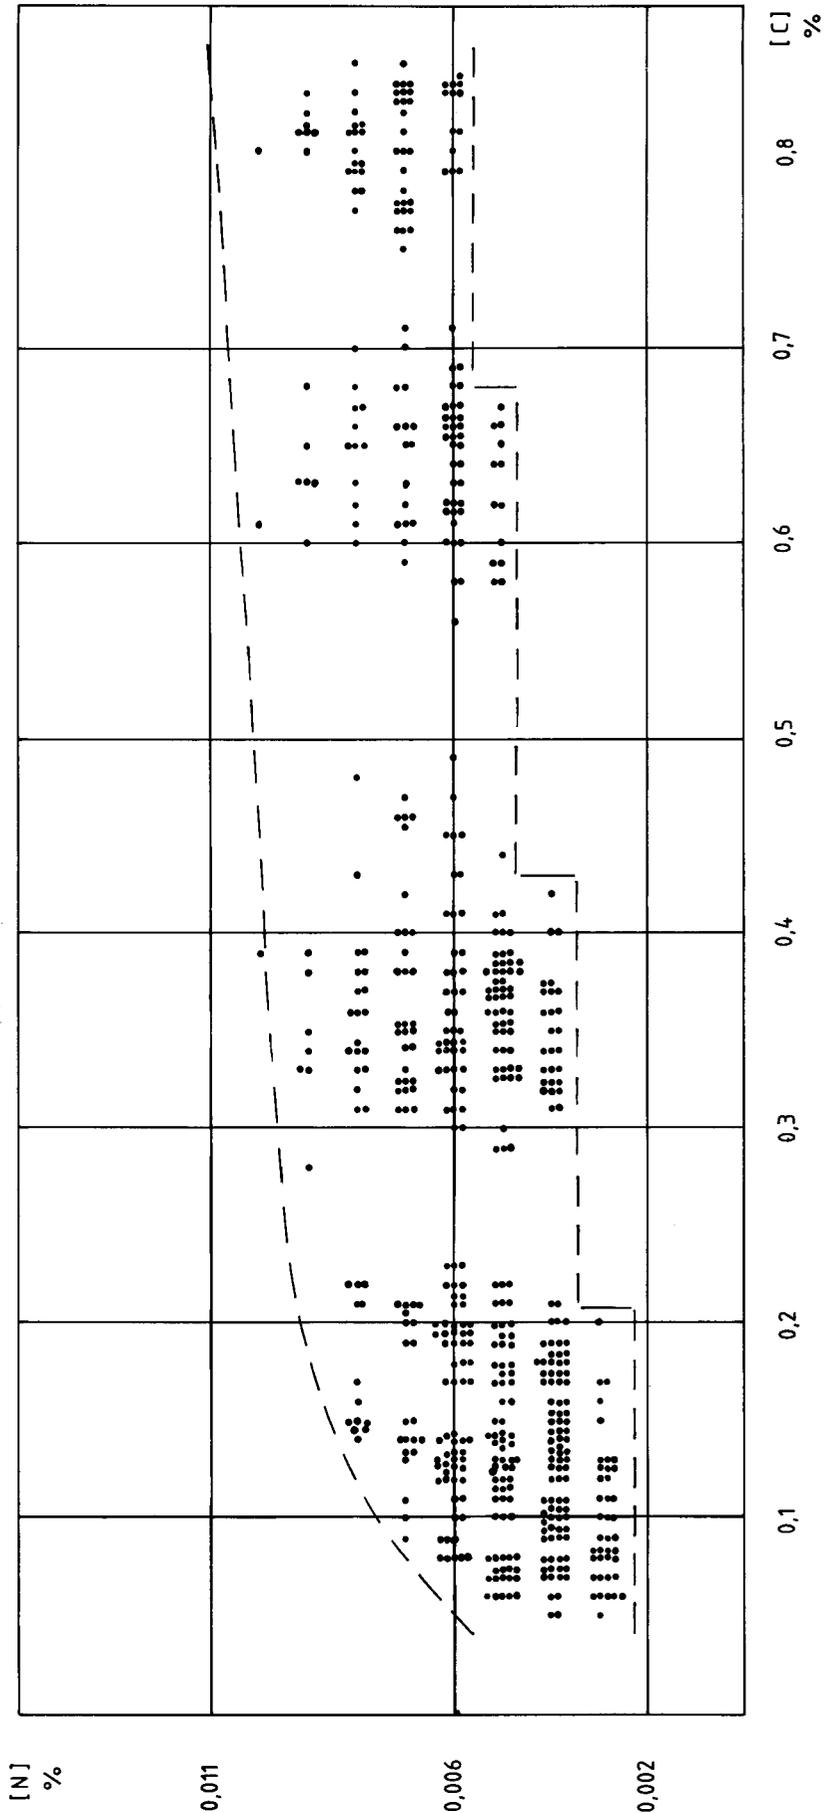
However, as shown in Fig. 6, there is a relationship between the nitrogen and the carbon levels. This is due to the practice followed in the making of high-carbon grades. Since the major tonnage of these grades is used for the manufacture of rod for use in wire ropes, the phosphorus levels have to be about 0,015 per cent to suppress the formation of martensite while the rod cools. This is achieved in oxidizing slag conditions, which are obtained at low carbon levels; use is made of a technique

Fig. 6—Dependence of the nitrogen content on the carbon content of the final sample. (Samples were taken from every heat made during the first 2 days of each month in 1981, $n = 632$. Because the reblooms were established as one of the major sources of nitrogen pick-up, the plotting of those heats on this graph would have biased the overall picture. Therefore, only the heats without a reblow are shown.)

As can be seen from Fig. 6, there is a relationship between the carbon and the nitrogen contents of the steel. As stated earlier, the practice at the Works is such that the heat is blown down and then recarburized to the required level. Thus, the final carbon level is a direct reflection of the amount of graphite added and, because the increase in the nitrogen content is tied to the carbon content, it is clear that the bulk of the nitrogen pick-up is from the inherent nitrogen in the graphite. This is not surprising when it is considered that the nitrogen content of the graphite was 1830 p.p.m., which is almost eight times higher than that of the second-richest alloy, high-carbon ferromanganese (230 p.p.m.).

As regards nitrogen, it has been found very difficult to decrease the reblow ratio, but the situation may be different when the planned ladle-injection plant comes on-stream. The availability of such a unit may facilitate the transfer of at least some of the reblowing for sulphur and phosphorus to the injection unit. A further possibility is the introduction of low-nitrogen graphite for recarburizing, and the incorporation of effective ladle and tundish shrouding for the high-carbon steels.

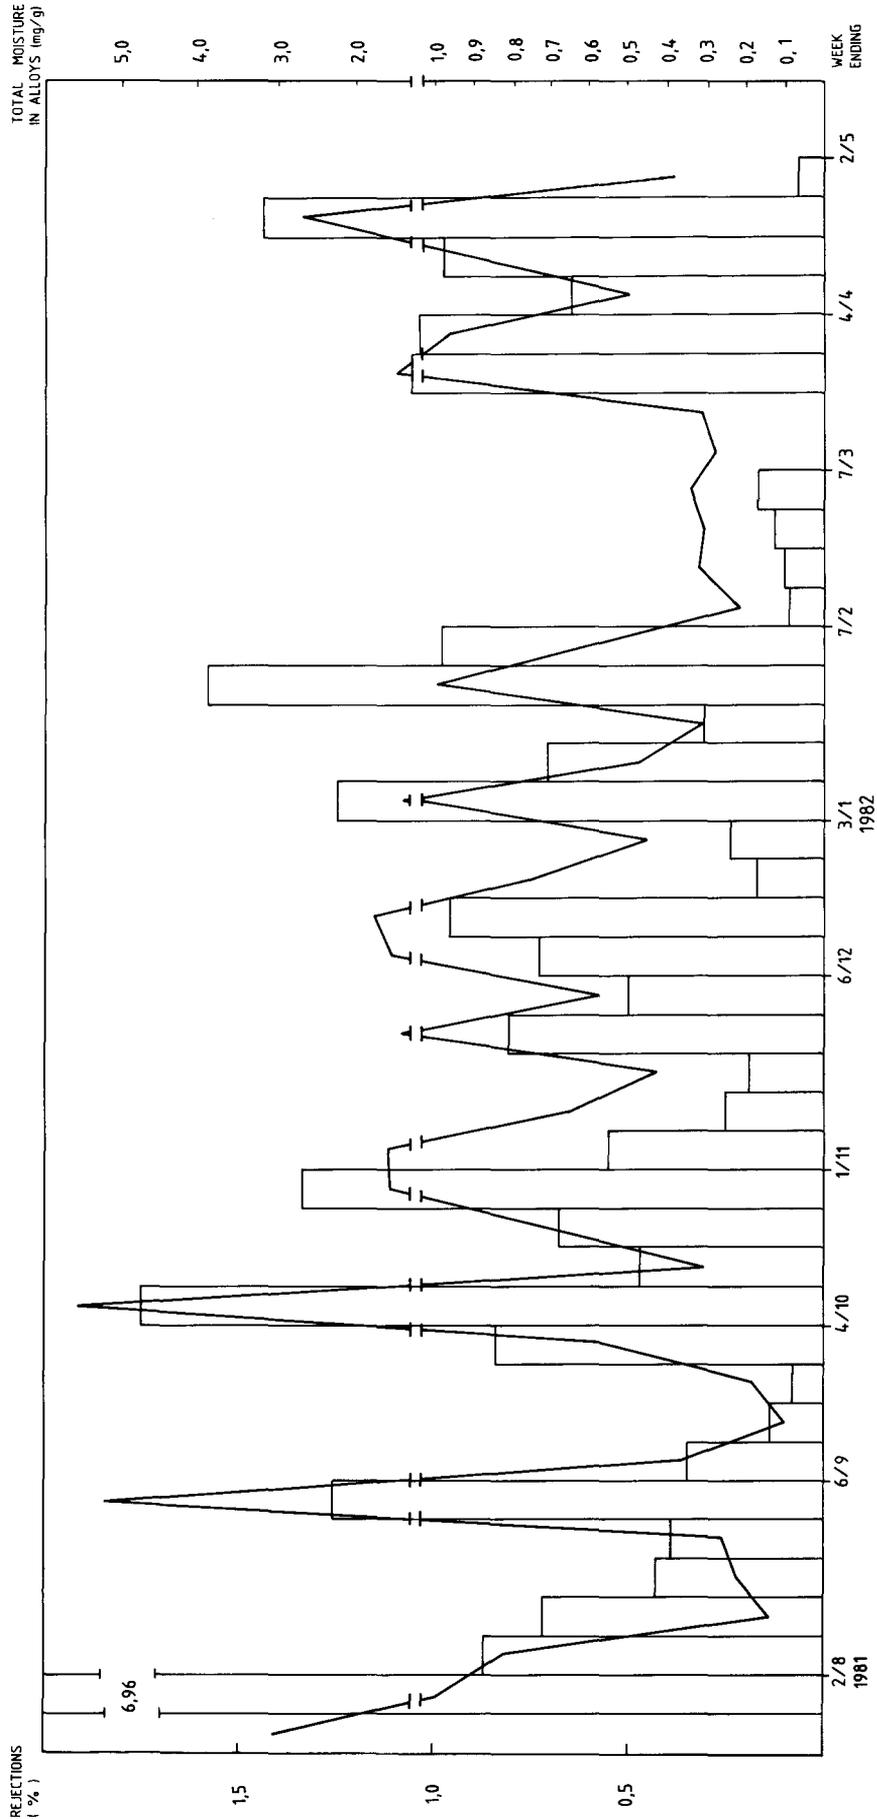
Fig. 7 gives a block diagram for Group 1, showing the percentage of torn-corner rejections and the moisture content. A clear relationship emerges, although, for the material of higher carbon levels (Groups 2 and 3), it ceased to be significant.

Fig. 7—Torn-corner rejections (block diagram) with the moisture content of the alloys during the period 1/8/81 to 2/5/82. (The carbon range was C ≤ 0.20 per cent.)

As far as hydrogen is concerned, the following steps could be taken. Firstly, the exact source of possible water contamination of the alloys could be found, and secondly, the lump size of the ferro-alloys could be increased to eliminate the small fractions, which always contain the bulk of the moisture⁷. If the above action does not produce satisfactory results, steps could be taken to dry out the high-carbon ferromanganese and the silicomanganese, which were the main moisture carriers.
