# A fractographic study of corrosion-fatigued specimens of A533B steel

by J.H. BULLOCH\*

This paper describes detailed fractographic analyses of several specimens that had undergone corrosion-fatigue tests at high stress ratios in simulated pressurized water-reactor environments.

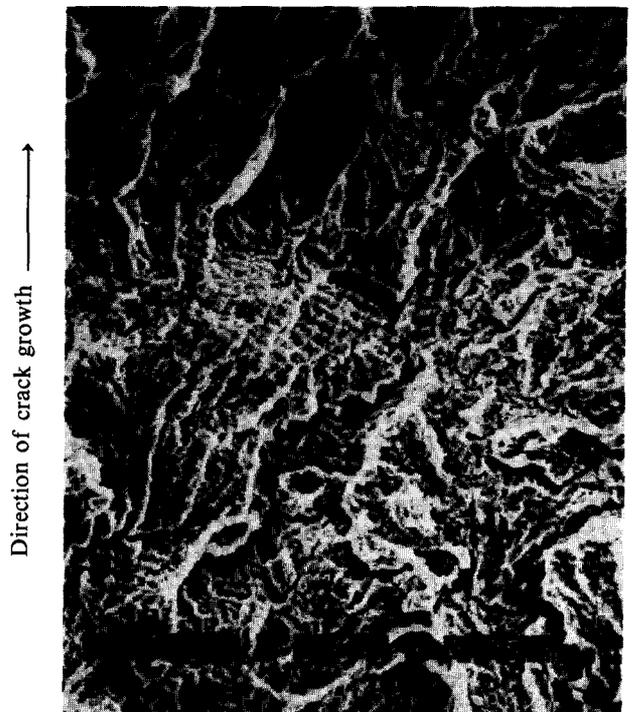
In the initial growth stages (region I),  $\Delta K \approx 26 \text{ MPa} \sqrt{\text{m}}$  ( $da/dN = 2 \times 10^{-4} \text{ mm per cycle}$ ), the surface of the fatigue fracture was covered predominantly with ductile striations (Fig. 4). Little evidence of inclusion sites was evident. At about 1 mm from the pre-cracked area,  $\Delta K = 27 \text{ MPa} \sqrt{\text{m}}$ , many sites or holes associated with inclusions and/or inclusion clusters were observed. These varied in size up to a maximum length of about 0,2 mm, and were oriented perpendicular to the direction of crack growth, as shown in Fig. 5(a). A magnified view of one of these elongated sites is given in Fig. 5(b), showing that the general fracture mode is still ductile striations. Such sites probably arise from a cluster or grouping of manganese sulphide stringers that dissolved during testing. At the  $\Delta K$  level immediately before plateau formation (region II), viz 28 to 30  $\text{MPa} \sqrt{\text{m}}$ , the preponderance of these large elongated prior inclusion sites increased—Fig. 6(a). An interesting feature was the association of fan-shaped growth associated with these sites, as shown in Fig. 6(b). A detailed view of these fan-shaped areas, Fig. 6(c), showed that striated growth occurred in some instances, but in others it was not observed. The measured spacing of the striations within the crack growth was about  $1,8 \text{ to } 4,0 \times 10^{-3} \text{ mm}$ , which shows some agreement with the recorded macro growth rates.

Fig. 4—Just beyond the start of crack growth,  $\Delta K = 26,3 \text{ MPa} \sqrt{\text{m}}$ . Fully ductile striated growth in which there was little evidence of non-metallic inclusions

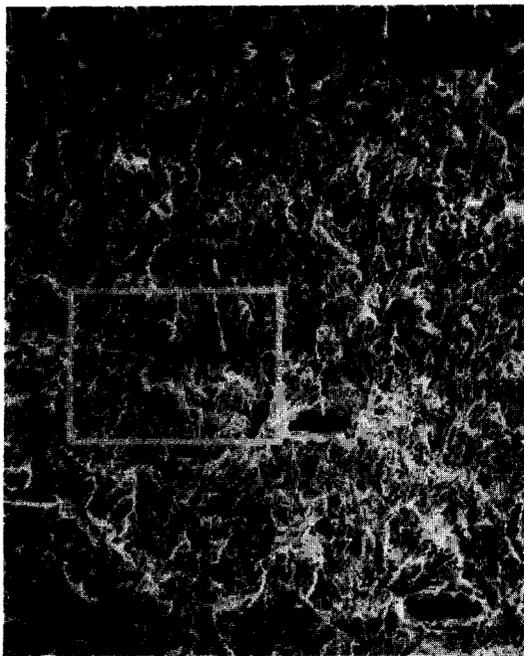
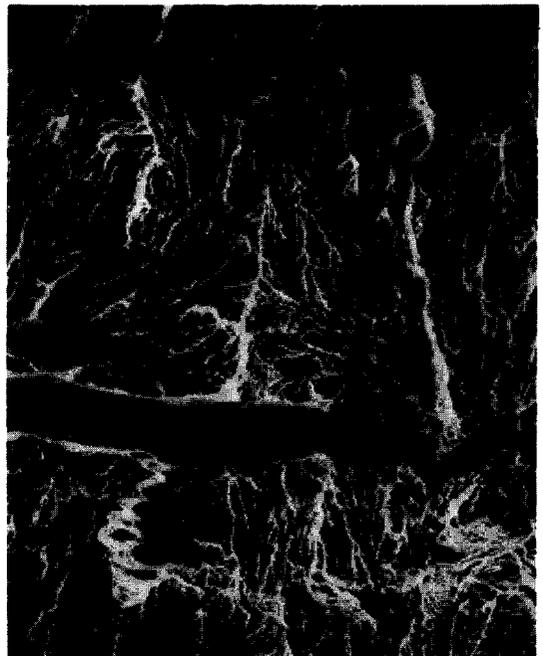
Fig. 5— $\Delta K = 27,1 \text{ MPa } \sqrt{\text{m}}$ . The incidence of many long inclusion sites perpendicular to the direction of crack growth, the fracture mode being predominantly that of ductile striations

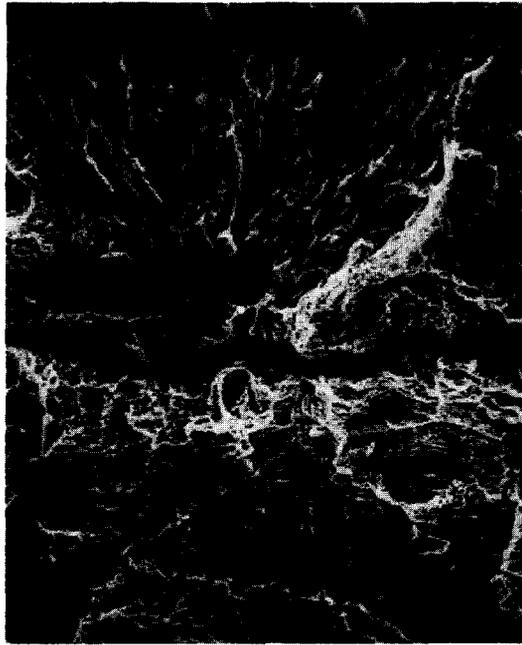
At the imposed  $\Delta K$  level of  $26 \text{ MPa } \sqrt{\text{m}}$ , region II crack growth occurred immediately, and a significant change in fracture morphology between this EAC region and the air-precracked region was evident (Fig. 7). The precracked region exhibited a flat topology and fissures running perpendicular to the direction of crack growth; this is typical of transgranular ductile striated growth. Region II was covered with a fan-shaped type of growth, with little evidence of fissuring. A general view of the fan-shaped fracture surface is shown in Fig. 8(a). A detailed view showed some fan-shaped areas that did not exhibit much striated growth, Fig. 8(b), while other areas did, Fig. 8(c). The average spacing of the striations in such areas was  $1,3 \times 10^{-3} \text{ mm}$ , which agrees well with the recorded determinations of growth rate.

**Fig. 7—Boundary between EAC growth (top) and air-precracked region (bottom). The EAC growth region exhibits a fan-shaped faceted type of growth, whereas the air-precracked region shows a much flatter topography, with fissures at right-angles to the direction of growth. The latter is typical of the growth of ductile striated fatigue cracks**

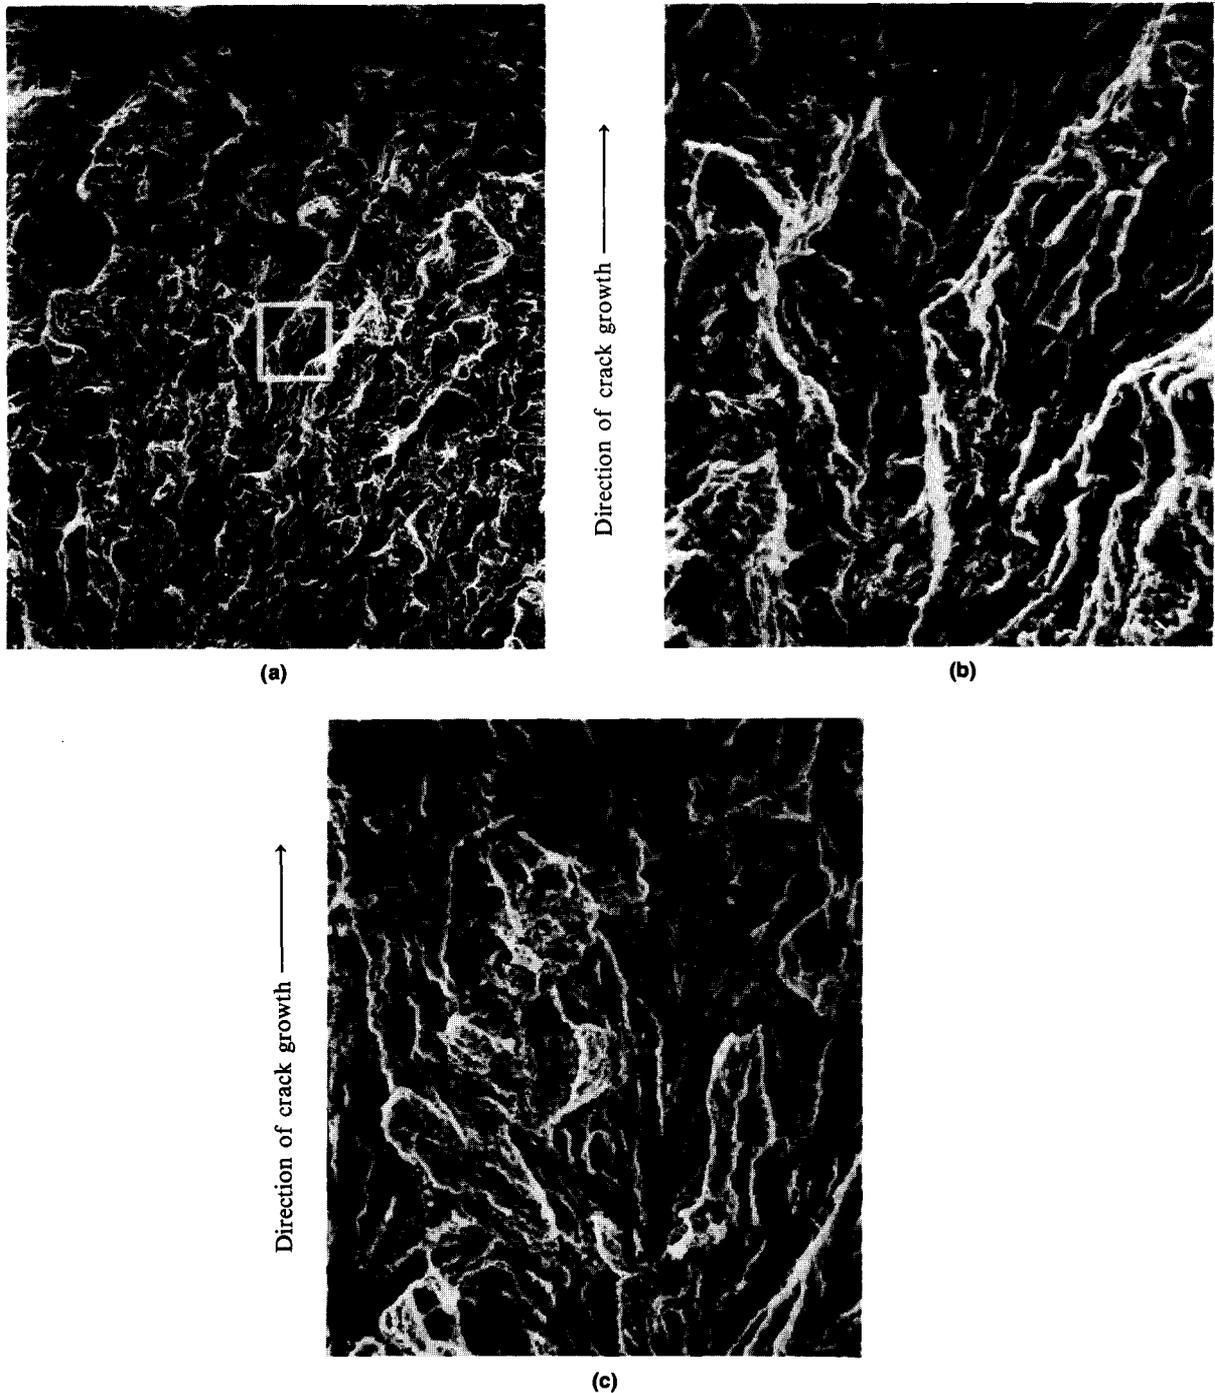
**Fig. 8—General fracture surface, showing a preponderance of fan-shaped growth. Striated growth is absent in some of these areas (a) and occurs in others (c)**

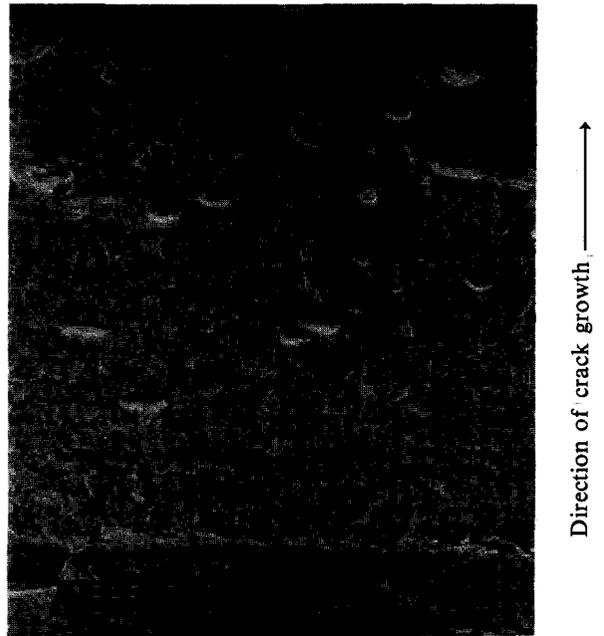
A general view of the initial 4 mm of growth in the triangle waveform is shown in Fig. 11. Again, as in the sinusoidal waveform test, there was a high incidence of elongated inclusion clusters, 0,1 to 0,4 mm long, running perpendicular to the direction of crack growth. Fractographic study established that, at all  $\Delta K$  levels, the predominant fracture mode was one of transgranular ductile striated growth (region I) characterized by flat topography with fissures at right-angles to the direction of growth (Fig. 12). Around the vast majority of these clusters, no fan-shaped type growth was observed and the fracture mode was predominantly ductile striated growth. However, at two isolated areas on the fracture surface, fan-shaped growth was observed, as illustrated in Figs. 13(a) and (b). These isolated areas were about 1 to 1,5 mm long and started at the elongated sites of non-metallic inclusions. The nature of the fan-shaped growth is shown in Fig. 13(c) and is similar to that widely observed in the sine waveform test.

**Fig. 11—General view showing the high incidence of inclusion clusters running perpendicular to the direction of crack growth**

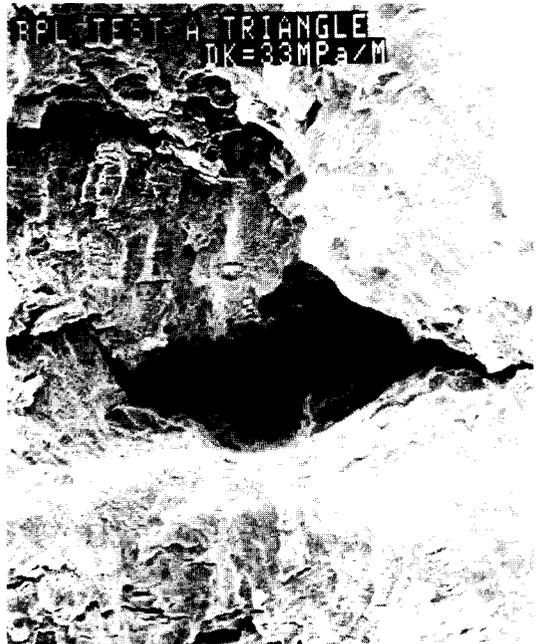
**Fig. 12—There is little evidence of fan-shaped growth around the inclusion site. The fracture surface is typically one of ductile striated fatigue-crack growth**

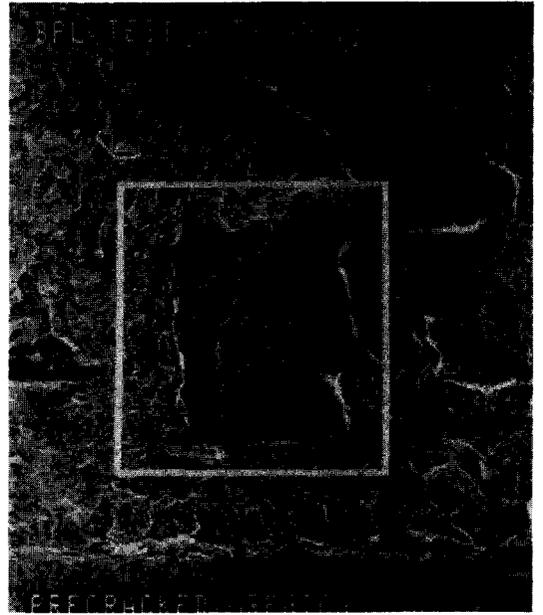
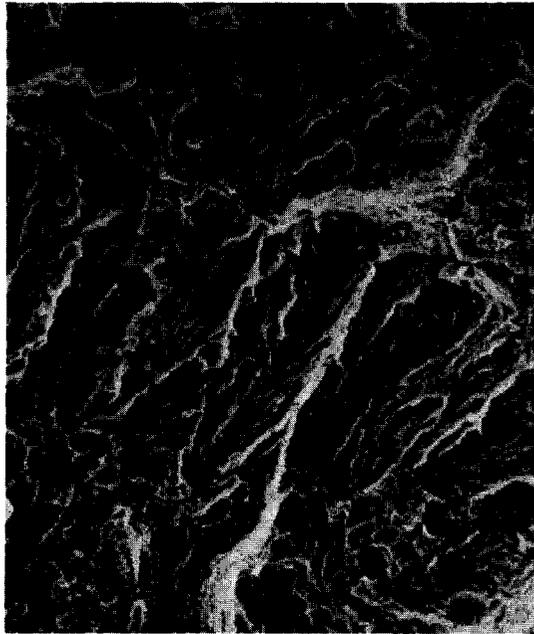
**Fig. 13—Two isolated instances, (a) and (b), of areas showing fan-shaped growth that starts at or around clusters of inclusions. Details of the fan-shaped area are shown in (c)**

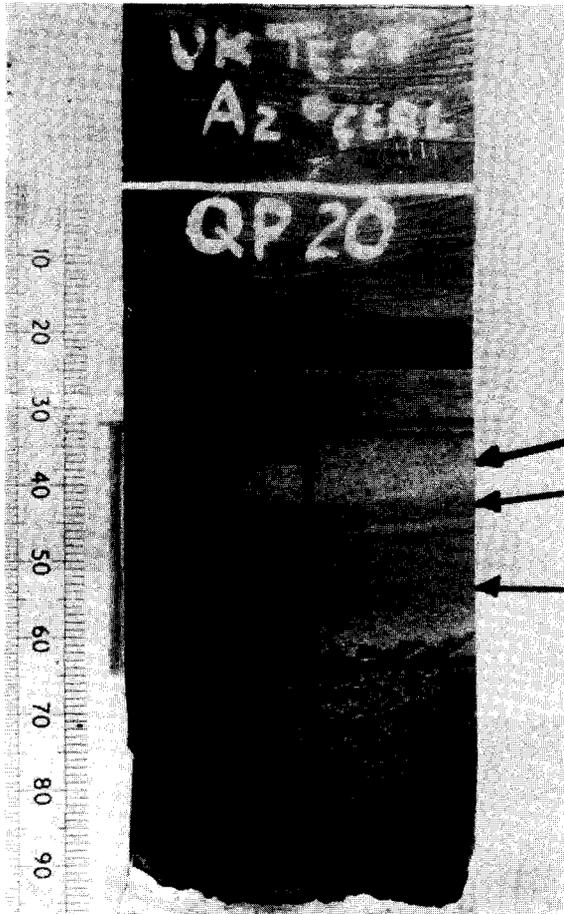
The dark band near the middle of the section in Fig. 14 is the region of fatigue-crack growth that occurred at  $\Delta K$  levels below the 'threshold'  $\Delta K$  value of about  $25 \text{ MPa } \sqrt{\text{m}}$ . An interesting macro-feature within this dark band is the occurrence of elongated light patches across

Air pre-cracking region  
 Pre-threshold  $\Delta K$  slow-growth region  
 Post-threshold  $\Delta K$  fast environmentally assisted growth region

Fig. 14—Broken half of specimen from test A4, showing the section supplied to Babcock Power Limited ( $\times 1,08$ )

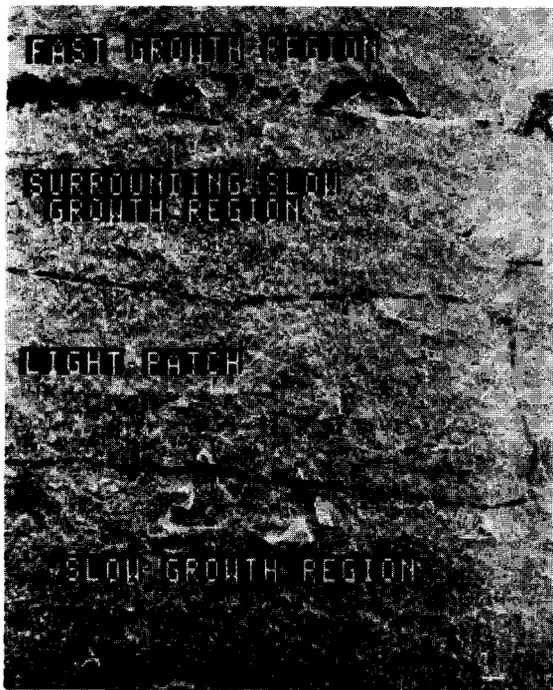
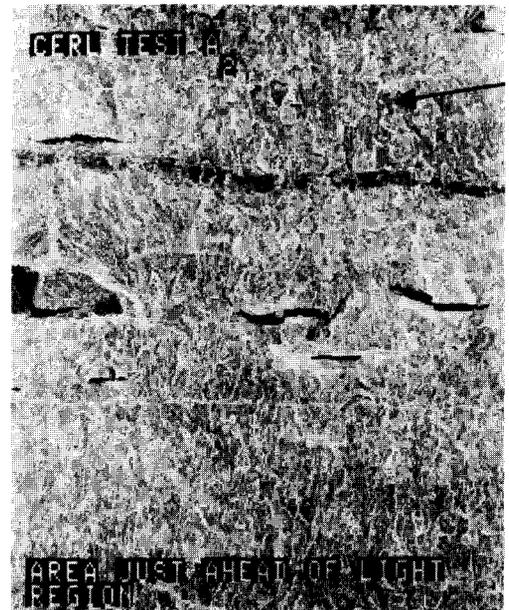
Fig. 15—Characteristics of a light patch surrounded by a region of slow crack growth  
 (a) The various regions on the surface of the fracture in CERL test A  
 (b) Elongated inclusion sites immediately in front of the light patch

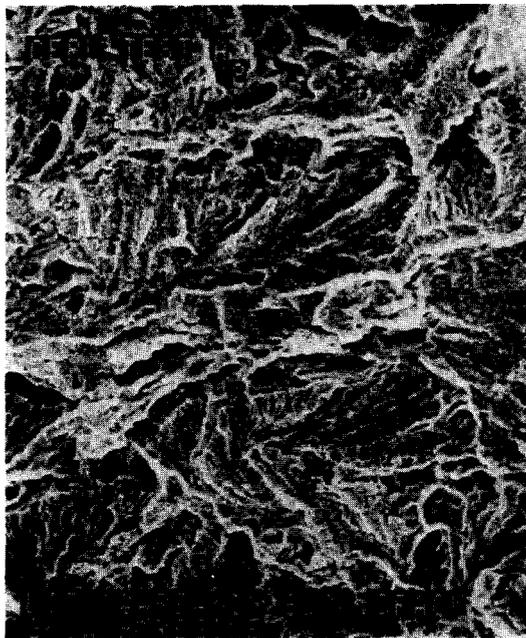
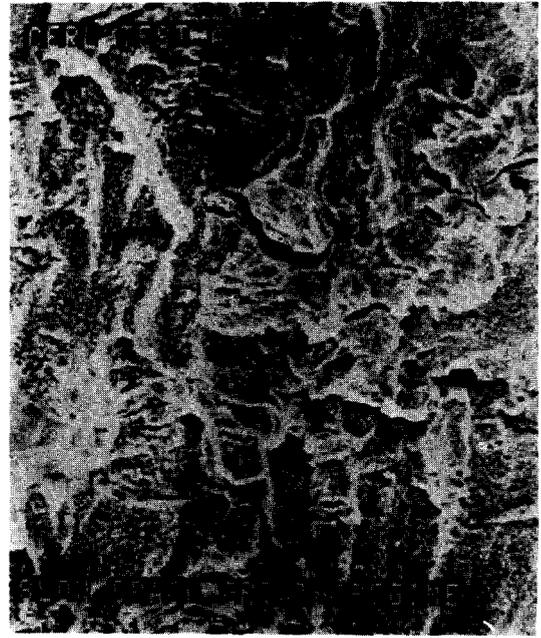
in Figs. 16(a) and (b) respectively. The fracture mode in the light patch appears generally fan-shaped, while the other growth region exhibits a rather amorphous appearance with fissures perpendicular to the general direction of crack growth; the latter is typical of ductile striated growth. The border region between the light patch and the darker growth region is shown in Fig. 16(c), which shows the abrupt transition from an amorphous type of surface with fissures to a fan-shaped type showing little evidence of fissures.

**Fig. 16—Characteristics of the light patch surrounded by the region of slow crack growth (Fig. 15)**  
**(a) General fan-shaped nature of the cracks within the light patch**  
**(b) General amorphous nature of the cracks and fissuring, which are typical of ductile striated growth**  
**(c) Border between the light patch and the slow-growth area. The upper area shows a fan-shaped type of morphology, while the lower area is more amorphous and exhibits fissures perpendicular to the direction of growth**

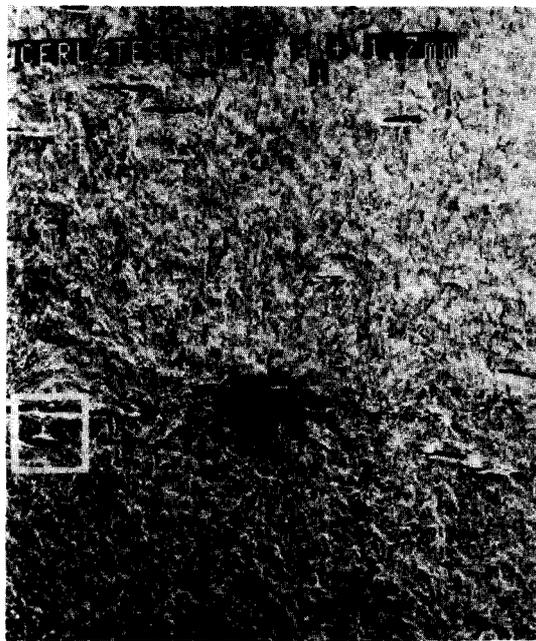
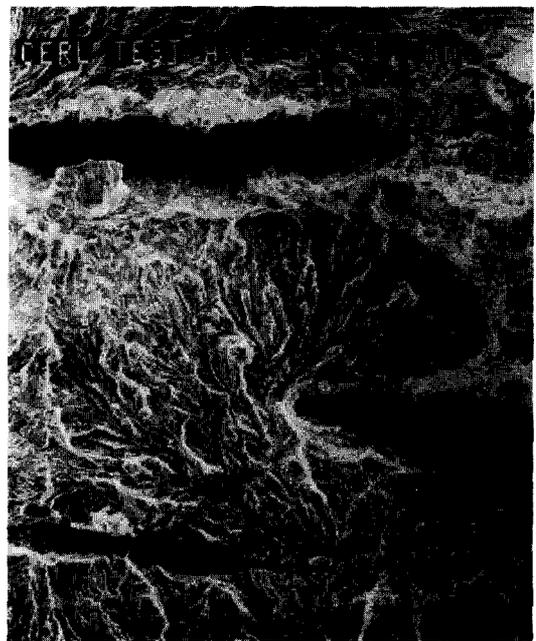
(a) General view, showing the elongated holes caused by inclusions

(b) Magnified view of the area boxed in (a), showing fan-shaped regions around the holes and individual inclusion sites within the elongated holes

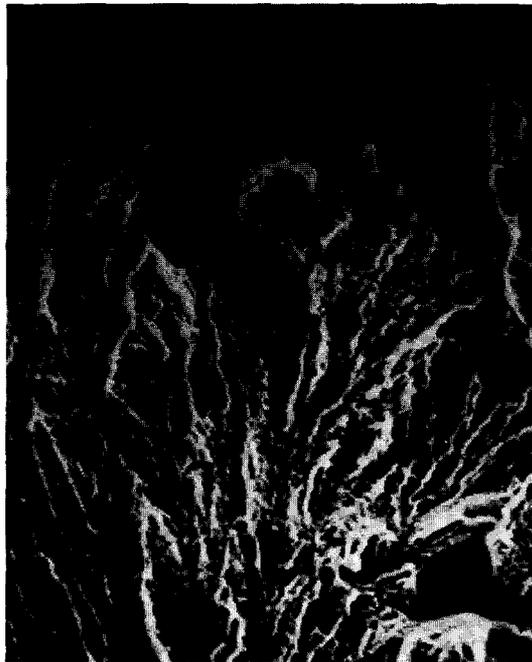
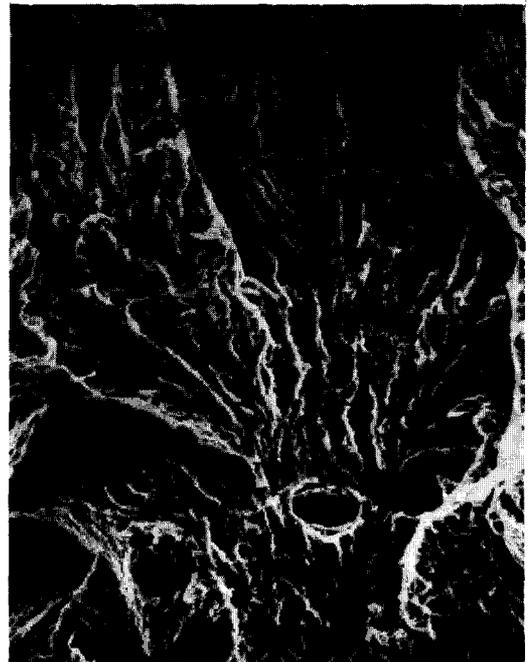
The fan-shaped areas in some instances exhibited striated growth, Figure 18(a), while less striated growth was observed in others, Fig. 18(b). The average spacing in striated areas was  $1,8 \times 10^{-3}$  mm, which is of the order of the macro fatigue-crack growth rate at these  $\Delta K$  levels.

(b) Fan-shaped area showing evidence of ductile ridges with little striated growth,  $\Delta K = 28 \text{ MPa } \sqrt{\text{m}}$

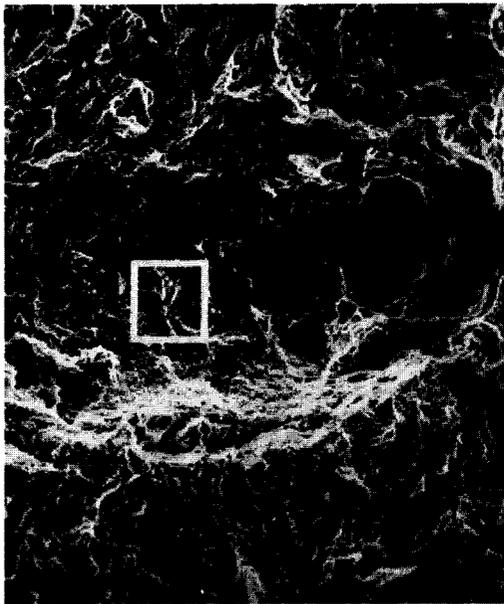
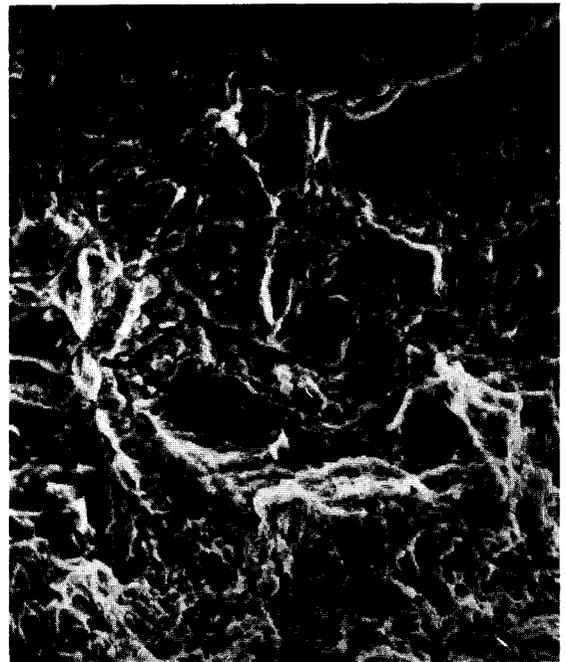
**Fig. 19—Details of the flat amorphous areas associated with inclusion sites at plateau  $\Delta K$  levels**  
**(a) Flat, featureless region about 0,3 mm in size**  
**(b) Magnified details of the boxed region in (a)**

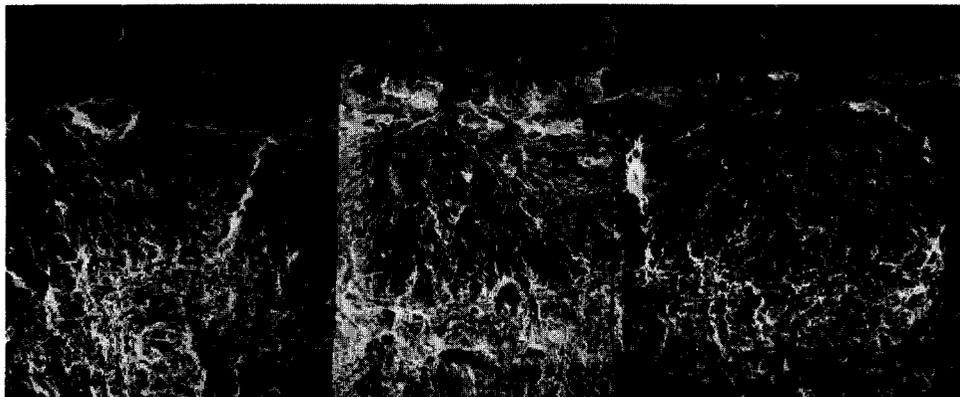
**Fig. 20—Initial crack growth in test C\*1. At the top of the photomicrographs is the air-precracked region. The initial growth is fan-shaped in character and starts from sites of non-metallic inclusions. The topography is much flatter at the bottom of the photomicrograph, with fissures perpendicular to the general direction of growth, which indicates transgranular ductile striated growth**

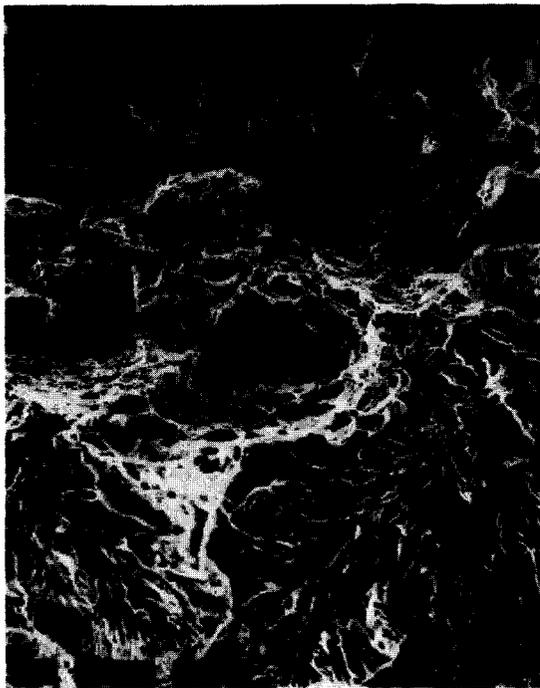
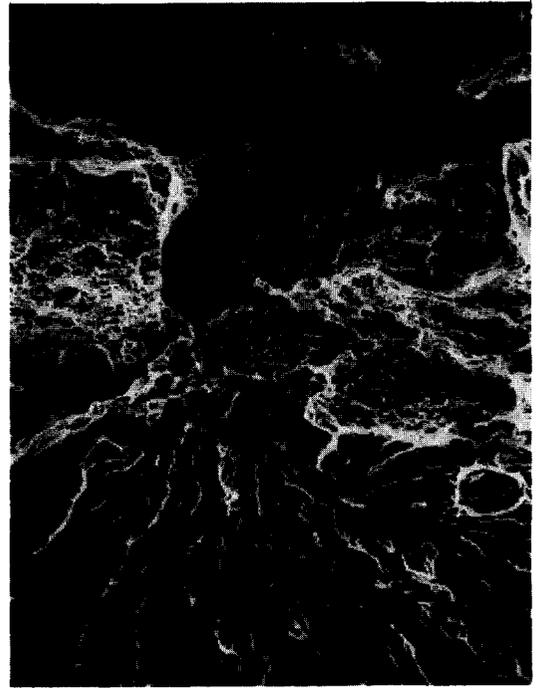
**Fig. 21—The initiation of fan-shaped EAC growth associated with elongated clusters of non-metallic inclusions. Individual inclusions are about 20  $\mu\text{m}$  in diameter**

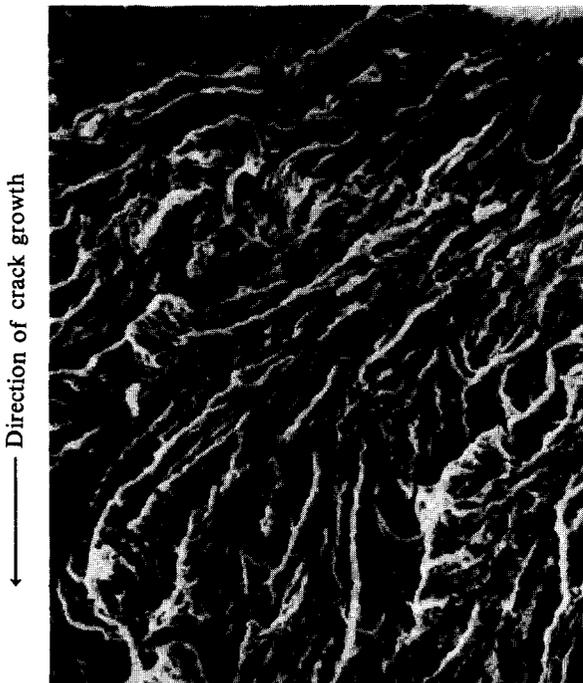
**Fig. 22—Details of initial fan-shaped growth, with little evidence of striations**

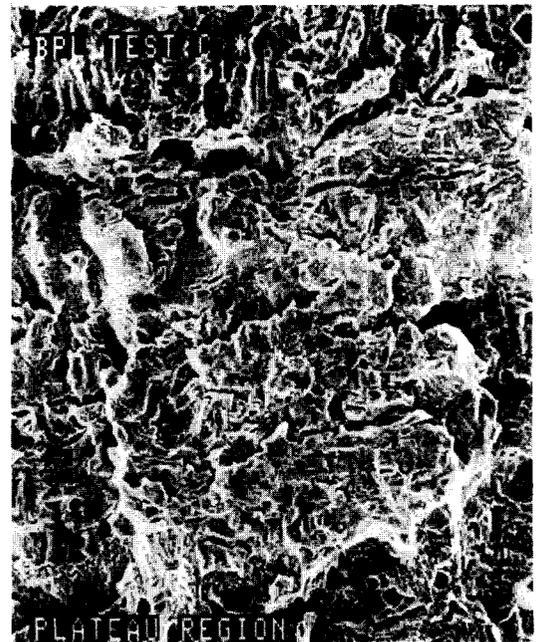
The initial stages of growth comprised a fan-shaped growth issuing from the precracked region. Along the width of the specimen, this region of fan-shaped growth varied between 0,3 and 0,5 mm. In several instances, this type of crack growth took the form of parallel rows of fans issuing from specific initiation sites, and are illustrated in Fig. 20. Each discrete fan was about 0,6 mm in width and about 0,4 mm in length. Immediately preceding the region of fan-shaped cracks is a large preponderance of elongated 'holes'. Upon closer inspection, Figs. 21(a) and (b), these 'holes' were identified as clusters of elongated non-metallic inclusions 0,02 mm in diameter that had dissolved during environmental testing. Also, such regions coincided with the initiation point of many individual fan-shaped facets. Fig. 22 shows details of the regions of fan-shaped growth. Without this initial 0,3 to 0,5 mm of fan-shaped growth, the fracture surface was rather flat, with many fissures developing at right angles to the general direction of crack growth; such features are typical of transgranular ductile striated growth. Details of this fracture mode are shown in Fig. 23.

**Fig. 23—Details of the type of growth during plateau formation, showing fissured features indicative of ductile striated growth**

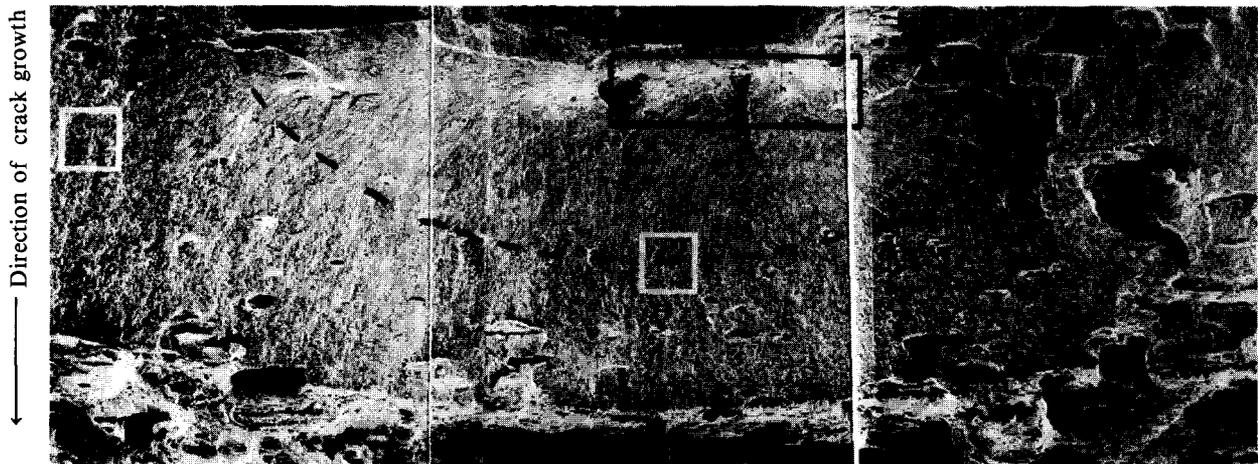
Fig. 25—Composite photomicrograph of the macro fan-shaped region (demarcated by the broken line) shown in Fig. 21. There is a sudden change in morphology at the boundary of the fan-shaped region. Also evident are the volcano-type features that are associated with the initiation site of the macro fan-shaped region

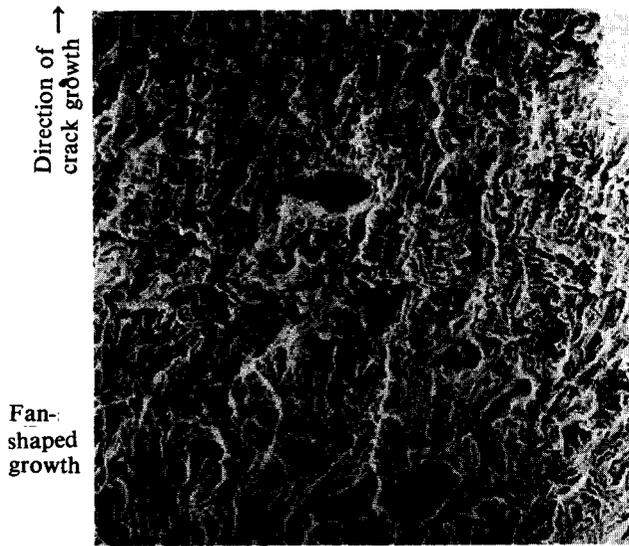
as the lower part shows fan-shaped growth, which was typical of the rosette, while the top shows fissured growth typical of transgranular ductile striated fatigue fracture. The latter fracture mode was prevalent in almost all the fatigue fracture surfaces in the macro fan-shaped region. The volcano-type initiation sites are further illustrated in Fig. 27, which shows evidence of ductile striated growth prior to the fan-shaped region (top of photomicrograph).

**Fig. 26**—Boundary region of a macro fan-shaped region, showing the abrupt change in fracture morphology: the lower region shows fan-shaped growth, while the upper shows fissured growth indicative of ductile striated growth

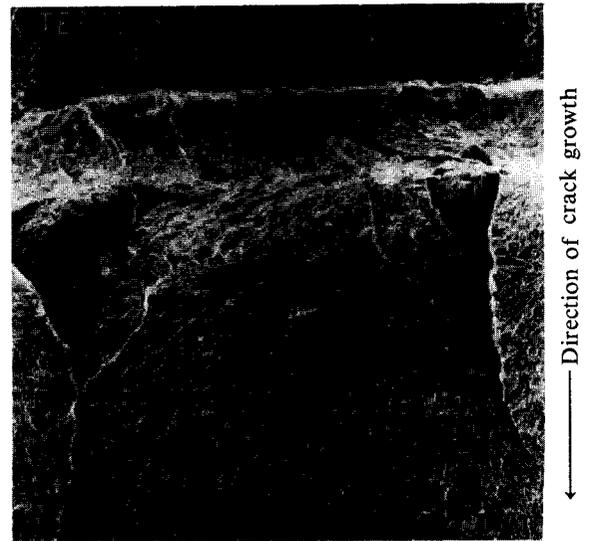
**Fig. 27**—A detailed view of the region associated with the initiation site of the macro fan-shaped area, showing volcano-type features associated with a large change in crack path and fissured striated growth prior to the initiation site (top of photomicrograph)

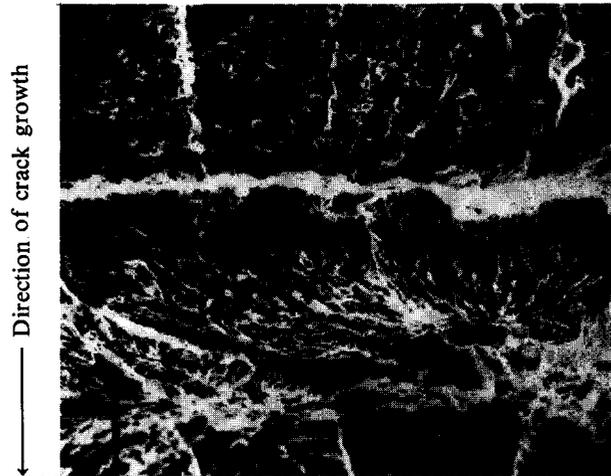
Fig. 30—The initiation of an EAC fan-shaped growth about 250  $\mu\text{m}$  ahead of the crack front. The fan-shaped EAC growth in this case is in the direction opposite to the general direction of crack growth

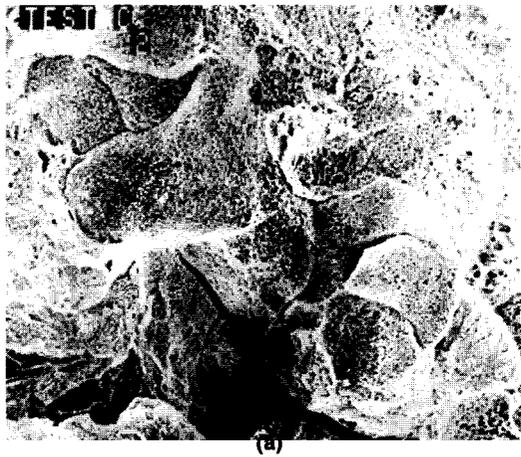
Fig. 31—Details of the region showing intergranular failure, the region being associated with the initiation site of the macro fan-shaped region

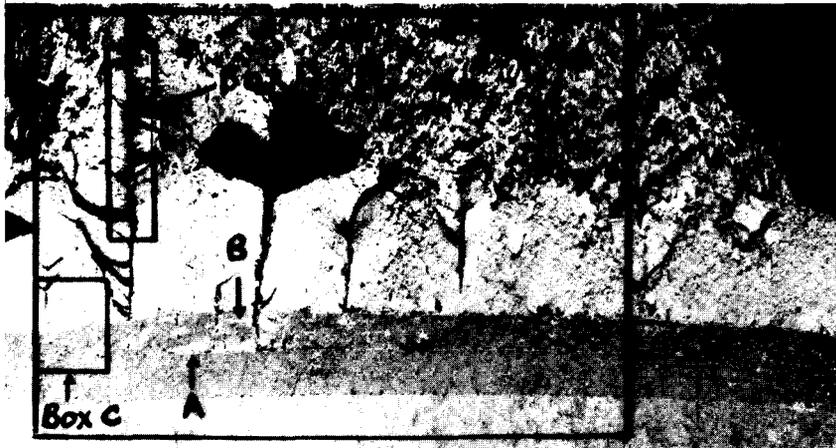
In Fig. 32 the dark-coloured area is the region of air-crack growth and shows the beach marks associated with each increase in  $\Delta K$ . The predominant failure mode in this region was ductile striations. An interesting macro feature in this dark-coloured region is the occurrence of elongated lighter regions, especially towards the left-hand side of the specimen, which are not unlike region II cracks.

Fig. 32—Details of the broken fracture surface from RR & A test C\*. The largest boxed area represents the portion that was submitted to SEM examination

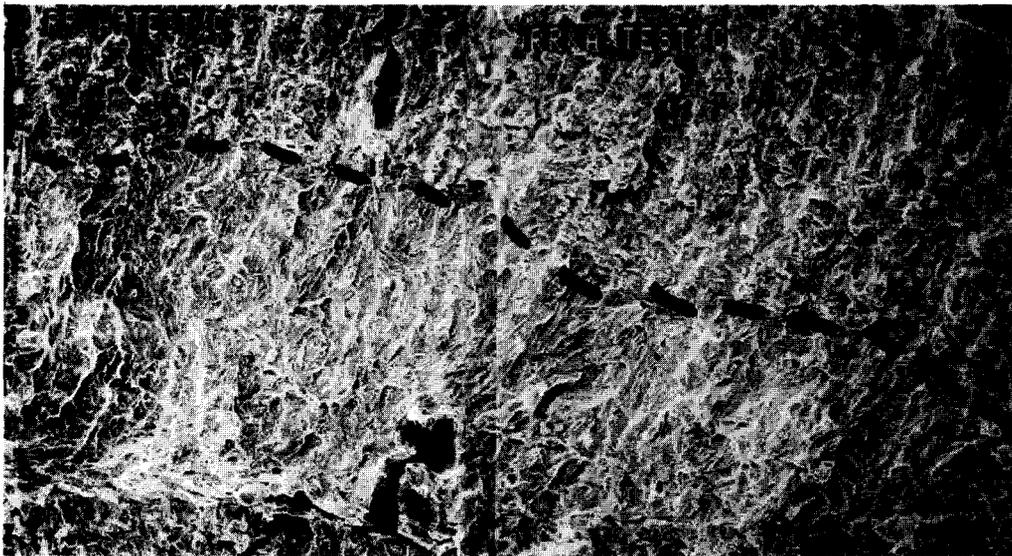
Details of two of the isolated lighter regions are exhibited in Figs. 33 and 34. Fig. 33 shows a detailed composite picture of the light-coloured region, designated point A in Fig. 32 that occurred abruptly at the  $\Delta K =$

18 MPa  $\sqrt{m}$  step during testing. This photomicrograph shows the occurrence of fan-shaped growth between a small fissure running parallel to the direction of growth and step  $\Delta K = 18 \text{ MPa } \sqrt{m}$ . However, the fan-shaped growth was not sustained, but lasted only about 0,5 mm before the fracture mode abruptly changed to ductile striated growth (shown by the broken line in Fig. 33). This fan-shaped growth is similar to that found in numerous tests that exhibited region II EAC growth.

Fig. 33—A ribbon of the EAC region. This burst of fan-shaped EAC growth resulted from the increase in  $\Delta K$  to  $18 \text{ MPa} \sqrt{\text{m}}$ , which is evident at the bottom of the photomicrographs. Again, this ribbon emanates from a large elongated cluster of inclusions (point A, Fig. 32)

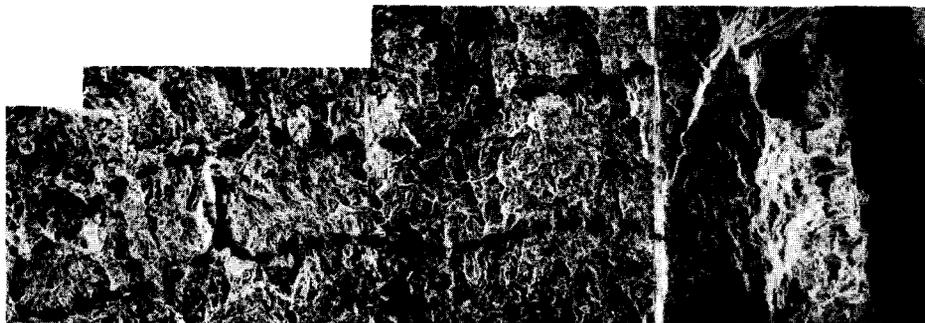
Fig. 34 shows another instance of a long finger of light-coloured region (as at point B, Fig. 32) surrounded by a darker-coloured EAC region (ductile striated region). Here, a thin ribbon (0,2 mm thick and 1,4 mm long) of fan-shaped growth runs out at right-angles from a large fissure and is surrounded by ductile striated growth; the boundary is shown by broken lines.

Fig. 34—A thin, long ribbon of light-coloured EAC region running perpendicular to the general direction of crack growth between  $\Delta K = 18$  and  $\Delta K = 21 \text{ MPa} \sqrt{\text{m}}$  (point B, Fig. 32). This ribbon is about 1,4 mm in length and  $200 \mu\text{m}$  thick, and is associated with a large elongated cluster of inclusions running parallel to the crack growth

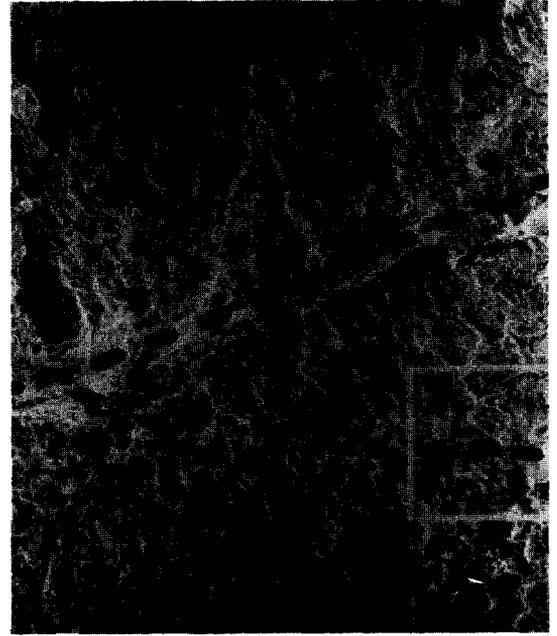
Another interesting instance of EAC growth is shown in detail in Fig. 35. The area between the  $\Delta K$  steps 18 to 21 MPa  $\sqrt{m}$  is shown in Fig. 35(a), from which it is evident that the  $\Delta K = 21 \text{ MPa } \sqrt{m}$  beach mark exhibits a localized bowing out (of about 1 mm) in the vicinity of a fairly large fissure. This is the result of the sudden localized occurrence of fan-shaped EAC growth (broken lines) between the  $\Delta K$  steps 18 to 21 MPa  $\sqrt{m}$ . Fig. 35(b) shows details of the edge of this EAC region, exhibiting a change from ductile striated growth to fan-shaped growth in Fig. 36(c), and the continuation of fan-shaped EAC growth beyond the beach mark  $\Delta K = 21 \text{ MPa } \sqrt{m}$ . The initiation for this region II growth was the front tip of the fissure running parallel to the direction of crack growth; this is illustrated in Fig. 36(b). A general low-magnification view of this is shown in Fig. 37.

(b) Details of boxed area in (a). The top part is the EAC region associated with step  $\Delta K = 21 \text{ MPa } \sqrt{\text{m}}$ . The middle, triangular region is EAC between the onset of fan-shaped growth and the step  $\Delta K = 21 \text{ MPa } \sqrt{\text{m}}$ . The bottom shows ductile striated growth associated with the step  $\Delta K = 18 \text{ MPa } \sqrt{\text{m}}$

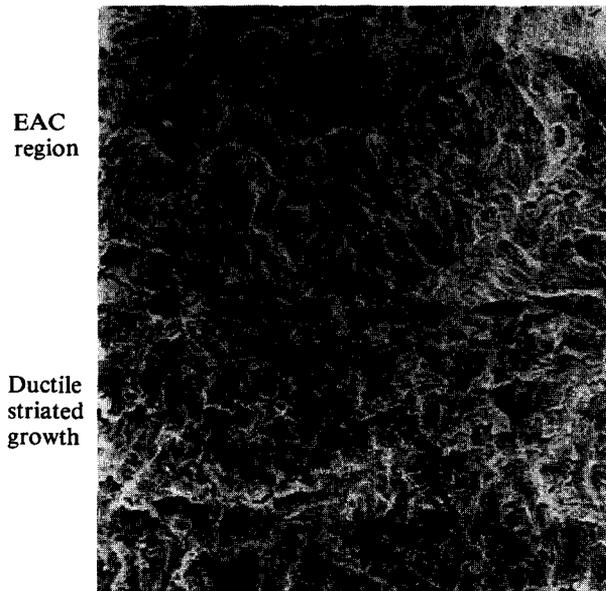
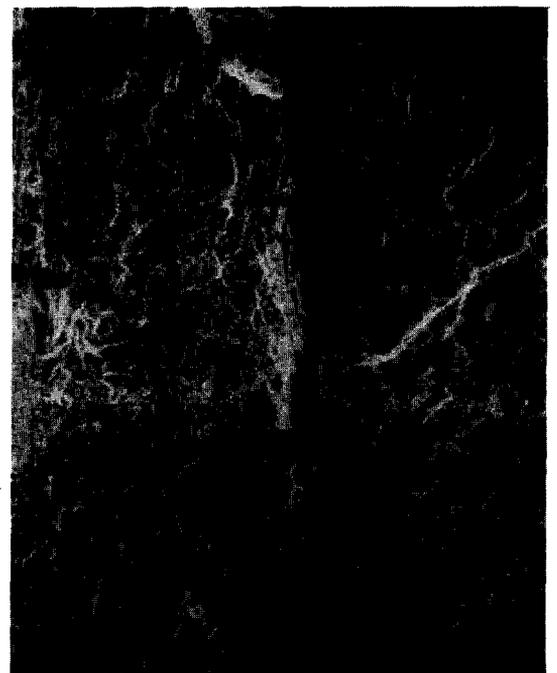
Fig. 36—(a) Details of the boxed region in Fig. 35(b), showing the abrupt change to EAC growth within the step  $\Delta K = 18 \text{ MPa } \sqrt{\text{m}}$   
 (b) Initiation site for the EAC region at the base of an elongated cluster of inclusions running parallel to the direction of crack growth

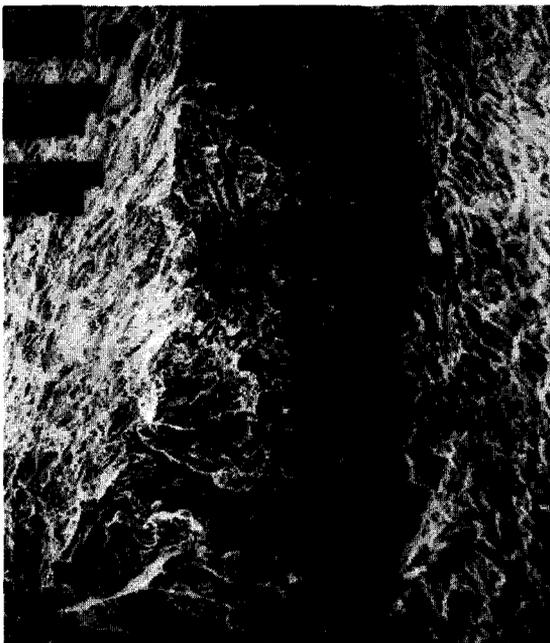
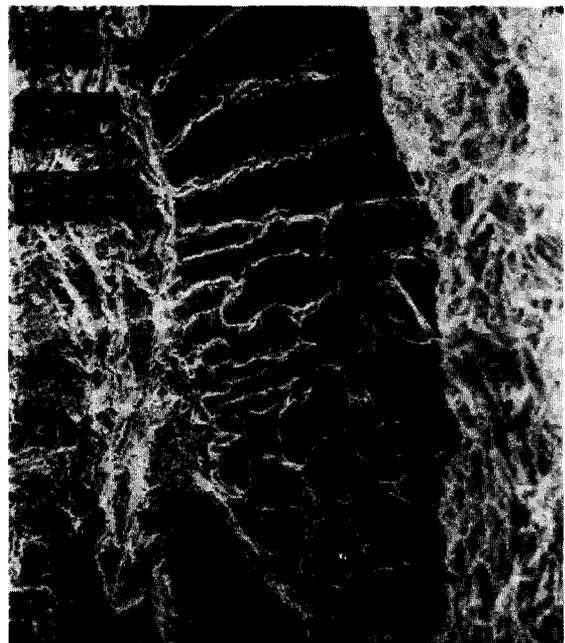
As a result of the occurrence of a number of deep fissures running parallel to the direction of crack growth and their association with localized bursts of region II EAC growth, the exact nature of these fissures was investigated. By use of the tilt mechanism, it was possible to obtain some details of the sides of selected fissures; these are shown in Fig. 38.

Fig. 38—Details of elongated fissures, showing the sides associated with type I and II manganese sulphide inclusions (45° tilt)

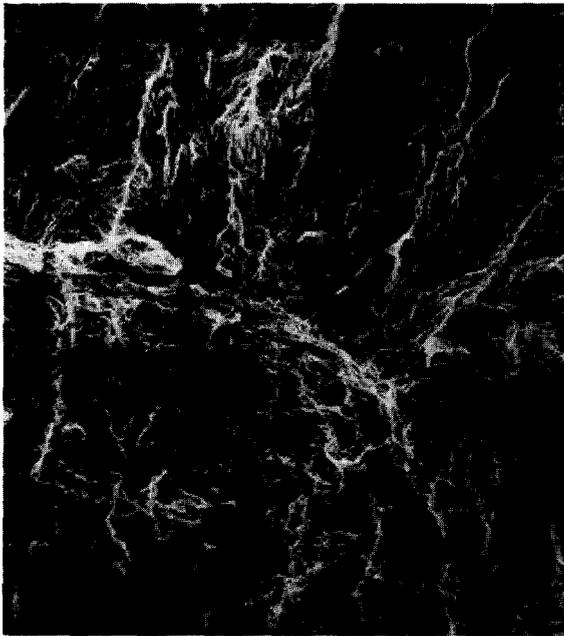
**Fig. 40**—Abrupt change in fracture characteristics from ductile striated growth to the fan-shaped growth indicative of EAC at the step  $\Delta K = 21 \text{ MPa } \sqrt{\text{m}}$

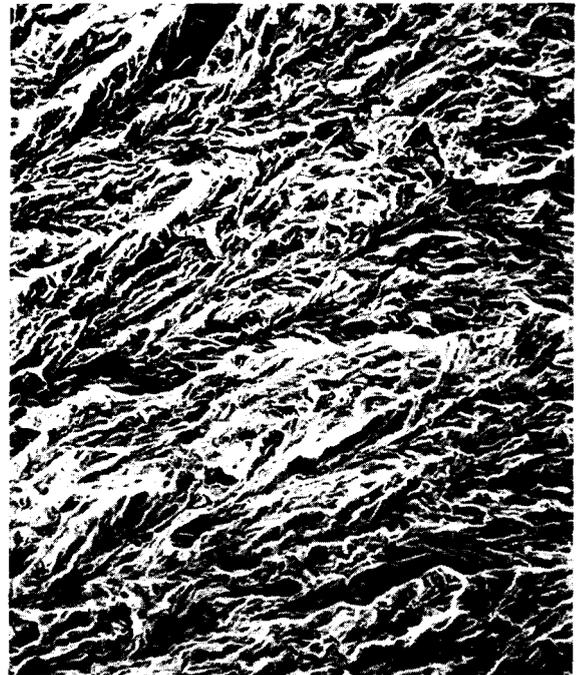
**Fig. 42**—Details of the box D in Fig. 32, showing fan-shaped growth extending some 7 mm into the unstable post-fatigue region. Such growth is identical to the EAC growth found at  $\Delta K < 25 \text{ MPa } \sqrt{\text{m}}$

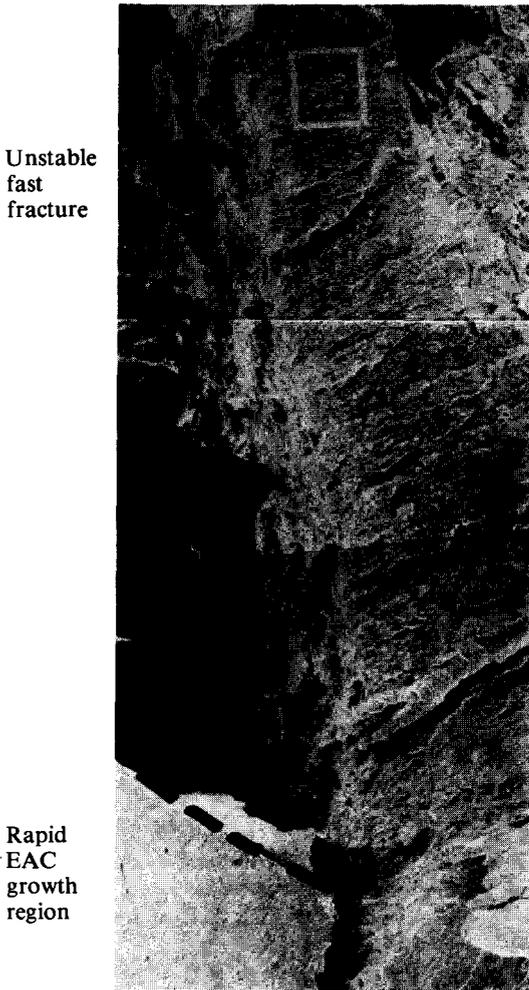
**Fig. 41**—Region of unstable fracture beyond EAC region, i.e.  $\Delta K > 25 \text{ MPa } \sqrt{\text{m}}$ . A ribbon of fan-shaped growth about 7 mm long runs along the right-hand edge of the deep fissure (box D in Fig. 32). Evident are the terraced sides of the inclusion down face D

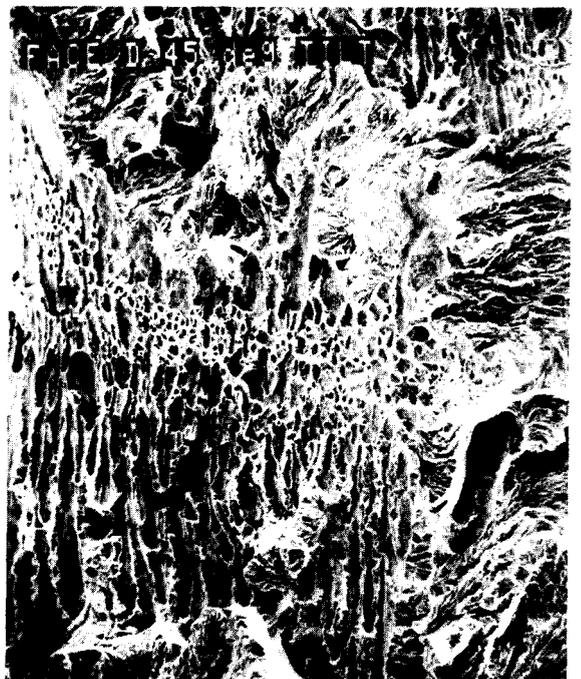
**Fig. 43**—Details of face D in Fig. 32 showing the massive inclusion clusters of types I and II manganese sulphide running along the edge of the fissure associated with the region of extended EAC growth

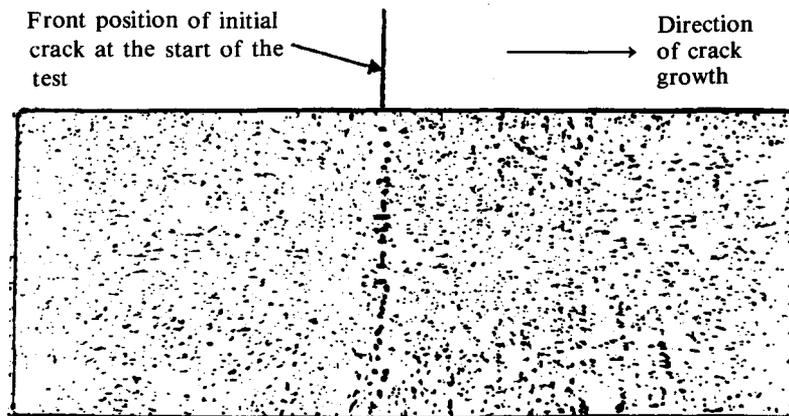
Fig. 47—Sulphur print of a triangular waveform in BPL test E
