Factors influencing the severity of rockburst damage in South African gold mines

by R.J. Durrheim*, M.K.C. Roberts*, A.T. Haile*,
T.O. Hagan*, A.J. Jager*, M.F. Handley**,
S.M. Spottiswoode*, and W.D. Ortlepp†

Synopsis

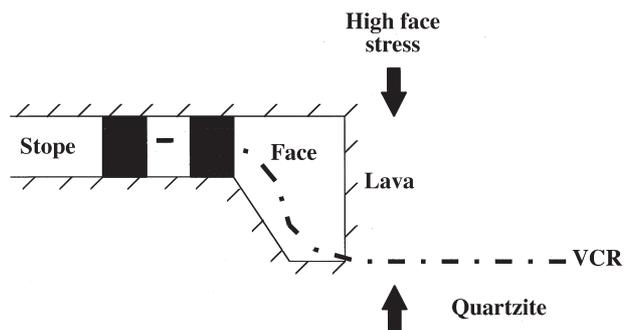
If trenching is carried out owing to a sudden change in reef elevation (e.g. faulting or 'roll'), the effective unconfined height of the remnant or pillar is increased (Figure 1). Calculations of the pillar dimension using guidelines based on the width : height ratio should be treated with caution.

Figure 1—Increased effective unconfined height of remnant or pillar owing to a change in reef elevation

associated with bedding-parallel faulting, as the frequency of weak calcite-coated joints appears to increase in these areas. The rock hangingwall has a greater propensity to disintegrate when subjected to seismically induced shaking. An additional hazard is posed by the exposure of lava in the face. The lava has a higher uniaxial compressive strength (UCS) and Young's modulus than the VCR, and can therefore store more strain energy and appears to be prone to face bursting (see Figure 1).

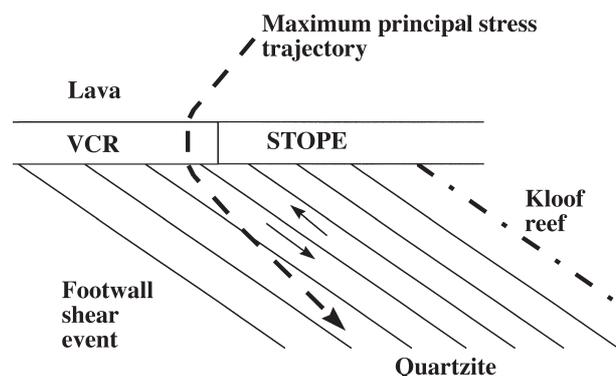
Figure 2—The possibility of shear slip between footwall strata with low cohesion may be increased by an unfavourable stress trajectory

If strata are not parallel, the refraction of the stress field due to mining may increase the shear stress on a bedding plane with low cohesion (Figure 2). This may contribute to a seismic event.
