# Construction of a concrete plug in South Deep's main shaft to seal off a major water intersection

by M.F. Wells\*

## Synopsis

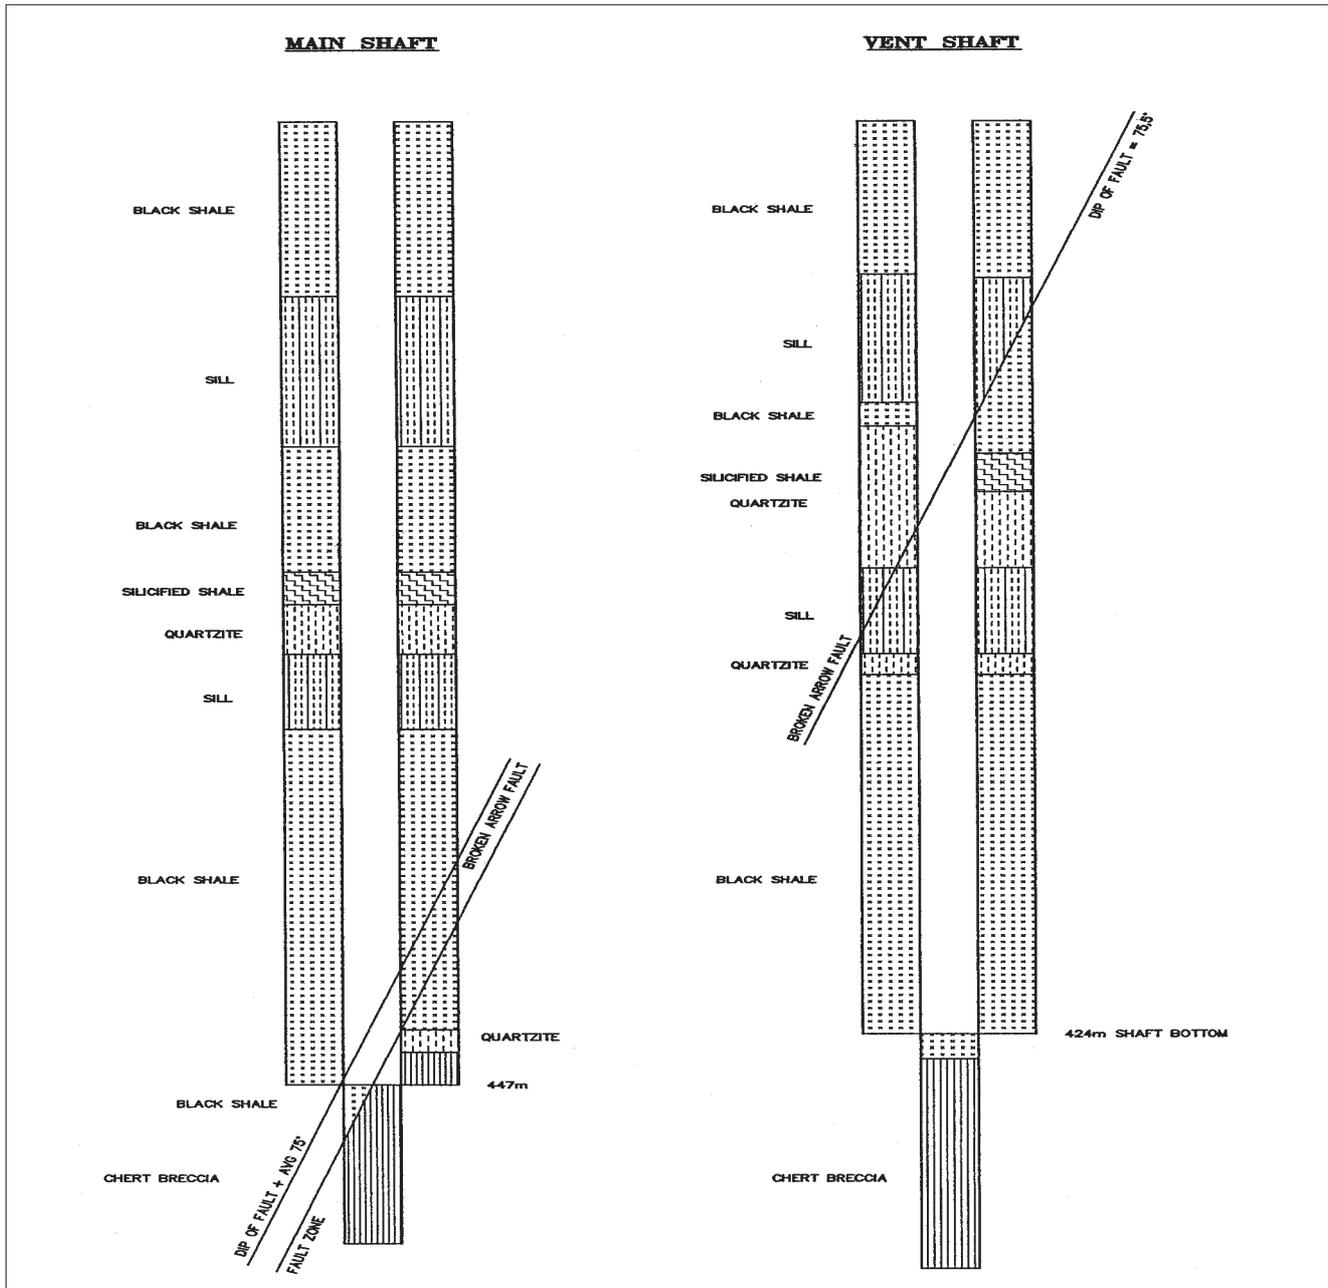
The shafts have been sited to traverse the steeply dipping Broken Arrow fault at the intersection point of the giant chert breccia above the Malmani Dolomites of the Transvaal Series, as shown in Figure 1.

On 1 May 1996 a round was drilled at -447 m and blasted at 08:30. On re-entry, water was noticed in the blasted rock. It was established that the water intersection was on the sidewall in the north-west sector of the shaft on the Broken Arrow Fault. The inflow occurred at an estimated rate of approximately 10 000 litres per hour. Water was bailed by means of kibles for approximately five hours, then split set rock support installation from the muck pile was started, while bailing continued for two further hours. Four hours of shotcrete operations followed which were concurrent with bailing. By midnight the bailing no longer matched the inflow and the bottom flooded. The inflow was now about 80 000 litres per

Figure 1—Geological section showing shaft elevations on 1 May 1996

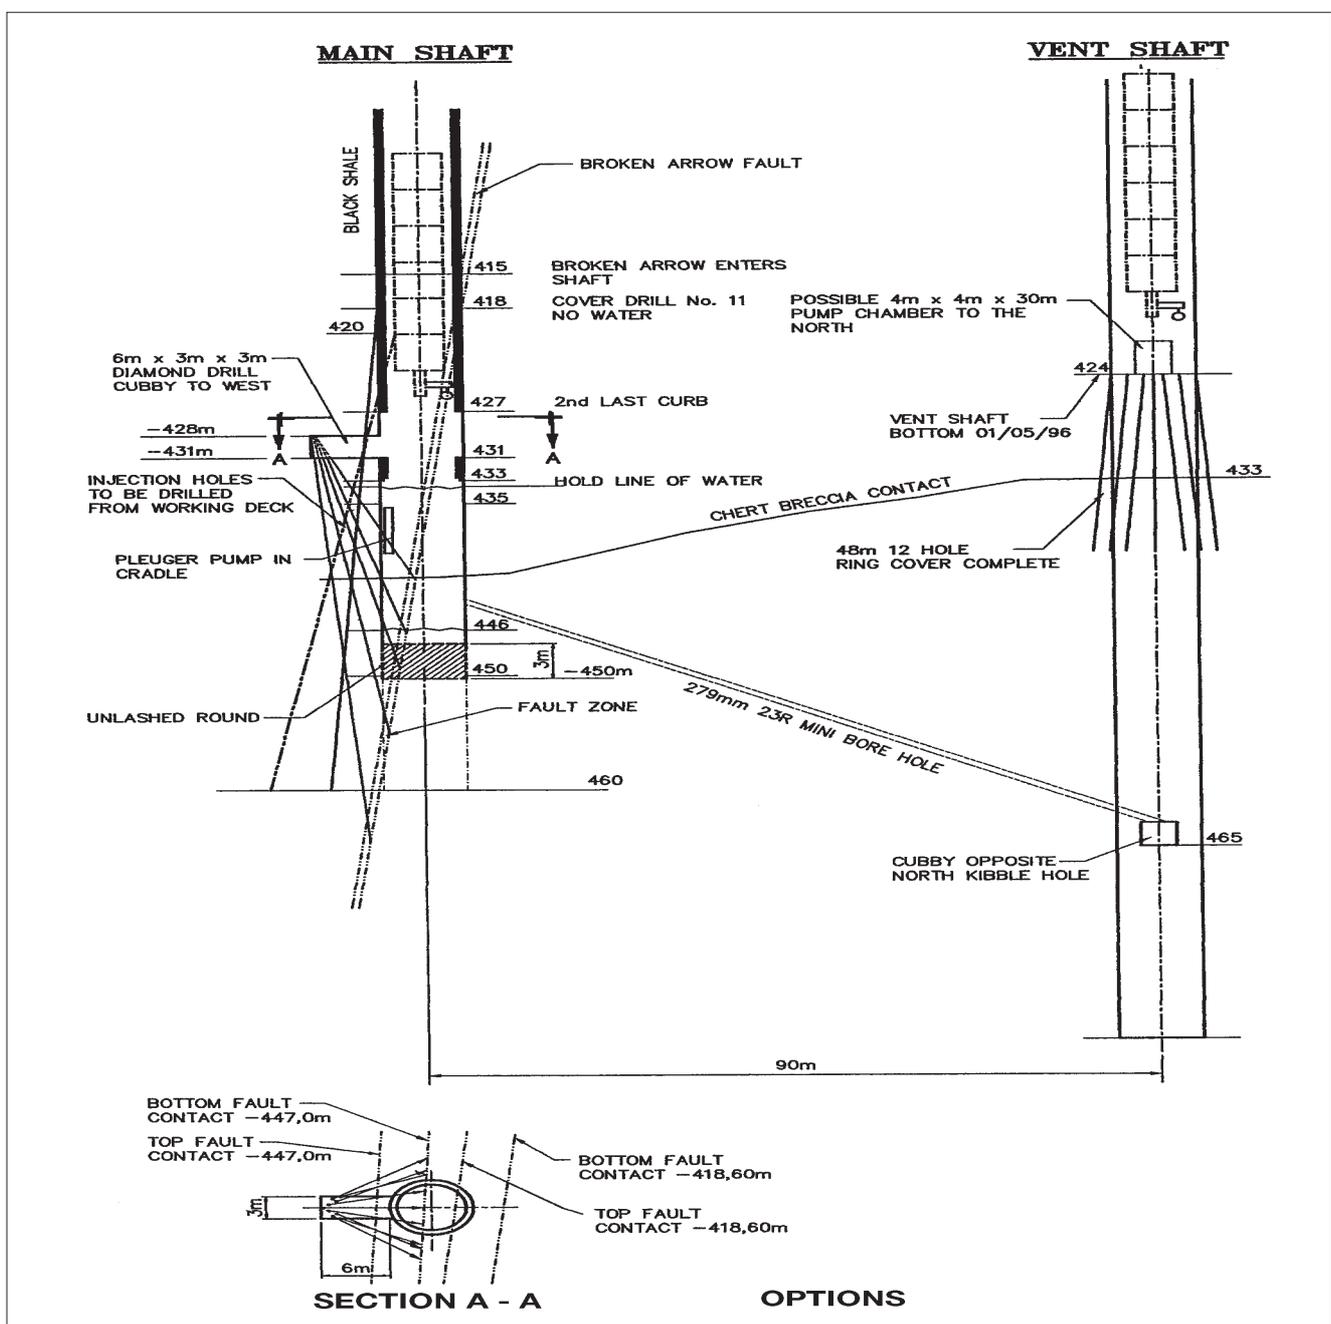
Several alternative options to overcome the flooding problem were considered. These included drilling and injecting grout, use of the ventilation shaft for access to -425 m, and the installation of a concrete plug to seal off the water inflow area. These alternatives are considered in turn below, and illustrated in Figure 2.

Figure 2—Considerations of options

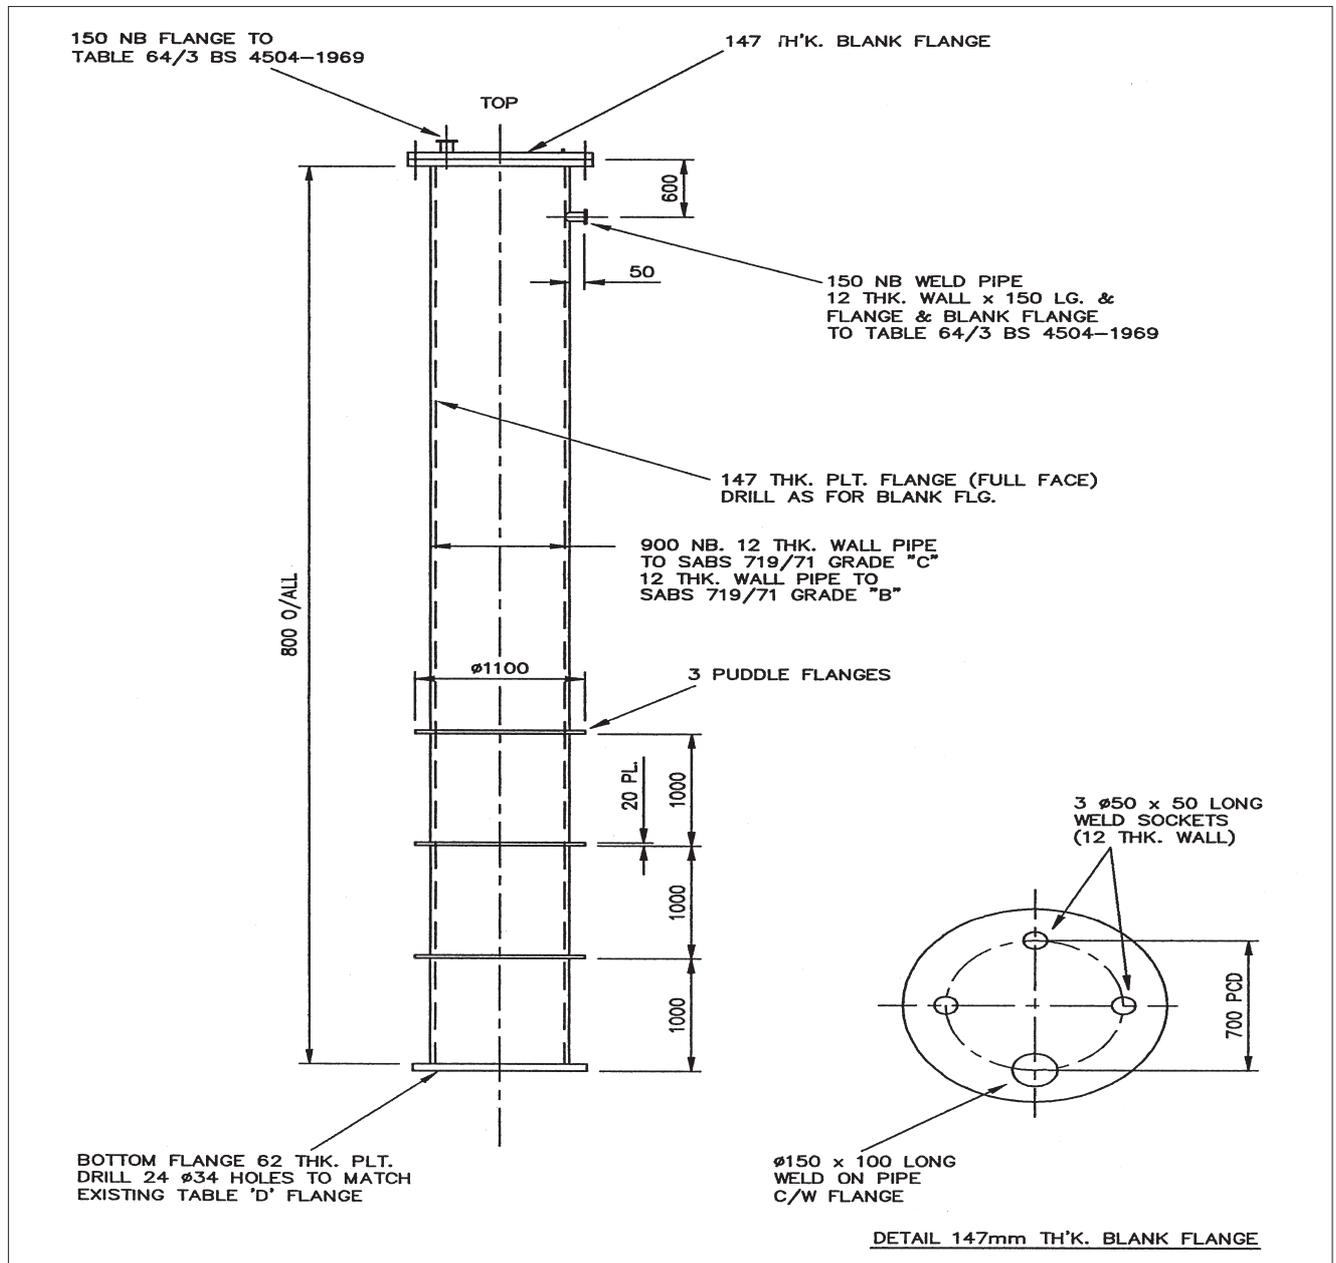
- Flange grade - SABS 1431 Grade 43A
- Gaskets - 3 mm thick Klingerite high pressure gaskets
- Puddle flanges - Outside diameter 1100 mm, 16 mm thick plate, 6 mm continuous fillet weld 900 mm NB pipe with flanges and puddle flanges (See Figure 3)

Figure 3—900 mm pipe with flanges and puddle flanges, top draft column

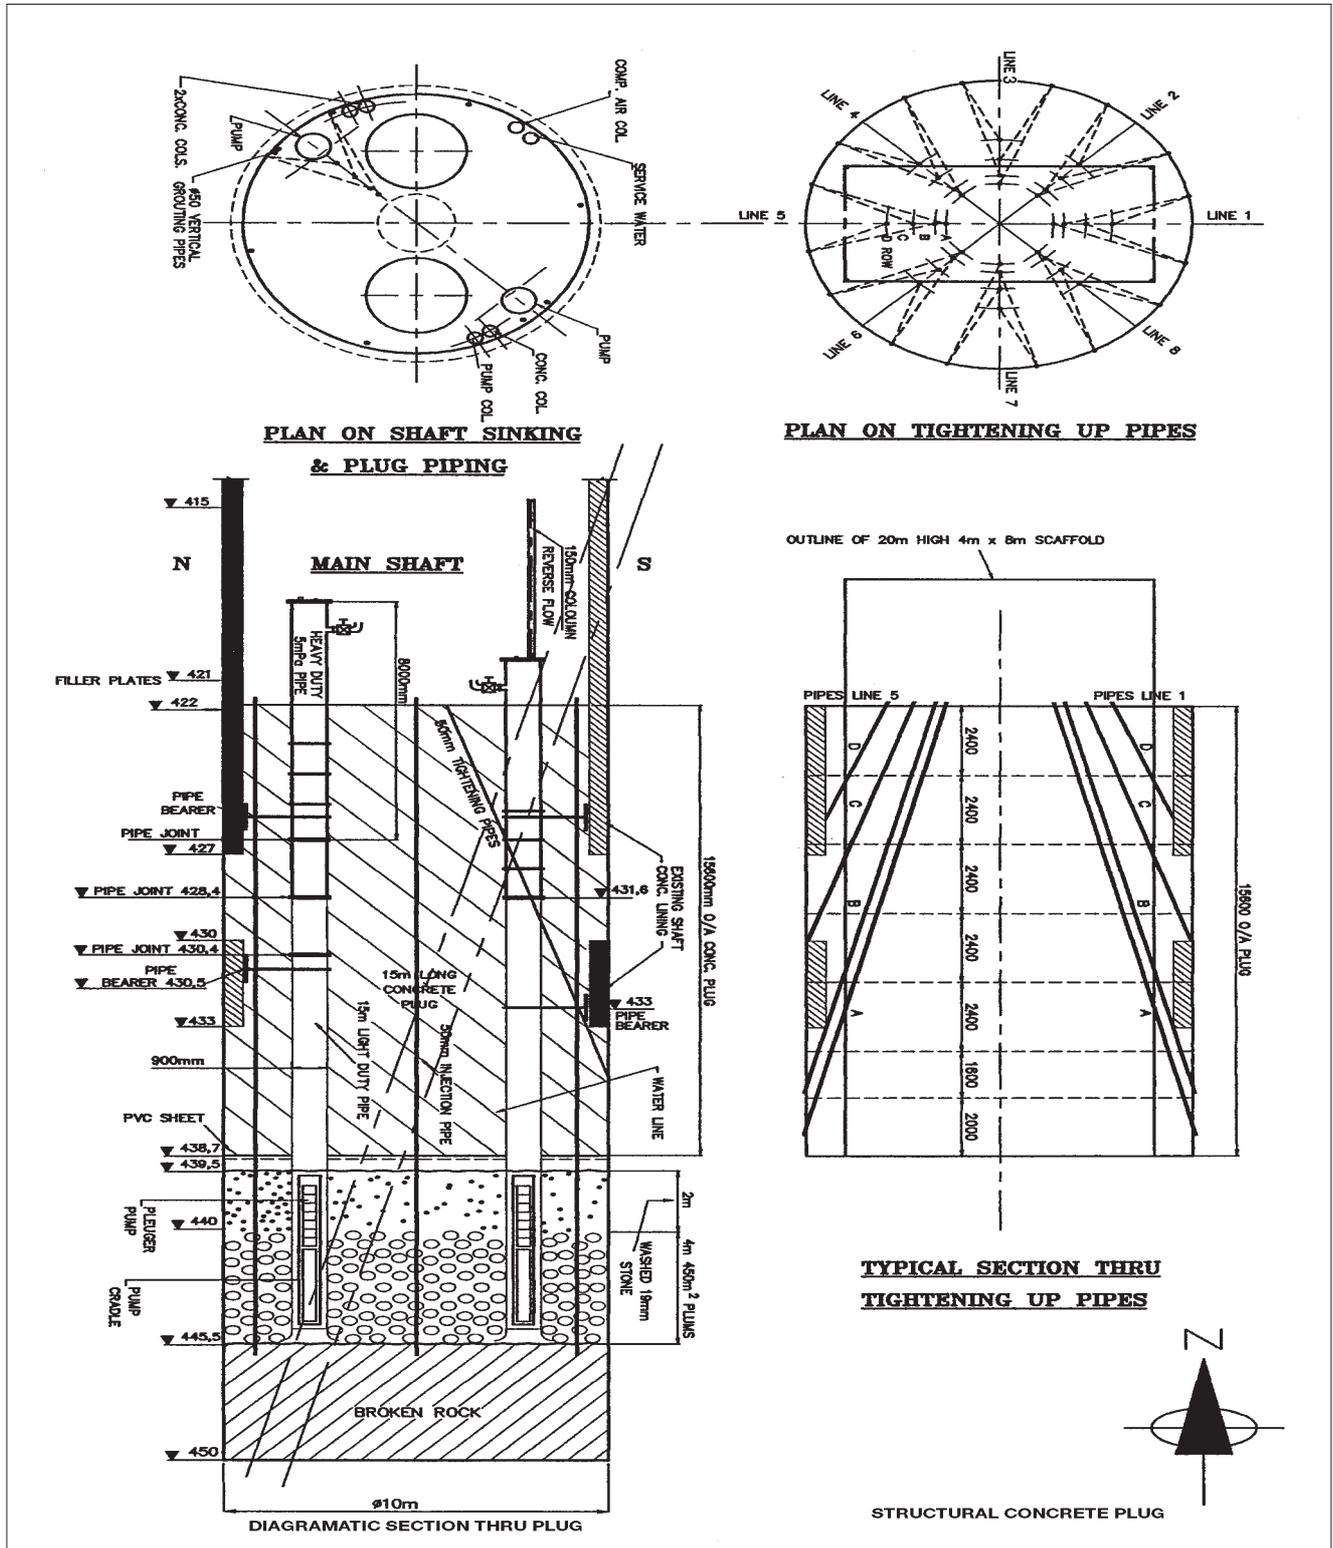
Figure 4— Structural concrete plug

The method, illustrated in Figure 4, entailed the construction of a French drain and structural concrete plug, whilst continuing to pump using one submersible pump, with another commissioned as a standby. A spare pump was kept on surface.

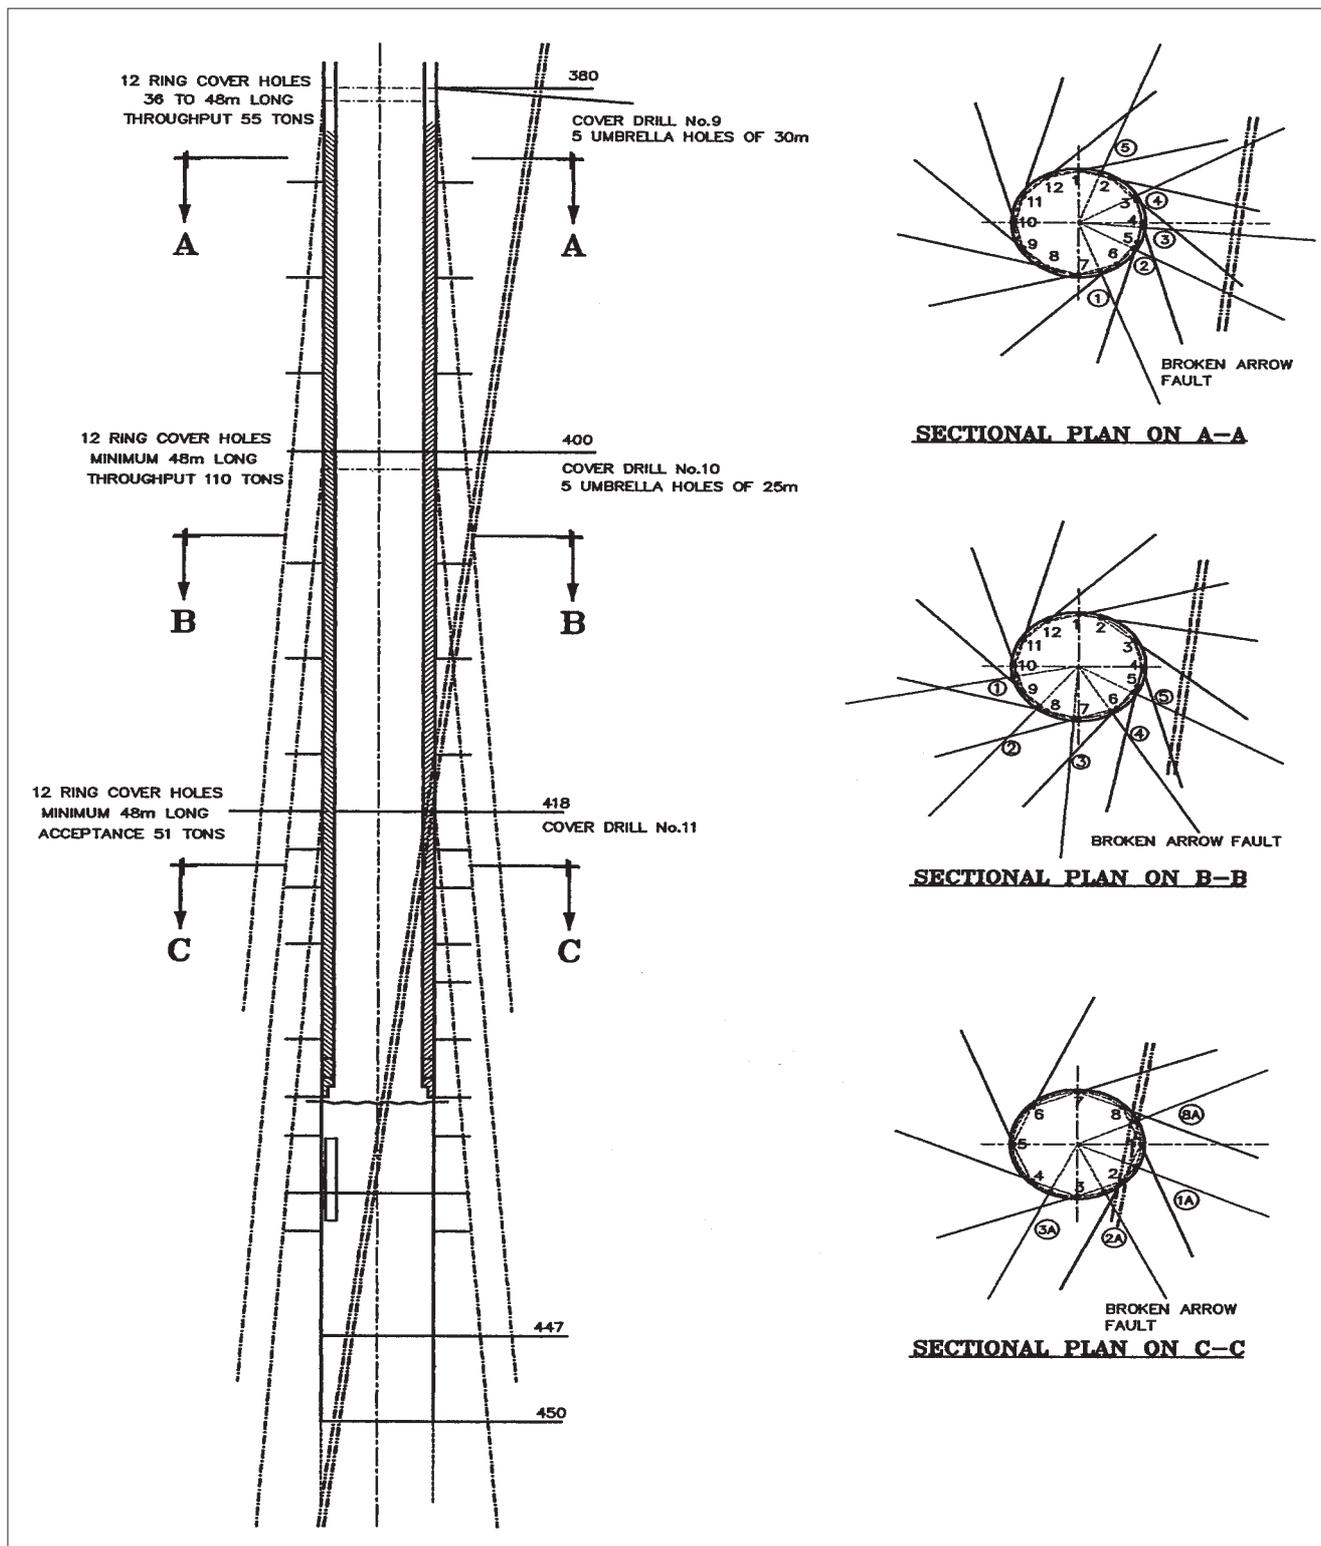
- ▶ The selection of the plug location: the proposed plug was within a fault zone. Concern was expressed regarding the anchoring of the plug, its water tightness and the possibility of water rising along the fault and breaking back into the shaft above the plug at the -415 m elevation.
- ▶ In response to these concerns, the cover drilling records at the -380 m, -400 m, and -418 m elevations were examined, and it was established that the fault was more than adequately tightened in this area of concern. The cover holes were sealed at a pressure of 7,5 MPa, indicating that the fault was well treated and very unlikely to transfer water where tightened. This was confirmed by previous drilling and injections in the tightened fault zone (see Figure 5, cover drill numbers 9, 10 and 11).

Figure 5—Cover elevations 9, 10, 11

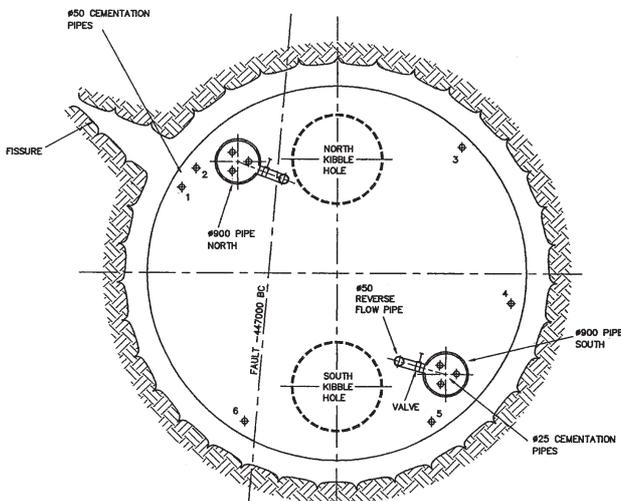
Figure 6—Plan view of reverse flow process pipes

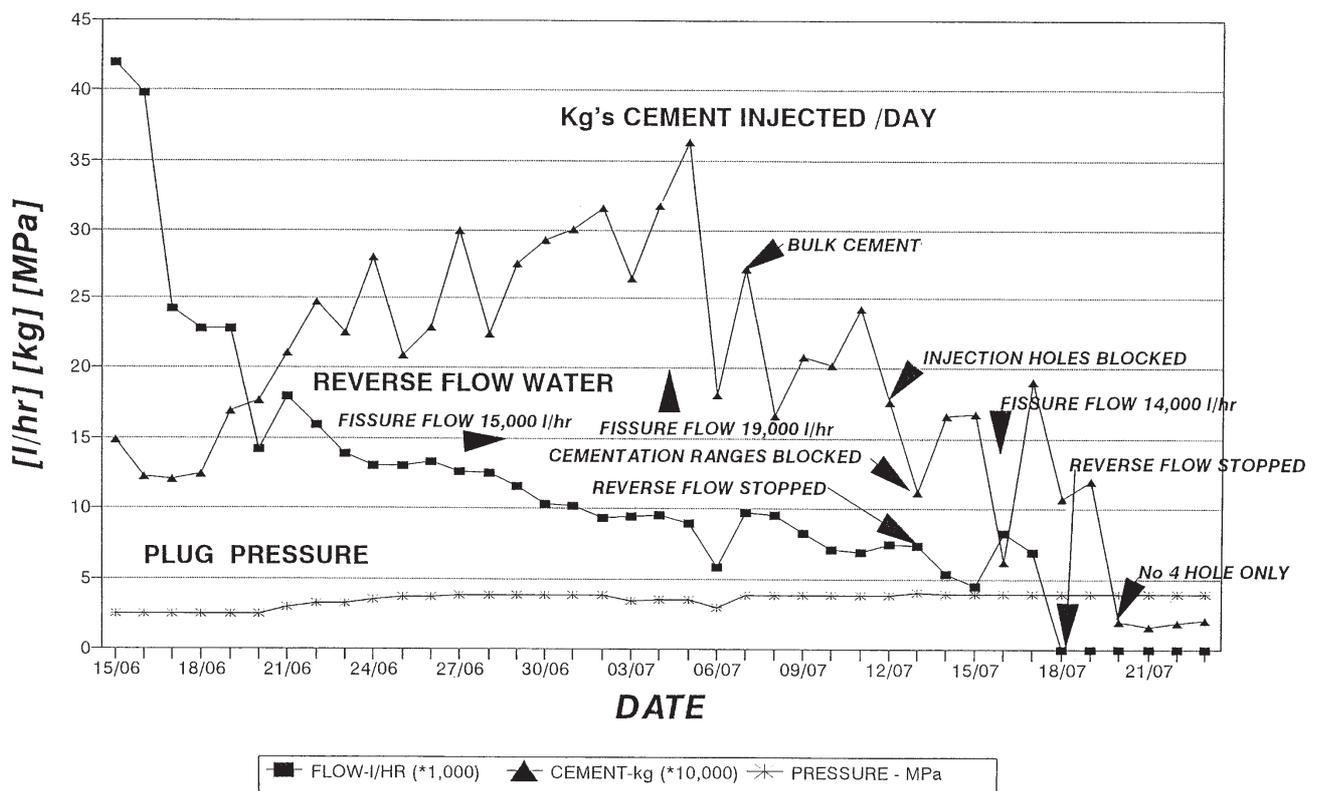
At this point the reverse flow and intrusion phase was considered complete, and the probe drilling began. Figure 7 gives a summary of the reverse flow and cement intrusion phase.

Figure 7—Reverse flow and cement intrusions

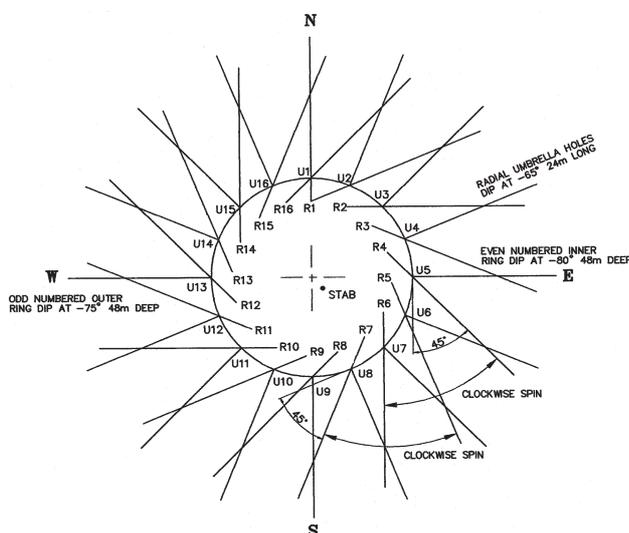
Figure 8—Typical cover drill rounds used in dolomites
