Pit wall failures on 'unknown' structures

by P.M. Dight*

Synopsis

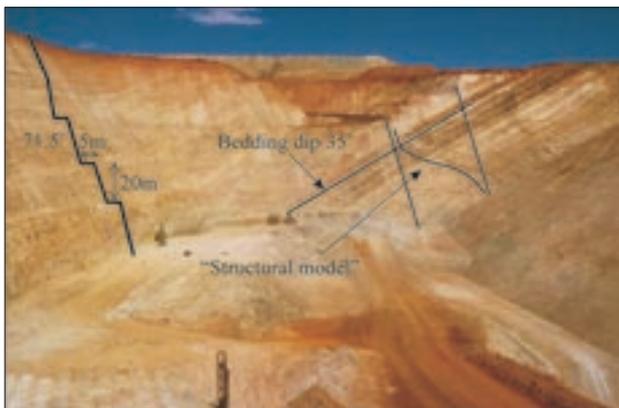
This open pit mine was developed on a sequence of siltstone and sandstone. A view of the south wall of the pit is shown in Figure 1. Originally the south end of the pit was mined with 20 m high batters at 71.5°, 5 m berms and a design probability of geotechnical failure of 15% and a depth of 120 m.

Figure 1—Mine A: looking south in the South Pit

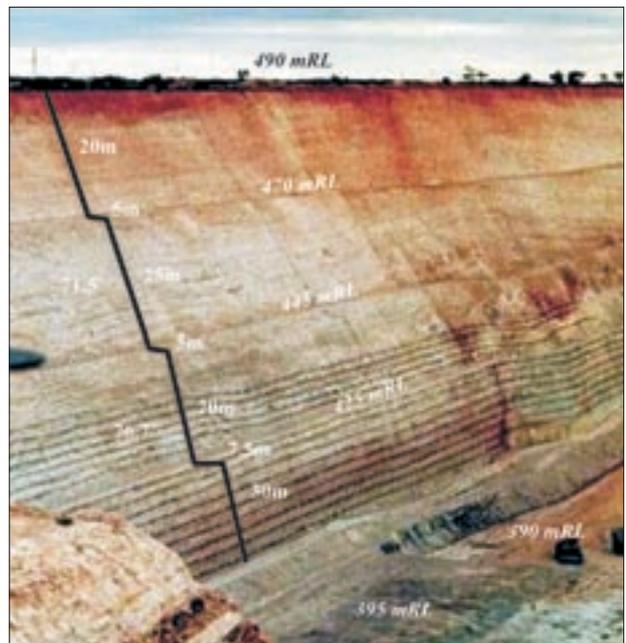
Figure 2 shows the wall 24 hours prior to failure. Large cracks had opened up on the face; the ground had been experiencing audible cracking after blasting (locally called 'booting') for several months, and the rock mass strength had dropped from 27 MPa to 5 MPa. Failure was imminent.

Figure 2—Mine A: highwall just prior to failure

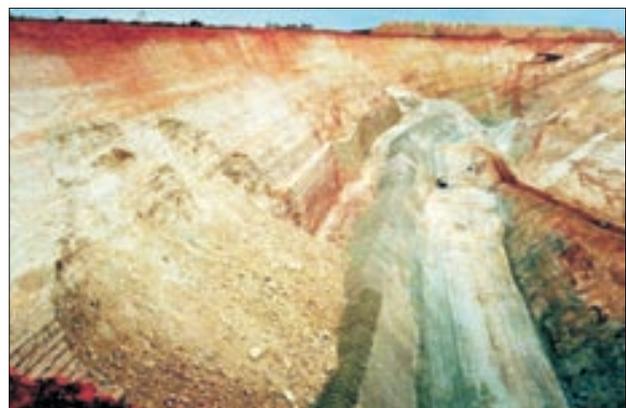
The failure was witnessed by the site geotechnical engineer who described it as '*son et lumiere*' as the barrel and wedge anchors were stripped off the cables. The failure measured 200 m along strike, approximately 10 m deep and 80 m high. The back scarp appeared to follow the trace of the thrust line created by the oversteepening.

Figure 3 shows the wall after the failure and after a large windrow had been constructed through the pit.

Figure 3—Mine A: showing extent of highwall failure. Windrow in centre of pit built afterwards

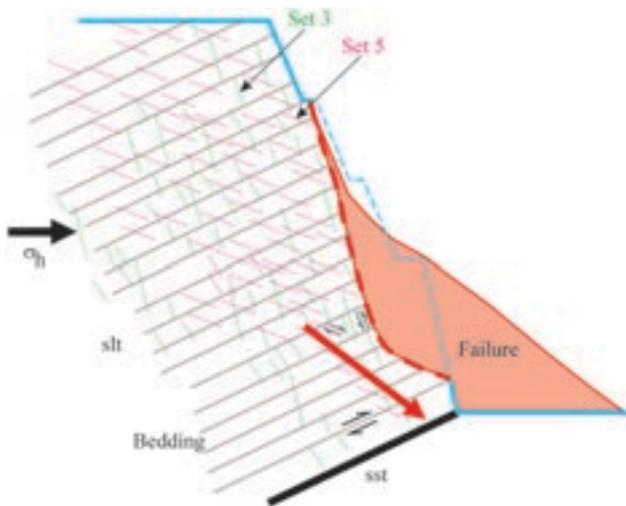
Figure 5 shows a cross-section through the failed rock mass. The failure scarp is plot deep (<10 m).

Figure 5—Failure scarp and shape of rill. Note failure occurred adjacent to change in rock type

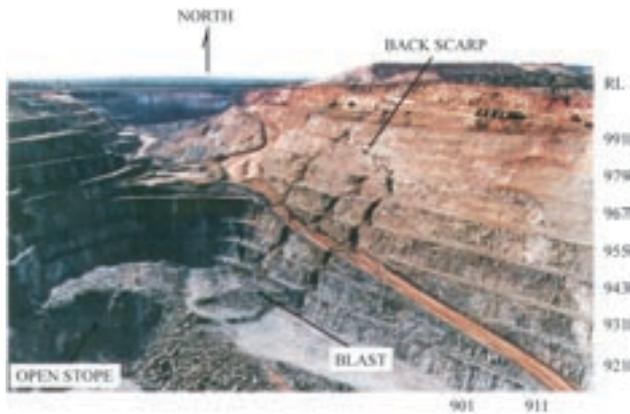
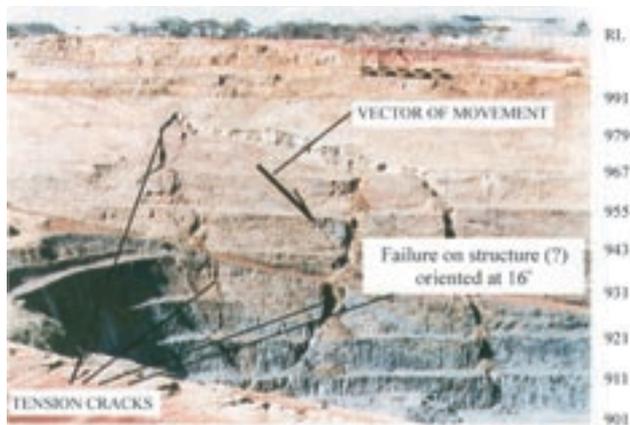
Figure 8—Mine B: looking north with failure on east wall

Figure 9—Mine B: looking at failure. Vector of movement was 16°

A failure occurred on the east wall of the pit affecting the main access to the pit (Figure 8 and Figure 9). The failure occurred rapidly.

Examination of the movement vectors showed the failure was inferred to be occurring on a structure dipping at 16° towards the south-west. However, there were no features mapped in the pit that correlated with this direction.

This later failure was interpreted to be the result of buckling in the quartz biotite schist, followed by flexural failure and sliding on the 16° plane. Figure 11 shows the stress analysis undertaken at that time. Once the lateral stress was relieved, then the driving force for the failure dissipated and the rock mass reached equilibrium.

Subsequently the east wall of the mine was cut back. The design recognized the potential for another failure but laid the slope back to minimize the extent. During mining, another failure did occur. With the confidence built up from the previous experience, rather than cease mining, the company continued, safe in the knowledge that the very strong amphibolite at the toe would buttress the quartz biotite schist. The strategy was successful.

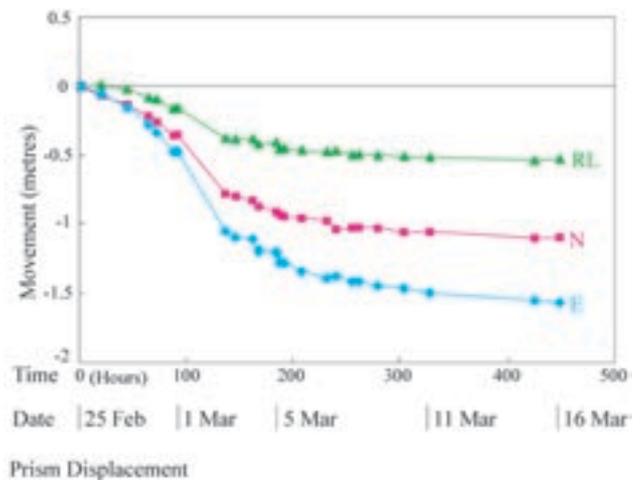
The movement that occurred immediately after the failure initiated (Figure 10) suggested that the failure was accelerating (in particular up to 100 hours after the prisms were installed) and that the pit would have to be abandoned until a new access was established. The equipment had already been evacuated (within 18 hours of the initial observation). Subsequently the movement rate slowed down (as seen in Figure 10) suggesting that the driving force for the failure had been exhausted.

Figure 10—Mine B: displacement profile developed with time

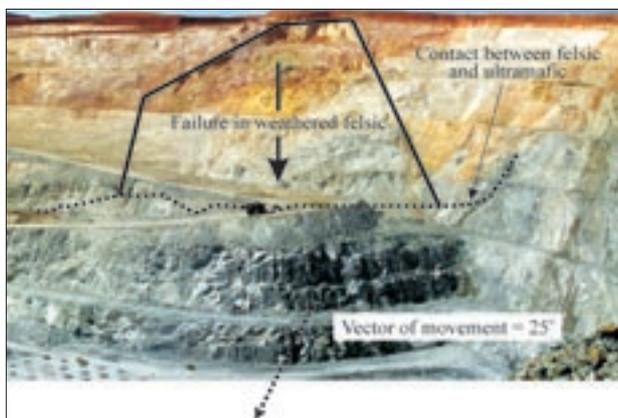
This potential failure initiated within an ultramafic rock mass. As can be seen in Figure 12 there has been an earlier failure characterized by shearing and rock mass failure within a highly weathered felsic/dacitic unit. Initially the failure was attributed to a rock mass failure as a result of the slope being too steep for the rock mass strength. The original design assumed a base of weathering extending to 100 m below surface. In fact the depth of weathering extended considerably further (140 m). On closer inspection, however, this failure involved shearing on steeply dipping faults. As depicted in Figure 12, this suggested that the failure was located in a zone of compression as indicated by the Kirsch equations (Figure 13). It is a coincidence but an earlier cutback of this same mine also experienced a failure in a similar location within that pit. As with case study B, this appears to be a signature of stress induced failures in open pits.

The design location of the switch back in the haul road was moved off the south wall to the position shown in Figure 12. The pit wall shown below the switch back was instrumented with 120 m long SMART Extensometers (Hoek *et al.* 1995). When the wall was approximately 90 m high below the switch back, visual observation showed that the face was deteriorating with the formation of large shallow slabs.

Figure 12—Mine C: showing extent of failure in scale from bottom of pit to switchback 90

Movement was also detected on the extensometers, coinciding with displacement along the contact between the felsic and ultramafic approximately 100 m behind the face. A review of the prism monitoring showed that the vector of movement was at an angle of 25° towards the pit.

A review of the extensive defect mapping database does not reveal any structures that would singly or in combination form a step path with this orientation. It was considered that the most likely mechanism comprised toe release of the face and local dilation. This allowed a change in failure mode for the mass behind the face to develop into an active wedge.

This item caused the ultramafic to respond in flexure and generate an initial 'tensile' crack at an angle of 20° to 25° resulting in a step-path angle (combining with the 70° foliation in the ultramafic).

- To install deep depressurization holes to relieve any excess pore pressure behind the slope, and
- Cease mining at the toe of slope and 'temporarily' abandon the ore until the next mining cutback.

As soon as mining stopped at the toe of the slope, the movement also ceased.

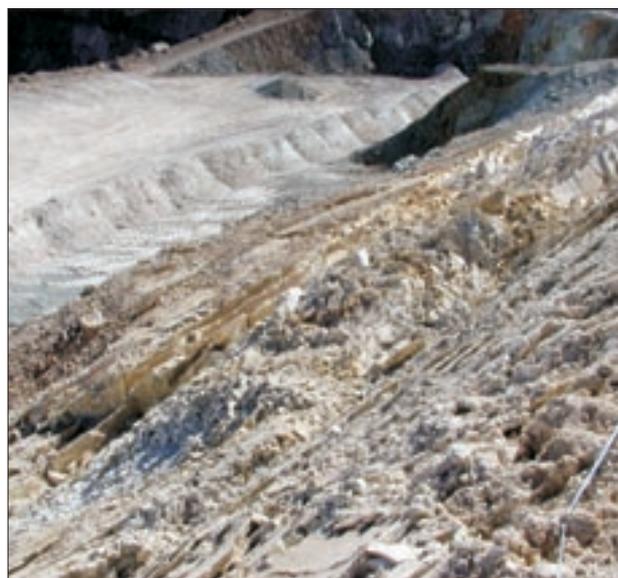
The author believes the stress model inferred from this failure was confirmed when later a toppling failure occurred in the region of low stress as predicted by the Kirsch equations (as shown in Figure 14) in the same rock unit.

Figure 14—Mine C: toppling failure located in 'tension' zone as interpreted using Kirsch equations

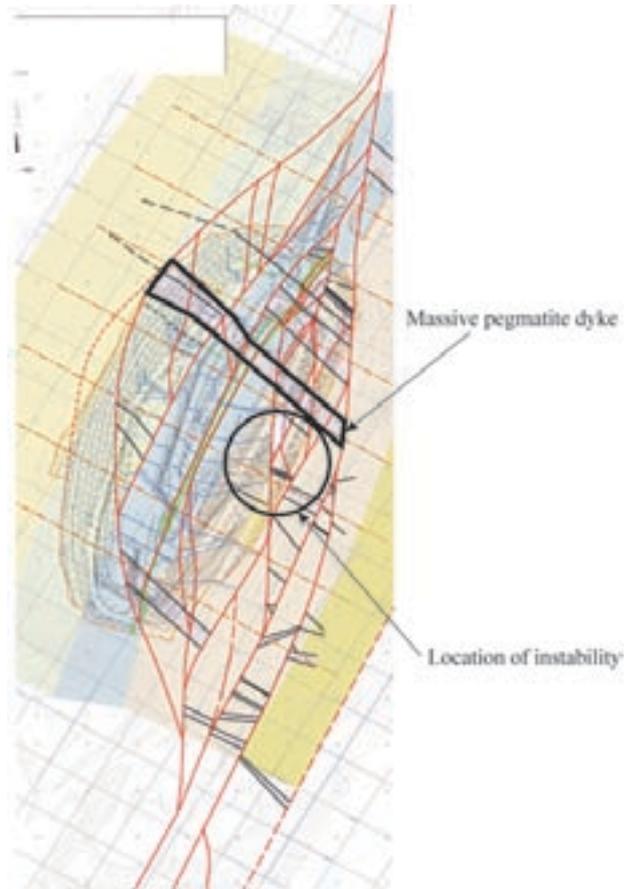
In this study the contours of extensional strain shown in Figure 15 do not comprehensively demonstrate the initiation of a new failure surface as noted by Lynch. This may, in part, be due to the assumptions relating to the local stress field, and the simplifying assumptions which arise from the 2D modelling, which can often ignore major structure effects. In the case of Navachab, the instability apparently occurred

adjacent to a major pegmatite dyke (Figure 16). A preliminary structural analysis of the published data suggests that a major influence on the local stress regime (and possibly associated with the mineralization events) can be traced to a granotoid intrusion located to the north-east of the mine.

Figure 16—Mine D: showing location of instability adjacent to pegmatite dyke
