Ground control at Leinster Nickel Operations

by J. Cahill* and M. Lee*

Leinster Nickel Operations, located in Western Australia, consists of an underground and three open pit mines in relatively adverse ground conditions. This paper reviews our ground control practices in the open pits, covering aspects of ground support, wall control and monitoring. These methods have been effective in allowing mining operations to continue beneath unstable slopes. In particular, the use of Groundprobe's slope stability radar has enabled the Harmony open pit to safely operate for months following indication of failure from traditional methods. This case study highlights the benefits of investing in appropriate slope stability monitoring systems.

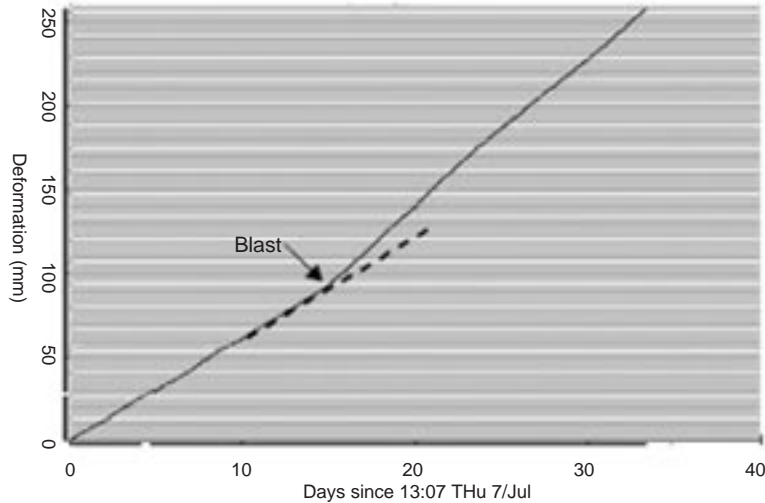
Figure 3 shows the increased rate of movement following blasting. Accelerated movement was monitored until a steady rate was established prior to blast clearance.

Figure 3—Accelerated wall movement due to blasting

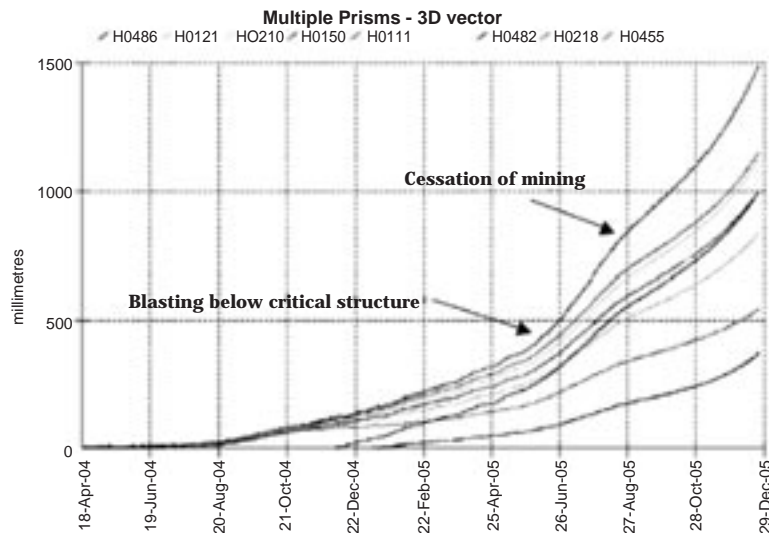
Figure 4—Prism movement data represented in Quikslope's graphing tool

Figure 4 shows typical prism movement in the south-east corner, where readings were taken every 24 hours. Prism rates accelerated after blasting below the critical structure. Rates decreased for a short time following cessation of mining, but continued to increase in the long-term.

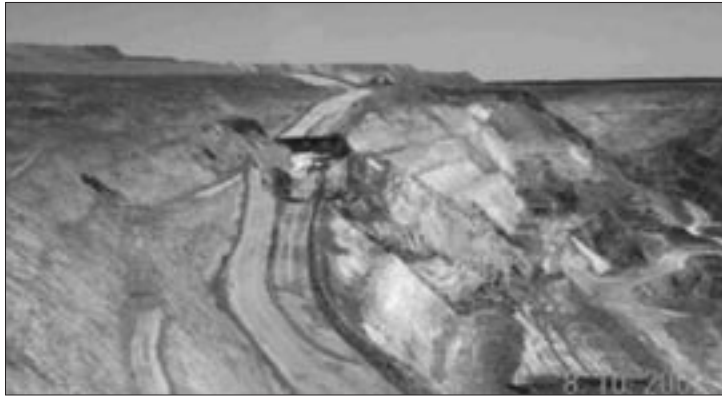
A major failure to occur in the Harmony pit was that of the Komatsu Ramp on 8 October 2002.

The structurally controlled failure occurred in weathered material and was predicted by prisms and crack gauges, giving adequate warning to remove the crew from the pit.

Figure 7—The Komatsu ramp failure, Harmony open pit

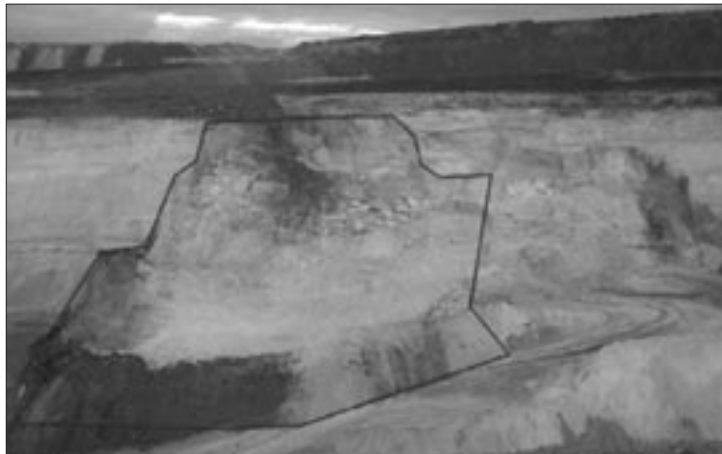
The 1C slip was an extension to a previous failure. It occurred on 23 June 2003 while a clean-up was being undertaken to reestablish mining in the area following the initial failure.

Figure 8—Harmony 1C slip, showing existing failure to the right, with extension outlined

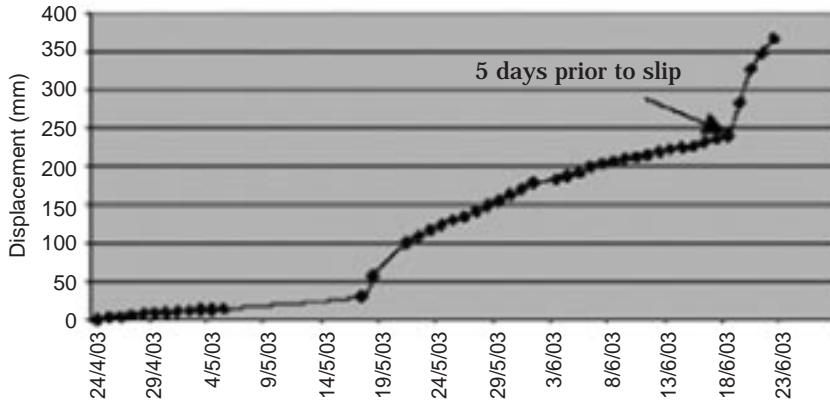
The failure was anticipated from 18 June due to movement observed in prisms and crack gauges. Figure 9 shows the crack gauge data, with distinct acceleration of movement.

Figure 9—Crack gauge data from the 1C slip

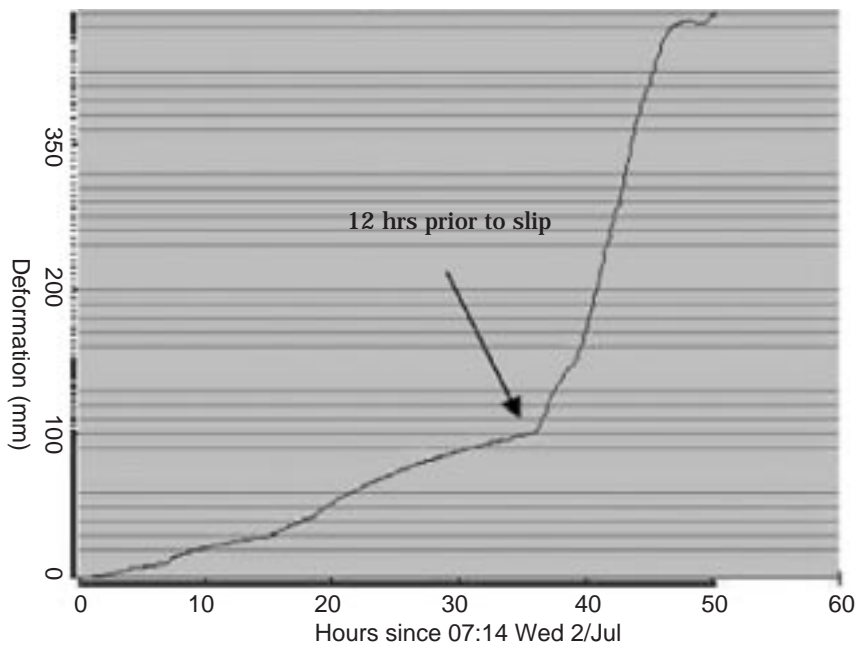
Monitoring of area continued by radar, which showed significant acceleration approximately 12 hours prior to failure (Figure 10).

Monitoring of this failure gave confidence that prisms and crack gauges would give adequate warning of impending failure in similar ground conditions. Furthermore, the radar monitoring showed that once the prisms and crack gauges indicated failure, there was still a significant amount of lead time prior to the onset of wall failure. This data clearly showed the benefits of radar monitoring, when working under unstable walls.

Figure 10—Radar data of the IC slip extension failure

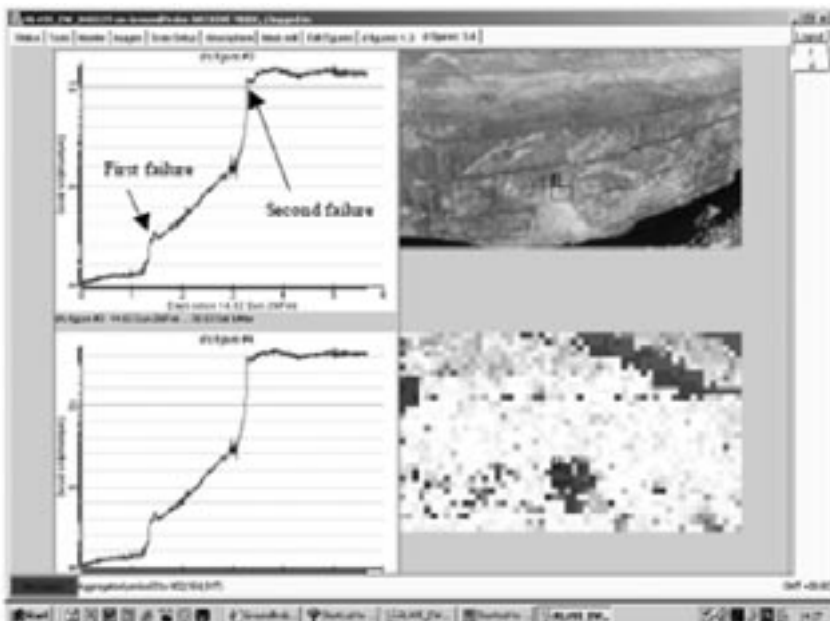
The north-east wall fresh rock failure occurred as an extension of a previous failure. Due to the recognized potential for further instability, the radar was used to monitor the area while work was occurring nearby. The prism system was inoperative, since no new prisms could be installed on the batter face. The radar detected movement prior to slab failure then movement continued until a second slab failed approximately two days later.

Figure 11 shows wall data as seen on the radar screen. The plot bottom right is a heat map of wall movement over the section in the photo top right. The two figures on the left show movement over time for selected areas of the wall.

Figure 11—Radar data of two slab failures in fresh rock

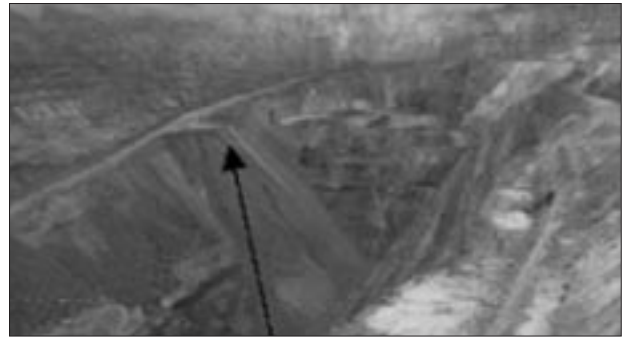
Figures 12 through 14 show the progression of the constructing, and then excavating the fill ramp. Figure 12 shows waste rock being placed to access upper benches. Placement of the fill temporarily slowed wall movement rates. Figure 13 shows excavation a further 30 m in depth. All geotechnical analysis to date indicated major wall failure if mining continues past this point. The final pit, a further 43 m past.

Figure 12—Construction of the fill ramp

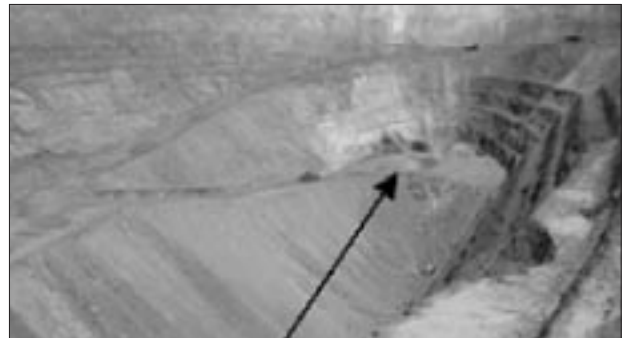
Figure 13—Excavation has advanced 30 m in depth

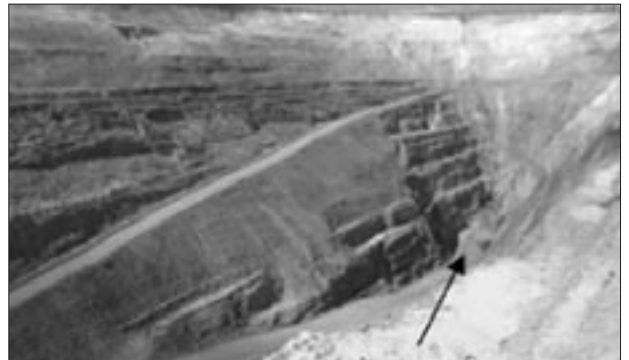
Figure 14—The final result a further 43 m in depth

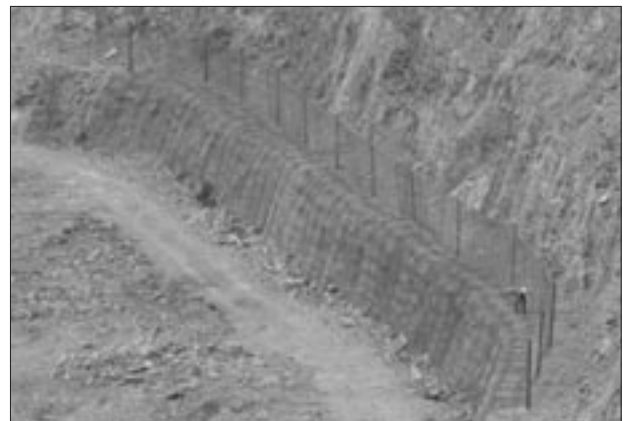
Cable bolts were installed along the crest of every berm and catch fences were installed in areas where access had prevented the installation of a curtain. During mining there were several failures that occurred behind the mesh curtain and fences that were fully contained. Figure 15 shows a newly constructed fence, with the start of a curtain begun below the fence.

Figure 15—Catch fence and mesh curtain

In order to reduce the risk of slab failure, ground support was installed in the fresh rock areas. A full face height rock-link curtain was installed from the base of oxidation and consisted of 20 and 30 m rolls that were pinned on a berm. These were then stitched together, with more rolls added as the floor was mined out. The final rock curtain was 250 m in length and 90 m in height.

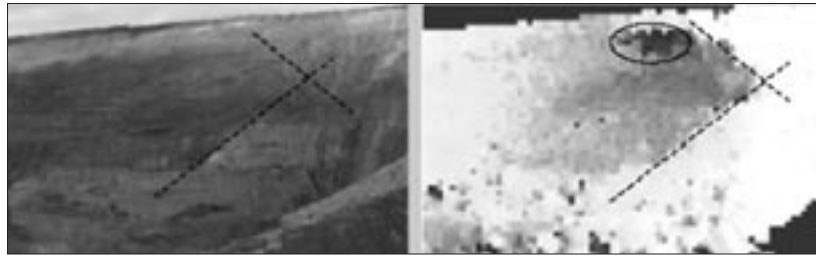
Figure 16—Radar data of south east wall

The ATS prism monitoring system, crack gauges and visual inspections had indicated movement in the SE corner of the pit since 2002. This was confirmed by the radar with data showing strong correlation. At the beginning of the South Park scavenge the overall wall movement was approx 1 mm per day. When mining ceased rates were up around 6 mm per day.

In the later stages of mining there were movements of up to 20 mm per day recorded on the batter faces by the radar, indicating that they were starting to buckle. Figure 16 shows radar data of the south-east wall. The structural boundaries of the movement are clearly visible on the movement heat map on the right. Circled in Figure 16 and photographed in Figure 17 is the uppermost berm, which showed extensive cracking and slumping.

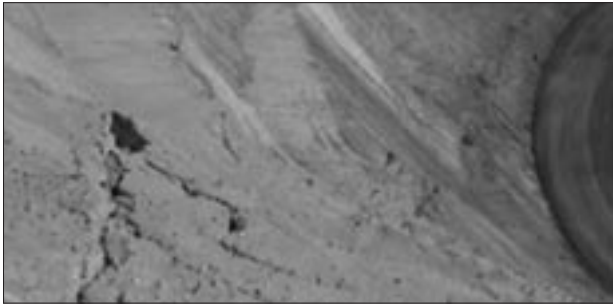
The accelerated movement in south-east corner was managed in a similar manner to the previous large failures in weathered material. Cracks existed down the pit wall 50 metres from the surface to just above the ramp, which was the only means of egress.

Tension cracks on the surface ran parallel to the strike of the bedding of the felsic material that makes up the upper east wall. These cracks extended up to 70 metres behind the pit crest. The base of the movement was believed to be one of set of major west dipping structures that would be exposed during the mining of South Park.

Figure 17—Cracking and slumping of a berm above the ramp

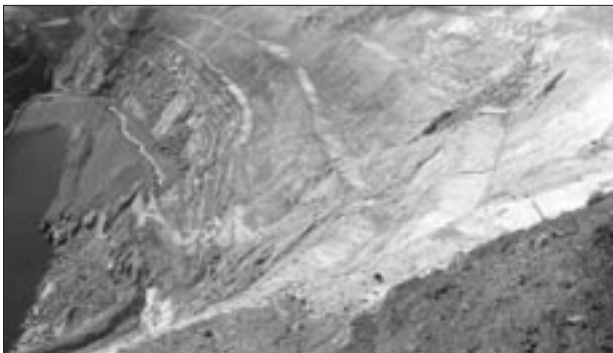
Figure 18—Post failure

Over the following days the pit remained closed as the area that had alarmed continued to accelerate, until failure of the batter face occurred at 01:00 a.m. on 16 August. As it was accepted that the wall had started to fail, it was decided by mine management that Harmony would close.

In the case of the Harmony open pit at Leinster Nickel Operations, managing the geotechnical risks using a combination of monitoring techniques and ground support enabled operations to continue for an additional 12 months. The South East wall of the Harmony pit failed early February 2006, 6 months after the pit was closed (Figure 18).
