Premature failure of re-sulphurized steel studs

Two rocker arm studs used on a 16-cylinder diesel locomotive engine failed prematurely after being in service for less than 5 months. The rocker arm studs had a life-cycle of 5 years. The studs were manufactured from re-sulphurized steel. The paper aims to establish whether re-sulphurized steel is applicable for the manufacture of studs in the automotive industry.

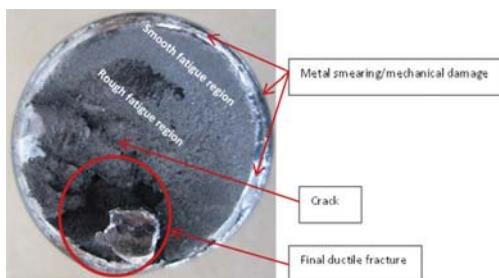
The fracture surface of stud A (Figure 5) was perpendicular to the stud axis. Mechanical damage and metal smearing was observed close to the stud peripheral, hence the failure origin could not be established. The roughness of the fracture surface was not uniform and the overload region displayed material tearing. The change in roughness of the fracture surface is one of the indications of fatigue failure. Progression marks were not observed on the fracture surface and final fracture occurred in approximately the 5 o'clock to 7 o'clock position. Lack of progression marks indicates that the load did not vary during the life of the crack. Cracking and material tearing was also observed. The final fracture displayed a ductile mode of failure.

Figure 5—Fracture surface of stud A, 2.4x

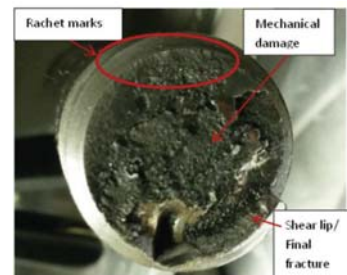
The fracture surface of stud B (Figure 6) was perpendicular to the stud axis. Ratchet marks were observed in the 10 o'clock to 1 o'clock position (Figure 6 and 7); these are

indicative of fatigue failure. Progression marks were not evident. A shear lip was evident in the 4 o'clock to 7 o'clock position, which is the point of final fracture and cracks were also observed on the fracture surface. The presence of a shear lip may indicate a ductile failure mode. Mechanical damage was also present in areas of the fracture surface, hence the difference in surface roughness of the fracture surface could not be observed.

Magnetic particle inspection revealed cracks on stud B (Figure 8). The crack observed on the fracture surface of stud B (Figure 6) was continuous in the longitudinal direction of the stud.

Figure 6—Fracture surface of stud B, 0.92x

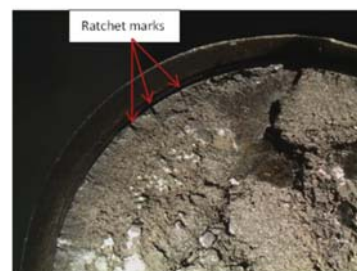
Figure 7—Ratchet marks on stud B, 0.64x

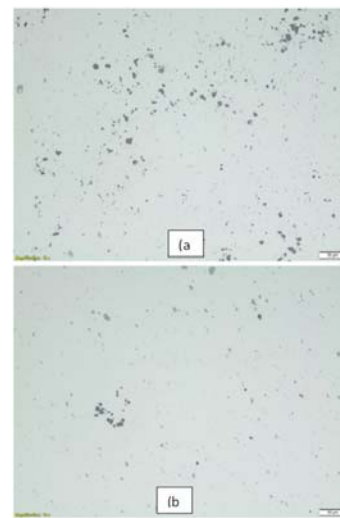
The microstructural analysis showed both studs to be composed of pearlite in a ferritic matrix. Level 5 sulphide inclusions were present throughout the ferritic matrix in accordance with specification ASTM E45 (2013). The presence of sulphide stringers indicates that the studs were hot-rolled. Figures 9 to 11 show optical micrographs of studs A and B.

Figure 9—Inclusions in the transverse view: (a) stud A, (b) stud B

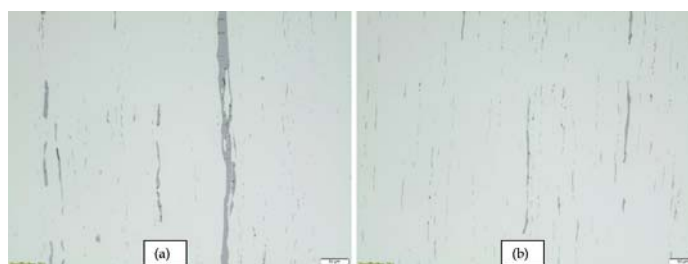
Figure 10—Inclusions in the longitudinal view: (a) stud A, (b) stud B

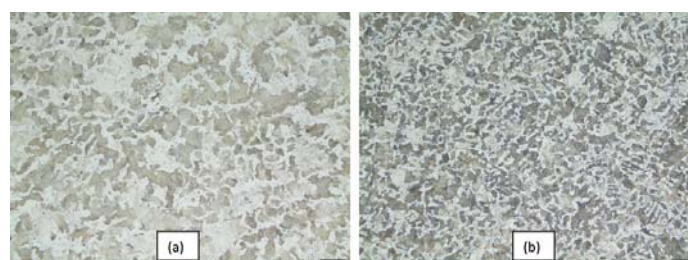
Figure 11—Ferrite pearlite microstructure: (a) stud A, (b) stud B

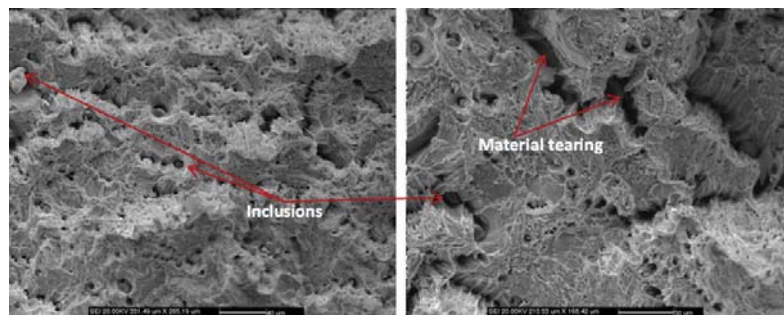
The fracture surface of stud A was cleaned using acetone and dried before examination under SEM. The fractography displayed material tearing with numerous cracks, which is characteristic of a ductile dimple fracture mode (Figure 12).

Figure 12—Fractography showing material tearing and inclusions in stud A

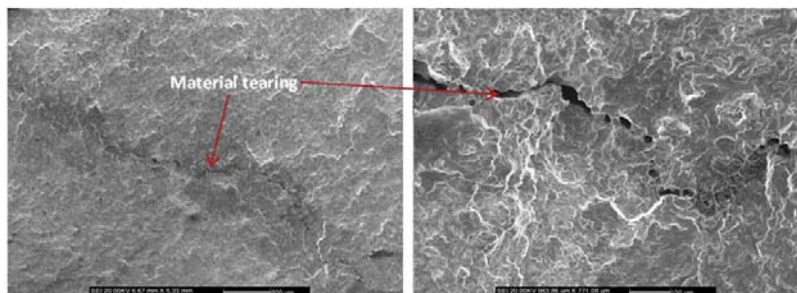
The cracks and tearing originated from inclusions, which were also present close to the stud surface (Figure 13 and Figure 14a). EDX analysis was conducted to identify and quantify the elemental composition of the inclusions; the EDX positions are shown in Figure 14b. The analysis revealed the inclusions to be MnS (manganese sulphide); results are shown in Table II.

Figure 13—Internal cracking in stud A

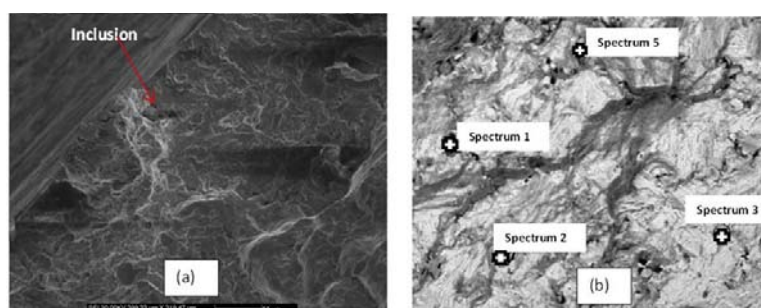
Figure 14—(a) Inclusion close to the surface in stud A, (b) EDX positions

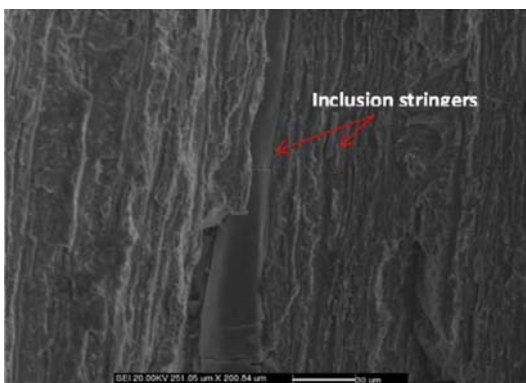
The crack observed on the fracture surface of stud B (Figure 6) was opened (Figure 15) and the crack fracture surface was analysed using SEM. Elongated inclusion stringers were present in the longitudinal direction of the stud (Figure 16) and the fracture surface had a ‘woody’ appearance, as shown in Figure 15. EDX analysis was conducted on the inclusion stringers to determine and quantify the chemical composition; the EDX positions are shown in Figure 17. EDX revealed the stringers of inclusions to be MnS (Table III). The MnS stringers were elongated in the stud rolling direction; which indicates that the studs were hot-rolled and confirms the pearlitic structure in the ferrite matrix. Sulphur is deformable at high temperatures and

Figure 16—SEM image of opened crack fracture surface with inclusion stringers
