The influence of mining sequence and ground support practice on the frequency and severity of rockbursts in seismically active mines of the Sudbury Basin

by P. Morissette*, J. Hadjigeorgiou*, A.R. Punkkinen⁺, D.R. Chinnasane⁺, and A. Sampson-Forsythe⁺

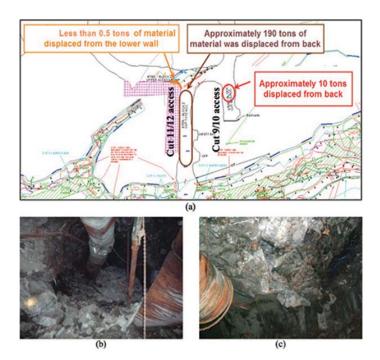
On 24 September 2010, a 2.6 m_N seismic event displaced approximately 181 t from two accesses to Block 2 of the 153 orebody on the 4700 mine level (Figure 15a). The seismic event was located in the footwall of the 153 orebody, approximately 55 m from the resulting damage. About 172 t were displaced from the back of the 11/12 access (5.5 m span) near the intersection, at the location of a narrow bornite stringer (Razavi, 2010).

The 2.4 m long rebars and mechanical bolts installed in the backs of the Cut 11/12 and 9/10 accesses were heavily corroded (Figure 15b, c). Consequently, the bolts were not effective in holding the damaged ground. The no. 6 gauge mesh-reinforced shotcrete was also severely damaged during the event. Cable bolts installed in the backs of the intersections were, however, very effective in preventing further damage from extending outside of the accesses.

Figure 15—Damage associated with a 2.6 m_N event at Coleman mine on 24 September 2010 located on (a) the 4700 level, (b) the cut 11/12 access, and (c) 9/10 access (Razavi, 2010)
