Cooling innovation in practice: A case study on composite copper-graphite cooler performance before and after a PGM furnace partial sidewall rebuild

Abstract

Cooling innovation in practice: A case study on composite copper-graphite cooler performance

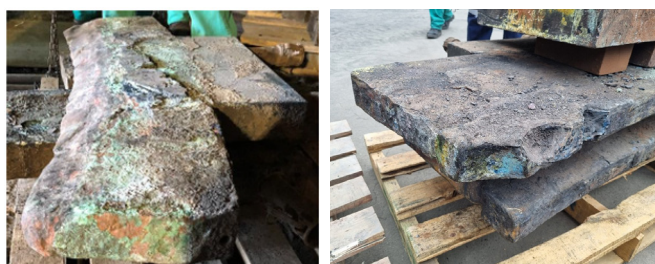
The operational environment within platinum group metal (PGM) smelting furnaces is characterised by extreme thermal loads and chemically aggressive conditions, particularly at the slag–concentrate interface (Shaw et al., 2013). This zone is notorious for rapid degradation of furnace sidewall copper cooling elements, primarily through chloride-accelerated sulphidation. Chloride-accelerated sulphidation is believed to be the prevalent copper corrosion mechanism at the slag–concentrate interface, due to the presence of labile sulphur and chlorine-bearing species in the uncalcined feed concentrates (Hoff, Rossouw, 2006; Marx et al., 2007; Shaw et al., 2013; Thethwayo, Garbers-Craig, 2010). This results in the localised attack of exposed copper surfaces, leading to thinning, pitting, and eventual failure of cooling elements, an example of which can be seen in Figure 1.

Figure 1—Examples of localised attack on exposed copper surfaces

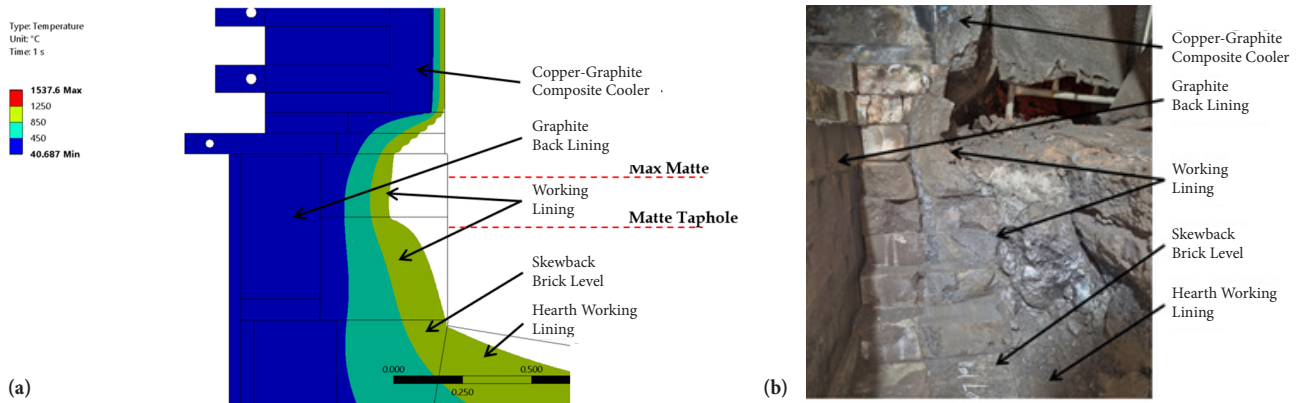
In Figure 3(a), the maximum matte and matte taphole levels are indicated, showing that the matte tapholes are positioned in this high-wear zone. Even though the sidewall wear stabilizes, as anticipated by the FEA modelling, the matte taphole areas (more specifically the matte taphole lintels) experience higher wear rates due to the increased activity in these areas during tapping operations. This was anticipated, and even though the rest of the furnace sidewall was designed for a 48-month campaign, the modular composite cooler design allows for a partial sidewall rebuild of the matte taphole areas, which was originally planned for every 24 months (Joubert et al., 2024b). Due to stable operation and good operating temperatures, this hot partial sidewall rebuild was executed in January 2025, 29 months after initial start-up. Even though the main intention of the partial sidewall rebuild was to replace the matte taphole lintels, it also afforded the opportunity to evaluate how well the copper–graphite composite coolers performed after 29 months in operation, as well as to inspect the matte–slag

Figure 3—Matte-slag tidal zone (a) FEA estimate, and (b) wear profile observed during partial sidewall rebuild

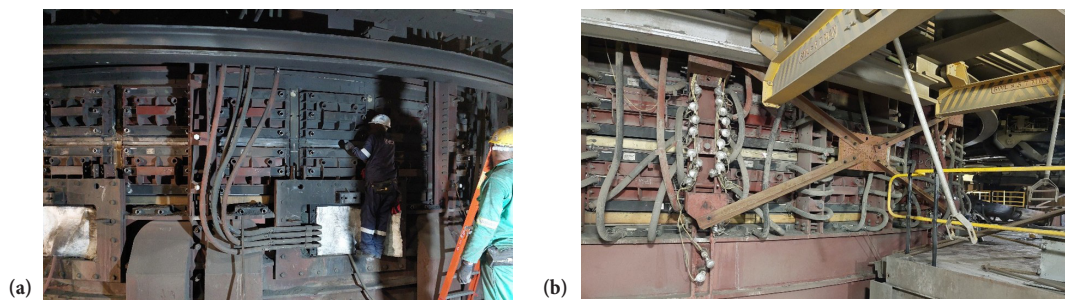
Figure 4—Furnace showing (a) isolated composite coolers above matte tapholes, and (b) the installed temporary cross-brace

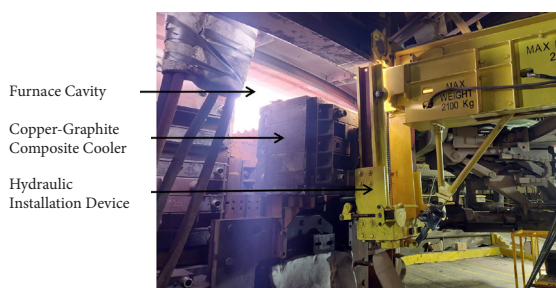
Figure 5—Composite cooler removal process showing (a) the composite cooler removed using the hydraulic installation device, and (b) showing the slag freeze-lining on the furnace hot-face

Due to the well-established freeze-lining and good adhesion to the composite coolers, more force had to be applied to the lower composite coolers to break them free from the freeze-lining, while avoiding damage to the cooler itself. Initially, it was attempted to be done with the installation device, but it was later found to be safer and easier to use the lifting lugs on the composite coolers to first break the cooler loose using rigging equipment, and then only use the installation device for removal and repositioning of the composite coolers.

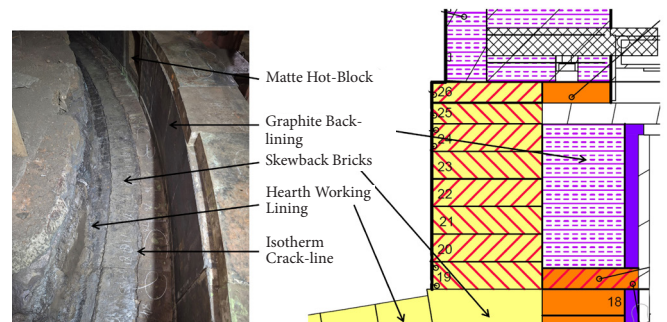
With all 18 composite coolers removed, full access to the lower sidewall and matte taphole lintel areas was now possible. The initial procedure only required the matte taphole lintel bricks to be removed and replaced, but considering that this was the first time this partial sidewall rebuild was done, it was decided to go down to skewbrick level to inspect the condition of this area as well. Eight additional brick rows were removed to get to the skewback brick level, as shown in Figure 6, and were completed by 18 January 2025. At this level, it was clear that the skewback bricks and hearth working bricks were still in good condition. It was also found that the graphite backlining was in good condition, and that there was no reason for replacing these blocks; therefore, the existing bricks were reused. One observation made at this level was the radial crack through the skewback brick row. A similar crack was observed during Furnace 2 rebuilds at Sibanye-Stillwater, and it is believed to coincide with the matte solidus isotherm in this area. The FEA modelling predicts that the matte solidus isotherm passes through the skewback bricks at this position, likely resulting in a substantial thermal and mechanical stress in the bricks, which could have caused the crack-line. From past experiences, it has been found that this crack is not of concern and does not compromise the hearth integrity. The uniform position of the crack in the skewback brick indicates uniform heating and expansion in the hearth, which speaks to a uniform hearth temperature distribution. If the crack is kept clean, it is anticipated to close up once the hearth reaches operational temperatures.

Figure 6—Sidewall refractory cleaned up to the skewback brick level

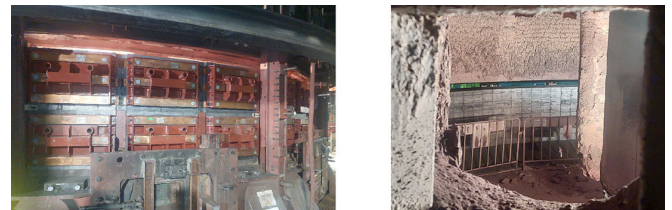
Figure 7—Reinstalled copper-graphite composite coolers from (a) the outside, and (b) from inside through the furnace freeboard inspection port

Once all the demolition work had been done, the required refractory inspections were completed – all of which were satisfactory. The next phase was to reinstall the required refractory in the lower sidewall as well as the composite coolers on the slag sidewall. The reverse order of the demolition sequence was followed, starting by rebuilding the lower sidewall refractory and matte taphole lintels, followed by the composite coolers and the remainder of the sidewall equipment and instrumentation. By 27 January 2025, the lower sidewall refractory installation was completed, slowed by some delays experienced at the matte taphole lintel installation. All 18 new composite coolers were reinstalled, and by 29 January 2025, the slag sidewall was completed and furnace freeboard and roof lowered, as shown in Figure 7. On 31 January 2025, the furnace started heating up again, with all sidewall equipment and instrumentation reinstalled.

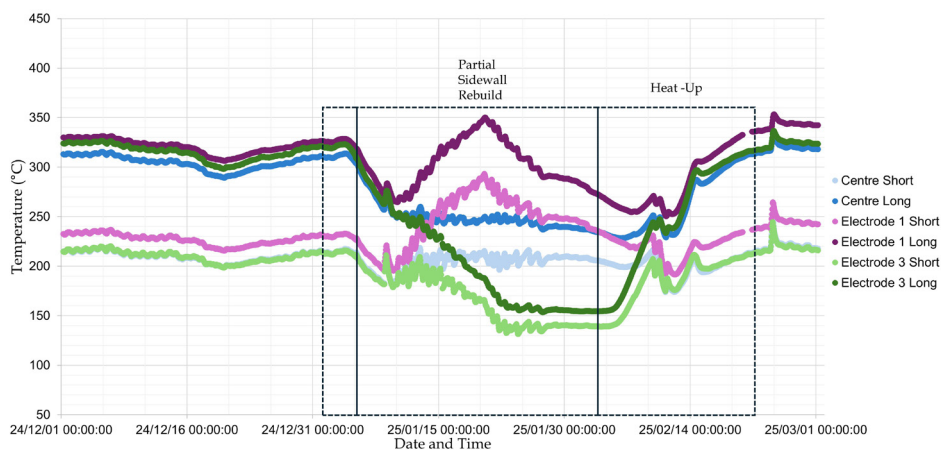
lifetime of the hearth. Figure 8 illustrates how stable the hearth temperatures were maintained during the hot partial sidewall rebuild. In this figure, it can be observed that during the January 2025 rebuild, the centre long thermocouple (at hearth permanent lining) only decreased by approximately 50°C from the operational temperatures, using December 2024 as a comparison. The centre short (at infill lining level) remained more stable and recorded a temperature decrease in the range of 20°C, which highlights the stability in temperature of the lower hearth refractory. Electrode 3 was positioned towards the matte taphole side, and for the duration of the rebuild, the electrode was raised, and no power input took place – this was done to ensure the safety of the rebuild team. As a result, it can be observed that the upper hearth temperatures in this area decreased more than at the centre of the furnace. In contrast to these results, Electrode 1 (positioned towards the slag tapholes) was powered during the rebuild project to limit the heat losses from the hearth. It is shown that the hearth was back at operational temperatures approximately 20 days after the furnace heat-up was started. These figures highlight the success of the design intent and will positively contribute to achieving the target hearth campaign life of 12 years.

Figure 8—Furnace 1 hearth temperatures before and after the partial sidewall rebuild

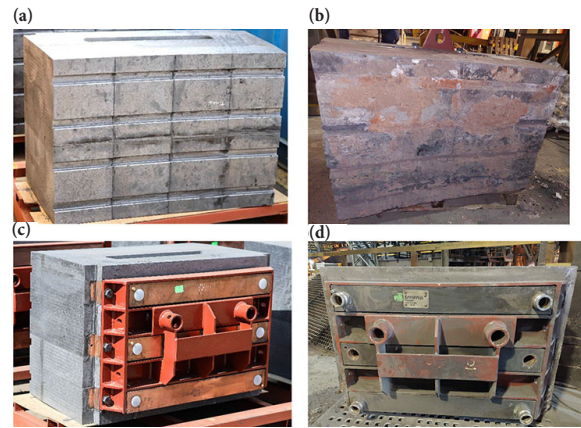
In Figure 9(a) to (d), the physical appearance of a typical cooler before installation, and after 29 months of operation is compared. Based on initial visual inspections, the composite coolers seem to be in very good condition, with little to no wear of the graphite hot face. Even though the stable freeze-lining layer, as shown in Figure 5, remained intact when the composite cooler was removed, the visual inspection of the composite coolers indicated that the hot-face grooves in the graphite worked as intended. It provided sufficient surface contact to stabilise the freeze-lining interface and ensure good adhesion to the composite coolers. Some wear and rounding of the graphite at the lower composite cooler's bottom edges were noticed, as shown in Figure 10(b). This is the edge closest to the dynamic matte-slag tidal zone, and with no deep cooling below this point, it is to be expected. This area is exposed to larger temperature gradients, higher heat loads, and does not

Preliminary visual inspections indicate that the removed composite coolers are still in perfect operating condition. The removed composite coolers have been sent for disassembly and internal inspections to confirm no internal or external defects. Pending these inspections, it appears likely that in the future the undamaged coolers will be reinstalled, further reducing the cost of the rebuild project. A future consideration is to establish a failure criterion for chips and wear to the graphite hot face, which will determine whether the composite cooler is to be reinstalled or replaced. The physical appearance of all the coolers seemed to be well within the expected condition after 29 months of operations, and in some instances, better than expected. When observing the temperature trends on the composite coolers from December 2022 to March 2025, a similar observation can be made regarding the thermal performance of the composite coolers. In Figure 11, the historic temperature trends of the bottom copper cooling element in the lower composite cooler are plotted. In Figure 11(a), the 50th percentile temperatures are plotted, and in Figure 11(b), the 99th percentile temperatures for the respective period are indicated. It is not a true representation to average the temperatures across all composite coolers, due to the dynamic nature inside the furnace as a result of tapping and electrode operations, but to generalise, an average temperature increase of 3.8°C/year is recorded across the bottom coolers. The top row of coolers records an average increase of around 1.2°C/year. The likely reason for the difference in temperature increase is the same as the proposed reason for the increased wear on the lower edge of the bottom composite cooler, that is, larger temperature gradients and heat load on the bottom composite cooler. The higher heat load and larger temperature gradient are a result of the wear profile in the matte-slag tidal zone and the cooling arrangement below the bottom composite cooler.

Figure 9—Physical appearance of the copper-graphite composite cooler: (a) front view of a new unit, (b) front view after 29 months of operation, (c) rear view of a new unit, and (d) rear view after 29 months of operation

Considering that this was the first attempt at a hot partial sidewall rebuild, it had been decided before the rebuild project was initiated to replace all 18 coolers with new composite coolers, rather than trying to reinstall the existing composite coolers. This was decided as it was not yet clear in what condition the composite coolers would be after being removed from the furnace. Pending inspections on the removed composite coolers, it appears likely that in the future the undamaged coolers will be reinstalled, further reducing the cost of the rebuild project. A future consideration is to establish a failure criterion for chips and wear to the graphite hot face, which will determine whether the composite cooler is to be reinstalled or replaced.

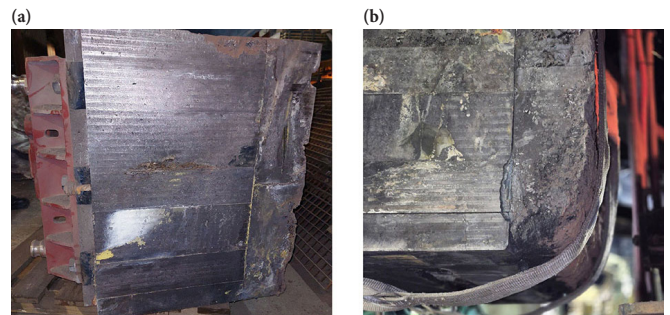
experience the additional cooling from below, as is the case with the upper row of coolers. The likely reason for this wear profile on the lower composite coolers is demonstrated in Figure 3 and was expected based on the FEA work completed during the design phase of the upgrade project in 2021. Figure 10(a) shows that the side surface of the composite cooler appears to be untouched, with the surface still showing the shiny machining surface of the graphite. This observation speaks to good contact between the individual composite coolers, which ensured no penetration of any process material. It also speaks to the fabrication tolerances of these composite coolers, which allowed for the good interface contact to be maintained.

Figure 10—Copper-graphite composite cooler typical wear profile for (a) the top row of coolers, and (b) the bottom row of coolers

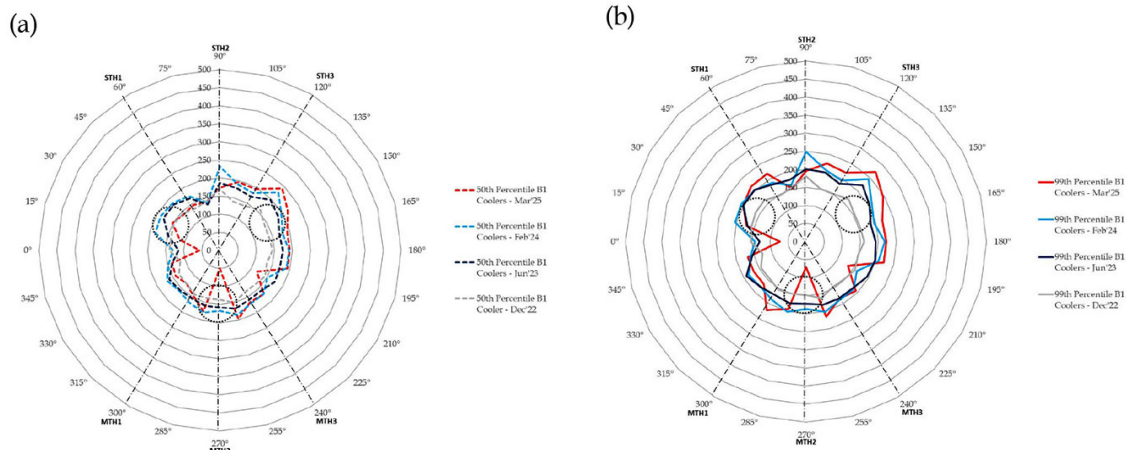
As shown in Figure 11, there is no significant temperature change from before the partial sidewall rebuild to after the rebuild, which highlights that the removed composite coolers were still well within the required operating conditions and could be reinstalled in the future. Note that only the composite coolers from 225° to 315° were replaced in January 2025, and a likely thermocouple installation error caused the low temperatures recorded at 270°.

Figure 11—Historic temperature trends on the bottom composite cooler with (a) showing the 50th percentile temperatures, and (b) the 99th percentile temperatures for the specified period

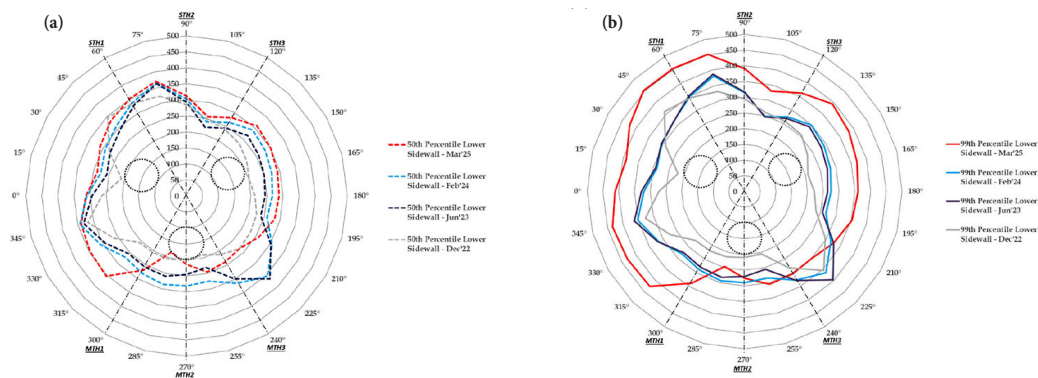
By observing the temperature trends for the lower sidewall refractory in Figure 12 (focusing on the 225° to 315° window replaced during the partial sidewall rebuild), a clear impact of the rebuild is noticeable. It can be seen that, for the section of lower

Figure 12—Historic temperature trends on the lower sidewall refractory with (a) showing the 50th percentile temperatures and (b) the 99th percentile temperatures, for the specified period

sidewall that was replaced, the average temperature is lower than that of the same area for the year before, and in some instances, close to the original installation trends from December 2022. An incremental increase in the lower sidewall temperatures, as illustrated in Figure 12(a), was expected due to the wear profile in the matte-slag tidal zone, and on average, increased 23.4°C/year. Interestingly, the mean temperature increase illustrated in Figure 12(a) speaks to incremental increase and wear expected in the lower sidewall. However, in Figure 12(b), a sharp increase for March 2025 is noticed when the 99th percentile temperatures are compared, likely as a result of a single upset event. Based on the site data, these high temperatures are restricted to a single day, after which the temperature returned to the expected range.
