# Determination of an Effective Slope-Monitoring Regime for Mining a Failed Zone on the North Wall of Nchanga Open Pit-Cut2

Nchanga Open Pits, Chingola, Zambia

Nchanga Open Pit Cut 2 experienced a complex slope failure in June 2016 on the hanging-wall side of the mine, involving approximately 1.5 million tons of failed material. This failure zone occurred where a strategic push back involving 16 million tons of waste material and approximately 5 million tons of copper and cobalt was planned to be carried out. While mining in this region, the monitoring regime that had been in place before the failure included slope stability radar, physical inspections and survey monitoring pegs. After the failure, mining through the failed zone involved reviewing the existing controls and defining an effective monitoring strategy to suit the prevailing ground conditions for safe mining operations. A back analysis of the collapsed area was carried out to ascertain the cause of the failure. Reclassification of the rock mass and the associated strength parameters were determined and used in the analyses to understand the behaviour of the failed zone while mining through it. Failed zone specific gro

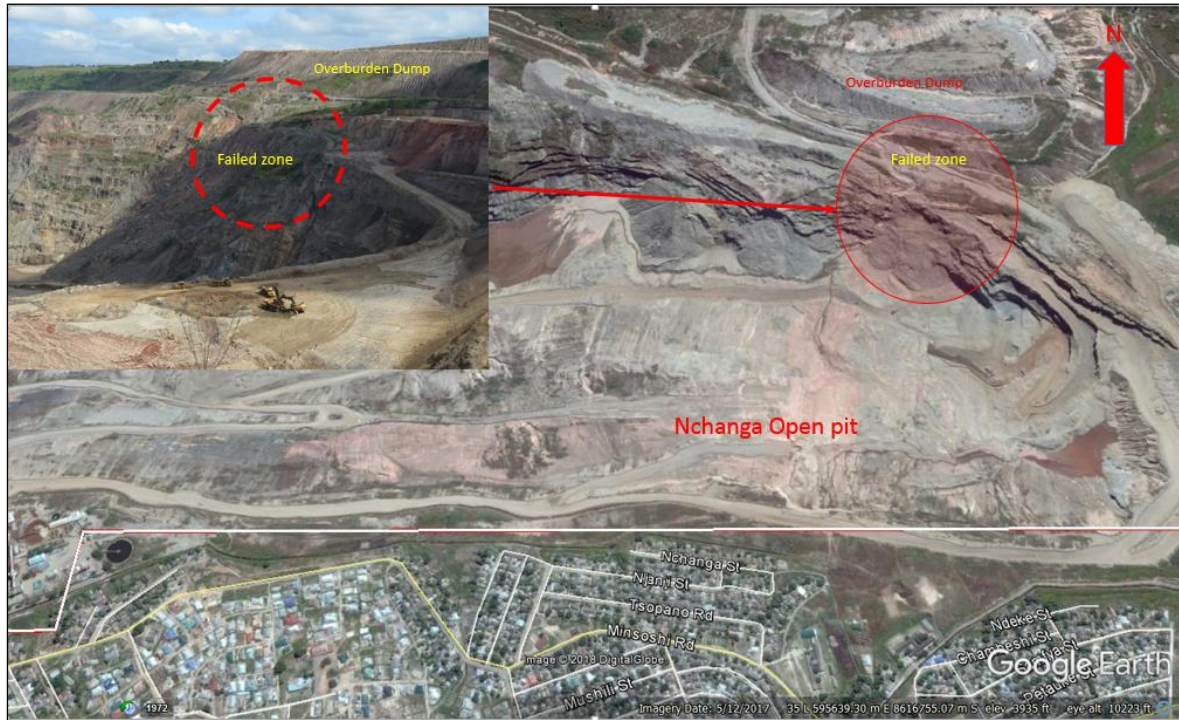
Figure 1: Nchanga Open Pit failure zone location.

Nchanga Open Pit Cut 2 experienced a complex slope failure in June 2016 on the hanging-wall side of the mine (Figure 1), involving approximately 1.5 million tons of failed material. A conducted back analysis showed that the failure was caused by surcharge originating from the overburden dump pressure, which the rock mass structure could not contain. Further, ground water pore pressure, which had been increasing over time, reduced the shear strength of the rock mass and resulted in instability. This failure zone occurred where a strategic push back involving 16 million tons of waste material and approximately 5 million tons of copper and cobalt was planned to be carried out.

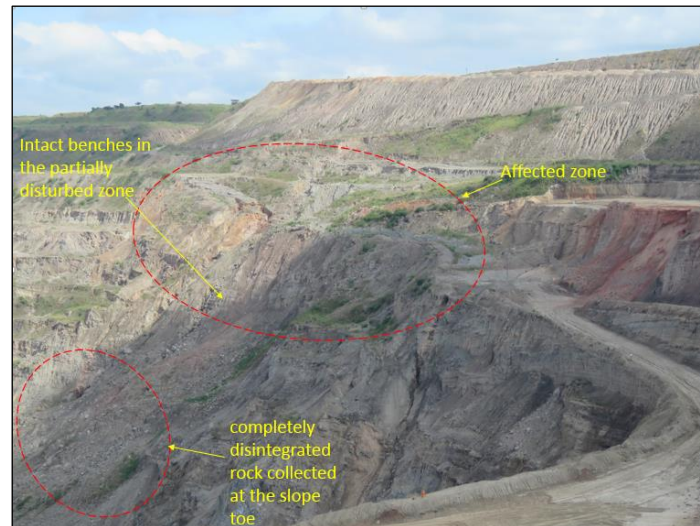
Figure 2: Photograph of the unstable zone.

The complex failure was categorized in two distinct zones: a completely disintegrated zone, which failed and collected at the toe of the slope, reclassified as backfill material, and the partially disturbed rock mass, which remained as part of the slope, reclassified as very blocky and disturbed (Figure 2).
