## CASE STUDIES OF SLOPE STABILITY RADAR USED IN OPEN CUT MINES

Dr Neal Harries<sup>1</sup>, Dr David Noon<sup>1</sup>, Mr Keith Rowley<sup>2</sup>  
<sup>1</sup>GroundProbe Australia <sup>2</sup>GroundProbe South Africa

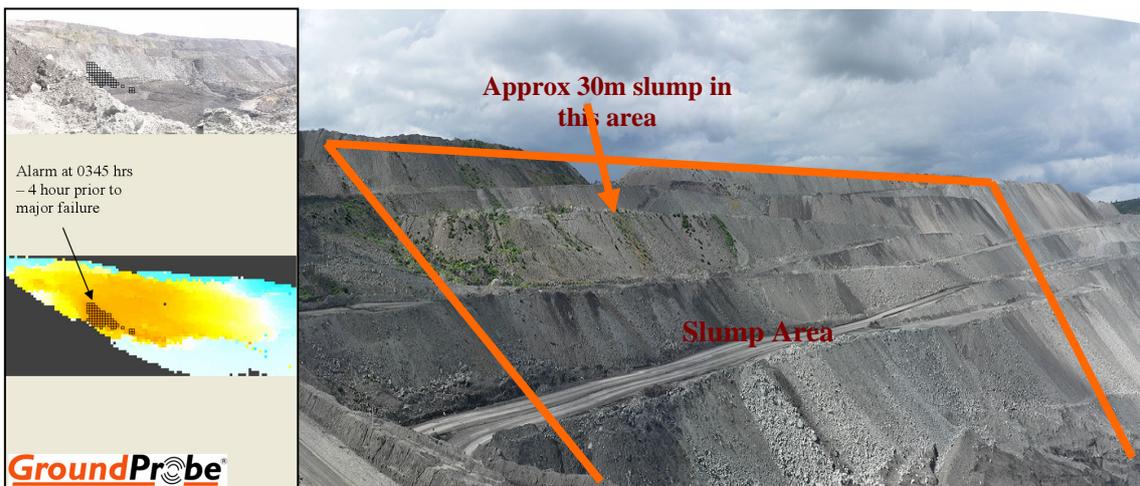
Figure 2: Visual of Alarm Trigger and Failure Surface

1. The red alert was first sounded at 03:43 on 29/01/05 (see Figure 2).
2. The alarm procedures were followed by the control room staff.
3. The slump occurred at approx 07:40 on 29/01/05.
4. The movement detected was consistent with that set in the alarm parameters.
5. Using the alarm settings discussed, approximately 4 hours of warning was received prior to the impending slump.

The SSR permits users to enter parameters that define the conditions for alarm generation. One urgent alarm (red alert) was set for the scanned area using a 70 mm movement threshold over a time period of 45 minutes. This alarm could be triggered within a scanned, pixelled area of 1029m<sup>2</sup>.

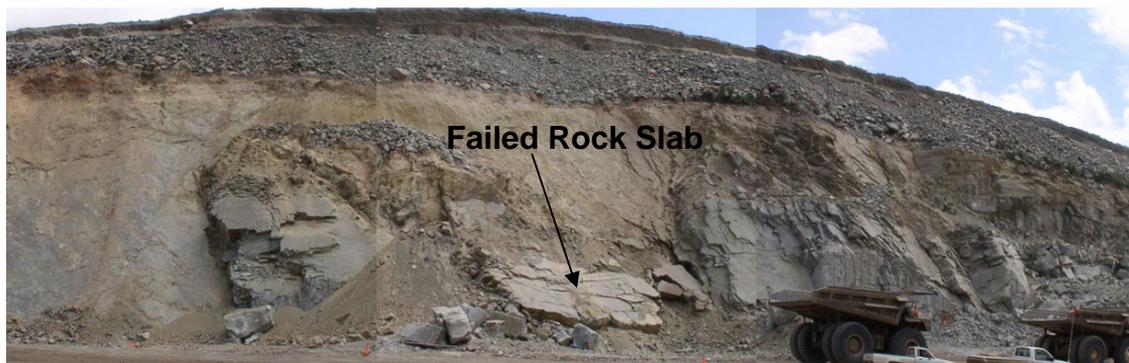
Figure 4: Small Rock Slab Failure

The second example highlights failure associated with active mining (excavation). In this example a small (less than bench height) rock slab failed due to excavation at the toe of the slope. The small size of the rock slab can be seen in Figure 4.
