# The design of rotary-mill liners, and their backing materials

by M.S. POWELL\*

An evaluation was made of the wear and performance characteristics of lifter bars, and the cost-life effectiveness of backing materials for rotary-mill liners.

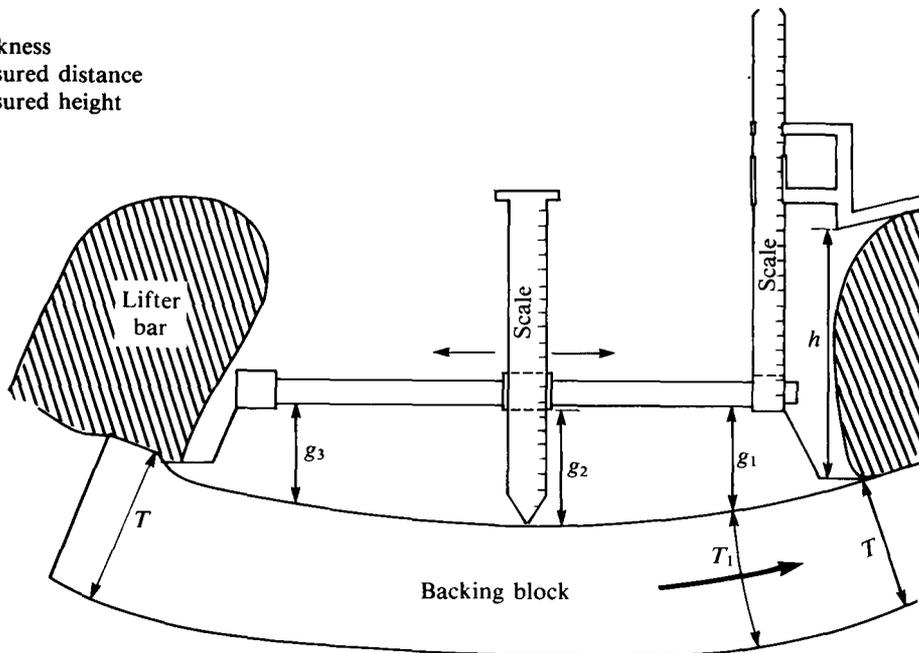
Fig. 1—The liner-wear monitor

A liner-wear monitor (Fig. 1) was developed that could be used to take many readings rapidly from both grid and solid block liners, thus minimizing downtime. The interface between the lifter bar and the backing block forms a constant reference point, and the monitor spans two adjacent lifter bars. The problem of erosion under the edges of the lifter bars was overcome by the attachment of a horizontal foot to the monitor, which could be pulled up under the base of the lifter bar.

- $T$  Thickness
- $g$  Measured distance
- $h$  Measured height

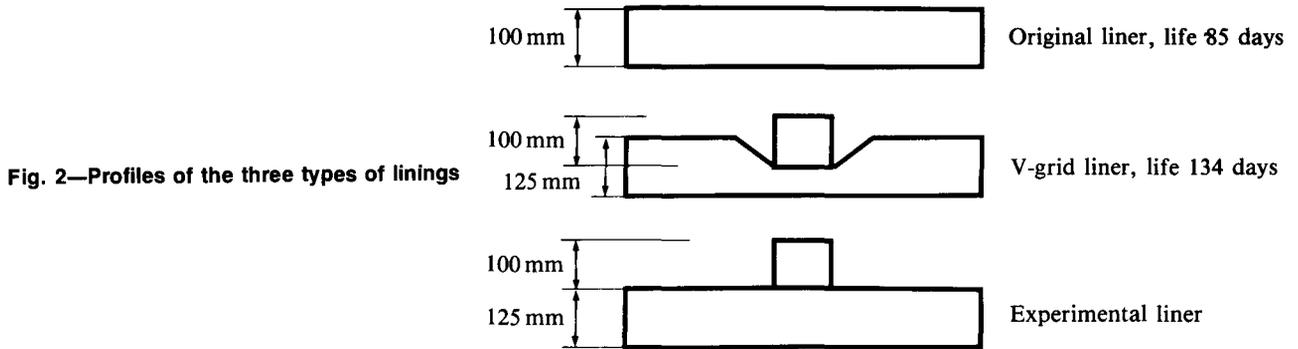
The mill had originally been lined with a flat-profiled grid with an average life of 85 days. It was then fitted with V-grids, with a lifter bar mounted in the groove and protruding just above the grid. The life of these grids averaged 134 days, with one change of lifter bars. For the experimental work, a flat 125 mm thick grid was used, with a 100 mm lifter bar mounted on top of it (Fig. 2).

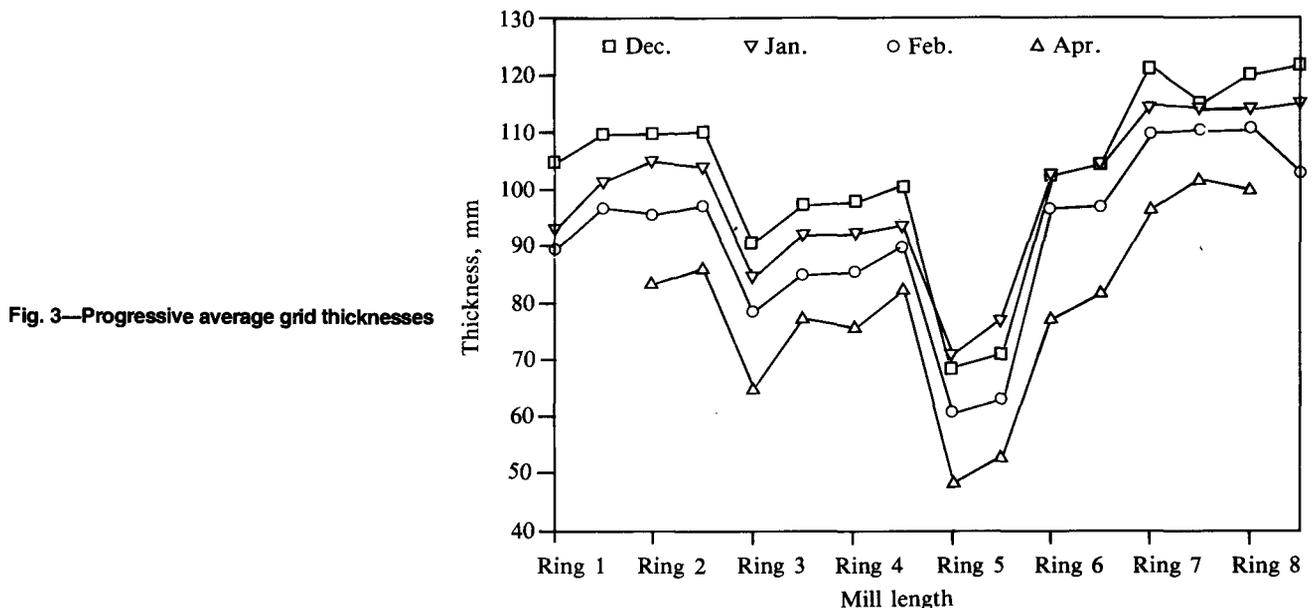
The progressive grid thicknesses are given in Fig. 3. These are the measurements taken at the centre of the grid, which is the fastest-wearing region. The values used are averages of all six grids measured in a single ring, any missing measurements being a consequence of broken lifter bars. It is clear that ring 5 was thinner than the other rings, which is not a reflection of the wear rate but rather an indication of the installation date since the rings were installed over a period of months. The inlet edge of ring 3 wore to a thinner profile because the old linings in ring 2 were much lower than ring 3 for a long period.

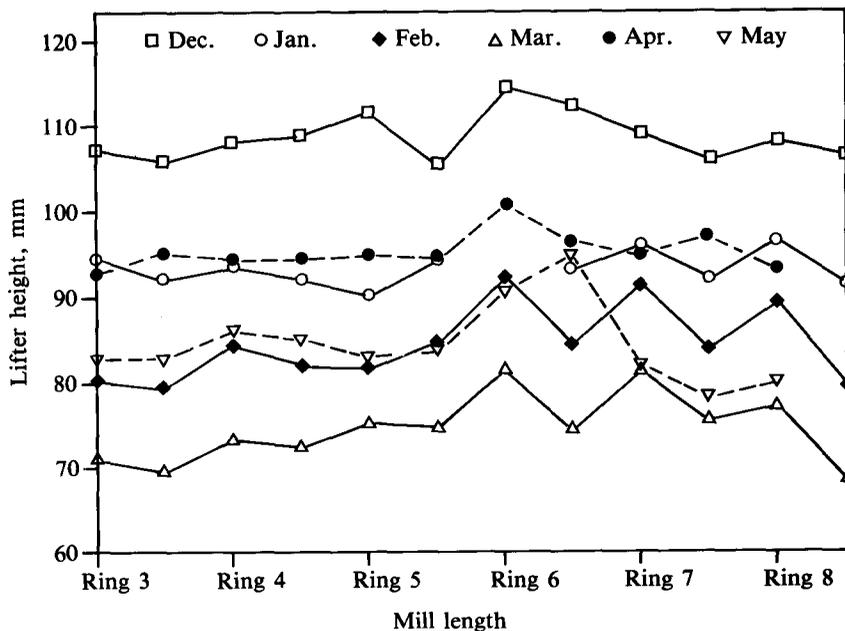
Fig. 4—Progressive average heights of lifter bars

The progressive heights of the lifter bars are shown in Fig. 4. The dotted lines link the data for the second set of lifter bars that were installed in April. Because of the problem with broken lifter bars, insufficient data were available for rings 1 and 2. From ring 3 onwards, there is not a significant difference in the wear rates of the different rings of lifter bars except for the end of ring 8.

After 6 months of monitoring, it can be predicted that lifter bars under these conditions will last 192 days on average, wearing down from 100 to 60 mm. It can also be predicted that the grids will take 665 days on average to wear down from 125 to 30 mm. This is five times the life of the previous grids, and nearly eight times that of the original flat-profiled 100 mm grids without lifter bars. The actual life of the grids was 656 days on average; the lifter bars averaged 180 to 200 days over a three-year period.

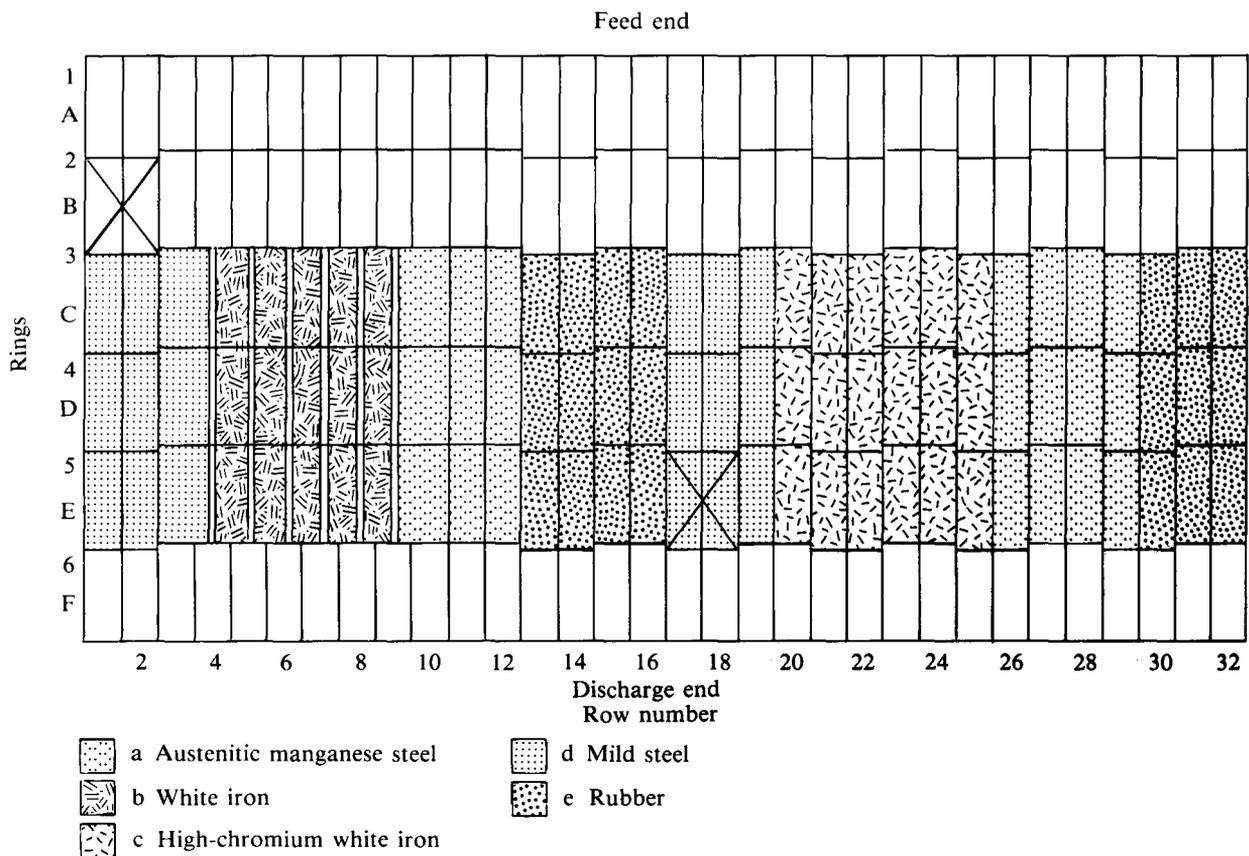
Fig. 5—The lining of the Kloof experimental mill

the critical speed, was fitted with five different liner materials that were protected by lifter bars (Fig. 5). Because the wear of the liners is uneven down the length of a mill, all five materials were installed in the same ring. In addition, a buffer ring was fitted on either side of the test ring to prevent the wear of the adjacent liners from affecting the results. All the liners had the same flat profile, were 80 mm thick, and were mounted under identical AMS lifter bars that were 80 mm high. These lifter bars isolated adjacent rows of materials from one another, and ensured that each material was subjected to identical conditions of wear.

a AMS to SABS 407, type 2, containing 11,5 to 14,5 per cent manganese and 1,0 to 1,3 per cent carbon  
 b HCWI to BS 4844 pt 3, grade 3D, containing 27 per cent chromium

c 'White iron' containing 2,4 to 3,4 per cent carbon and 0,5 to 1,5 per cent silicon  
 d Mild steel (carbon steel, grade A2)  
 e Rubber to Skega specifications

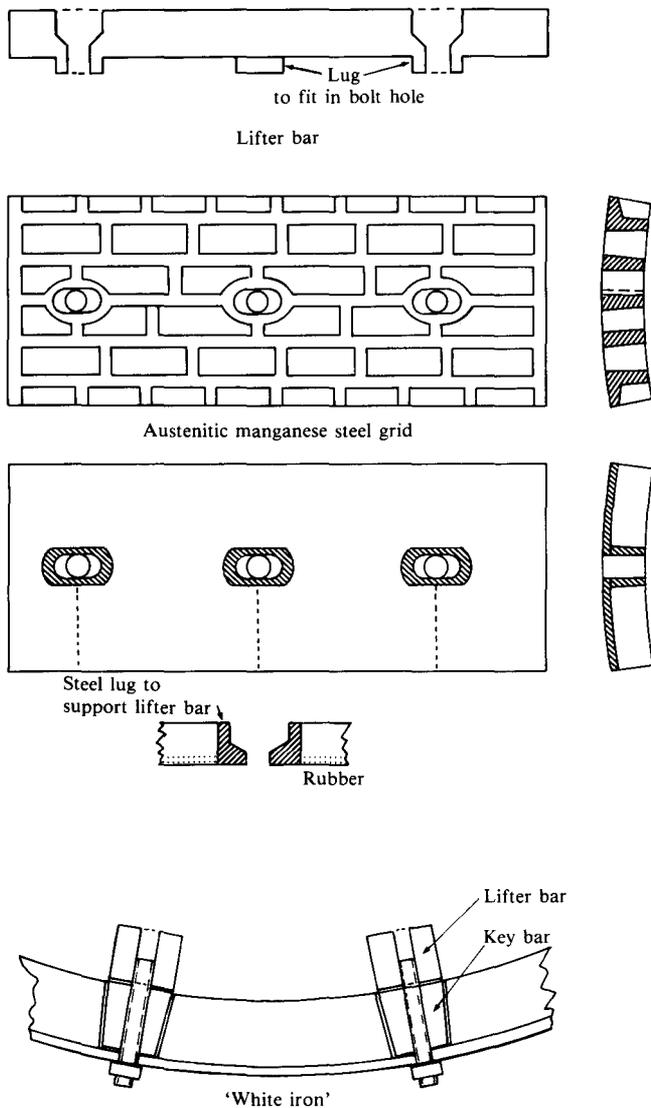
Fig. 6—Configurations of the test linings

The AMS was cast as a grid since this is its standard form when used in this type of mill, and the rest were cast as solid blocks. The materials were bolted centrally under the lifter bars, except for the 'white iron'. A rubber lining is usually clamped down between special lifter bars. To enable it to fit in with the experimental arrangement, three lugs were welded onto a 5 mm thick mild-steel plate for the lifter bar to be mounted on, and the rubber was cast onto this backing (Fig. 6). This configuration is far from ideal for rubber, but it was felt that the test would still serve to indicate whether rubber linings can last in large, high-speed mills grinding quartzitic ores. Mild steel is not normally used as a mill lining, but was installed to demonstrate the way in which a relatively soft low-carbon steel would perform when protected by lifter bars.

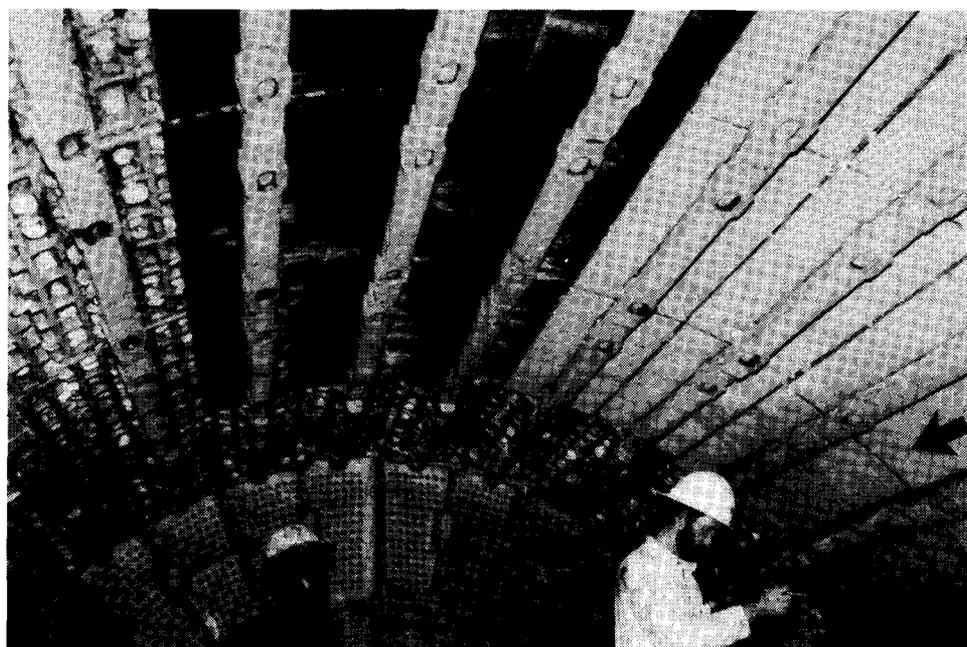
Fig. 7—An interior view of the Kloof mill, showing the discharge grate in the background. The materials are, from left to right, AMS grids, rubber, mild steel, and 'white iron'. The over-size mild-steel block is arrowed

cumbersome to handle. The experimental lining and measurements are illustrated in Figs. 7 and 8.

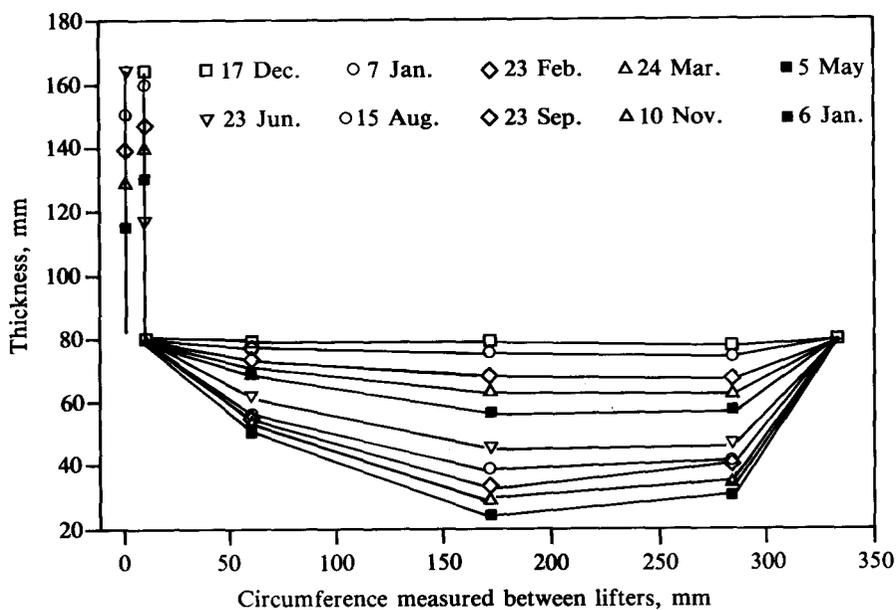
Fig. 12—The progressive average wear profiles of the 'white iron'

The wear modes of the various materials is discussed briefly in the Addendum. The progressive average wear profile of the 'white iron' is shown in Fig. 12. The lifter bar is shown on the left, and each set of bars is represented by separate vertical lines. A systematic wear pattern can be observed, but it should be noted that the time intervals between readings were not regular. The average thicknesses of all the materials on the centre line between the lifter bars except for the grids, which were measured off centre, were reduced fairly steadily (Fig. 13). It is important to observe that, because all these thicknesses were measured from the shell, they include the backing plates of the grids and of the rubber.

When the blocks had worn down to a minimum thickness of 10 mm they had a volume loss of about 16 litres, and the 'white iron', when it had worn down to 20 mm, had a loss of about 14 litres. The profiles were measured with vernier calipers on a few blocks of each material, and these volume losses were calculated from the estimated final profiles of the fully worn blocks. Because the grids were completely worn, their volume loss was taken to be what had been calculated when they were removed. This volume loss was 13,6 litres for a minimum thickness of 20 mm on the bar closest to the centre. The predicted lives can be calculated from these figures. For the HCWI, the lower wear rate of 0,0617 mm per day after the initial 6-month wear-in period was used.

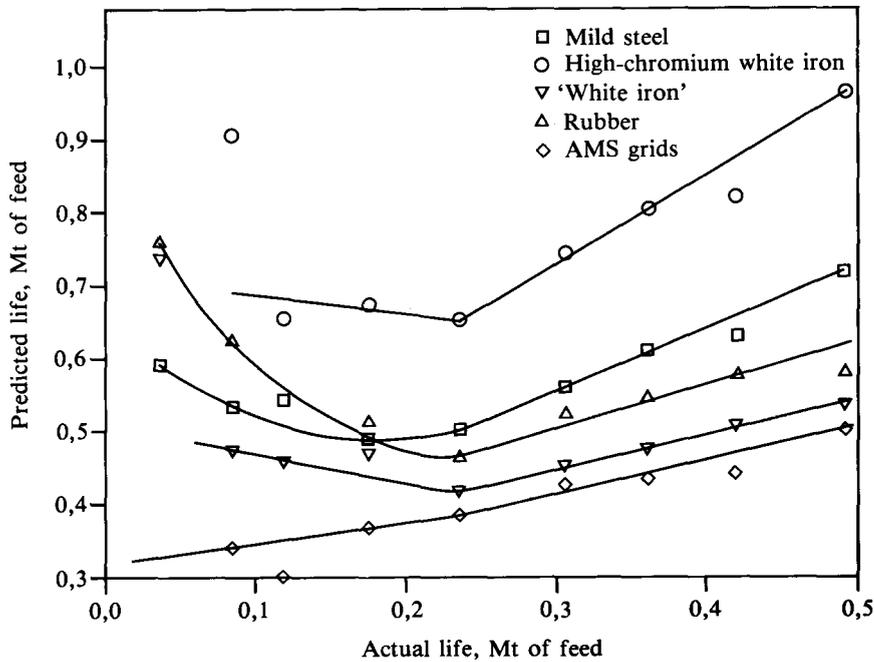
Fig. 14—The progressive predicted liner lives

The progressive predicted lifetimes (Fig. 14) tended to drop over the life of the first set of lifter bars, but then settled into a steadily increasing regime in which all the materials yielded progressively longer predicted lives with increasing wear. This indicates two important points. Firstly, it appears that the lifetime of a lining cannot be predicted from its initial wear rate since this changes with time, especially when lifter bars are used. Secondly, it is apparent that the height of lifter bars influences the wear rate of liner blocks.

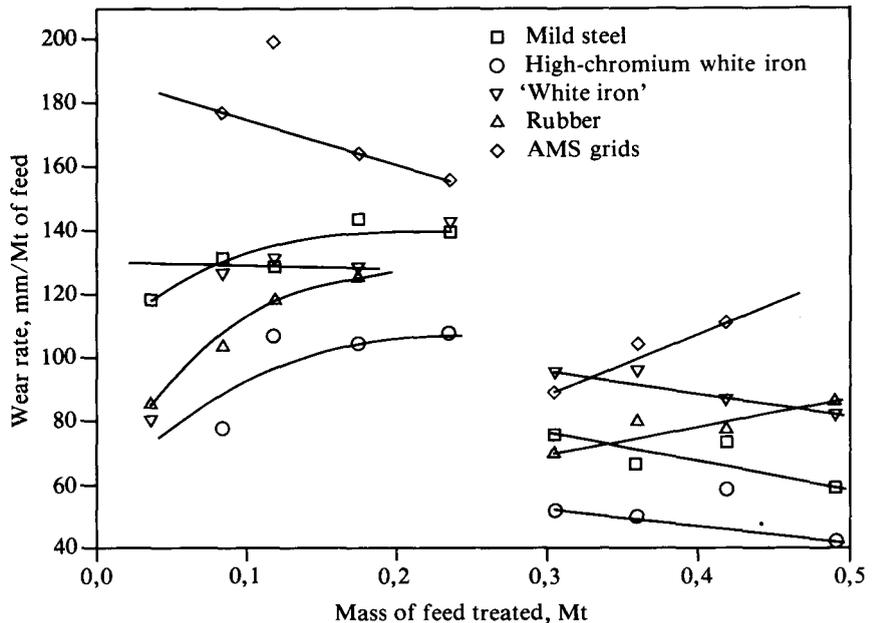
Fig. 15—The progressive average wear rates measured after each change of lifter bars

Fig. 15 illustrates the effect of changes in the height of lifter bars on wear rates. The wear rates were measured from each change of lifter bars so that the influence of the lifter bars is emphasized. The wear rates of all the materials, with the exception of the grids, increased and then levelled off until the lifter bars, which were worn to a height of about 35 mm, were changed. A dramatic drop in the wear rate, averaging more than 40 per cent, was observed in all the materials directly after the lifter bars had been renewed to a height of 80 mm. This demonstrates the substantial protective effect that lifter bars have on the lining.

A dramatic reduction in the wear rates of linings (over 40 per cent) achieved by the installation of lifter bars of an adequate height was apparent when worn 35 mm lifter

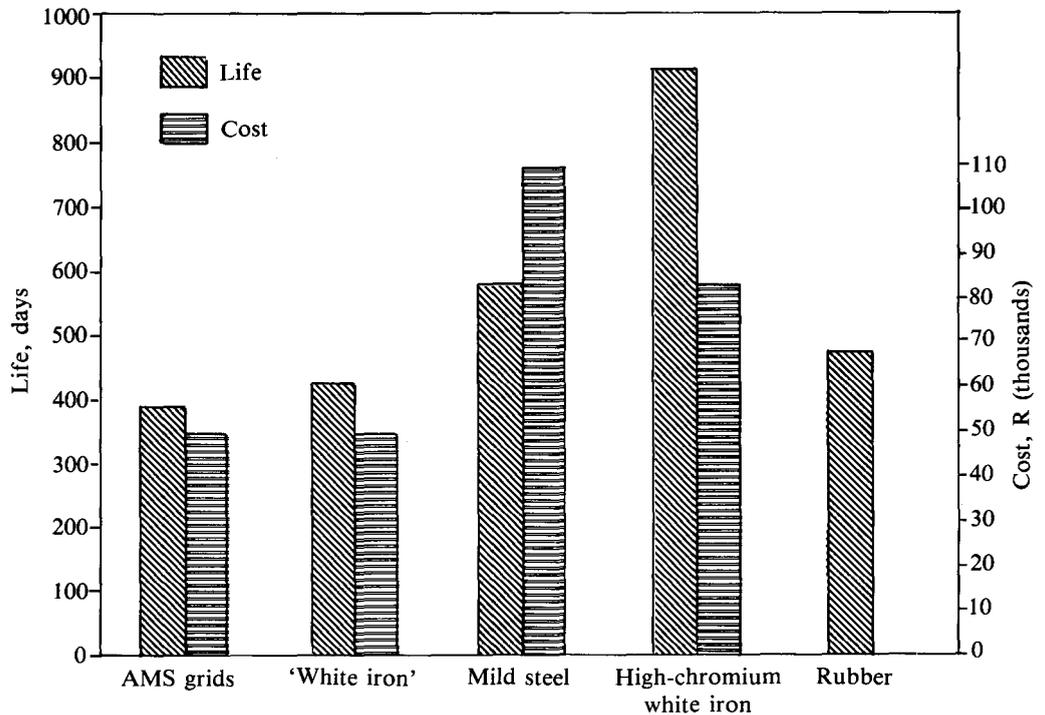
Fig. 16—Comparison of the life and cost of five materials

These results, illustrated in Fig. 16, indicate that, although the AMS grids and 'white iron' have the shortest predicted lifetimes, they are the cheapest on a cost-life basis. The HCWI has an excellent lifetime; however, its

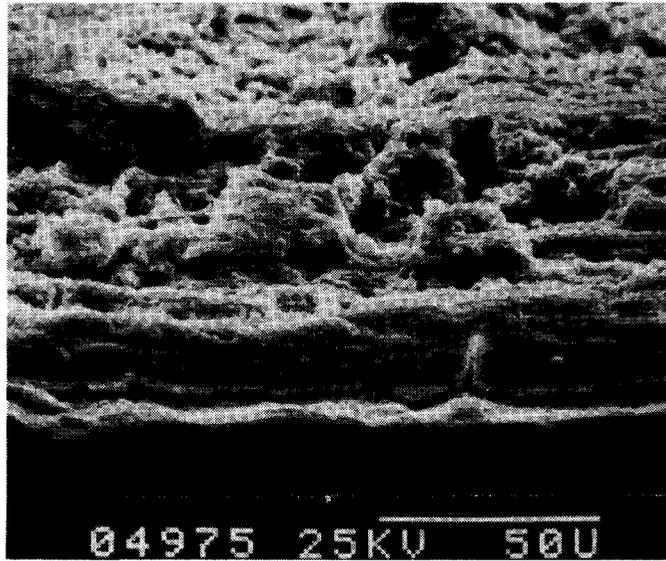
Fig. A2—Cross-section through the AMS, showing a 45° view of the wear surface

The scanning electron microscope (SEM) photograph in Fig. A2 illustrates the random-direction, gouging abrasion of the AMS and the cracking away of the worn surface layer.

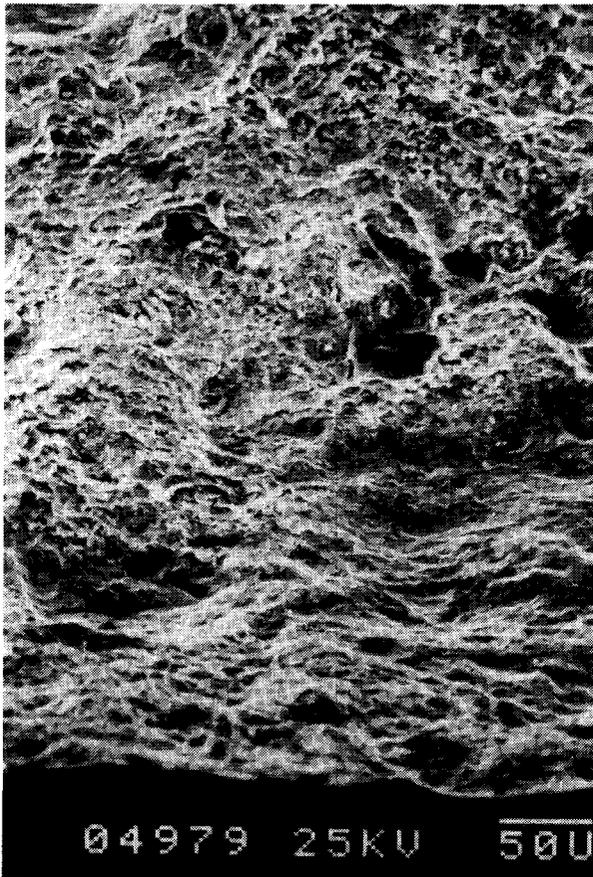
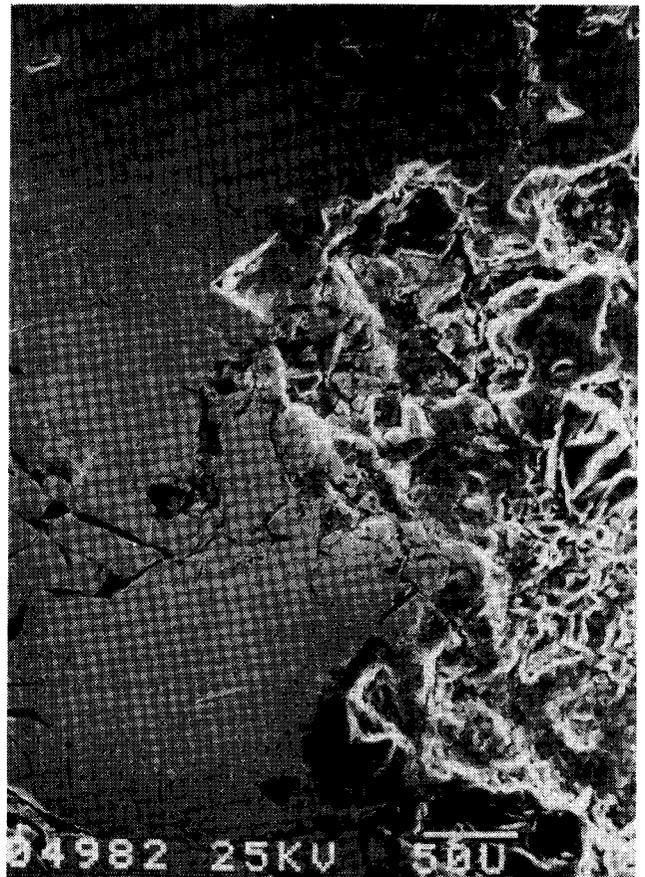
Fig. A3—The worn surface of the mild steel (left) and an 11° polished section of the 'white cast iron'

The left photograph in Fig. A3 shows the leading wear

edge of the mild steel. Extensive deformation and flow of the steel are evident, and numerous gouges and indentations in the steel highlight the severity of the abrasive wear. On the right of the figure is a polished  $11^\circ$  section through the surface of the 'white iron', which gives an idea of the profile of the wear tracks. The exposed blocky section that is evident on the centre right edge was almost wholly removed; the polished section shows the porosity of the casting and the surface cracking.
