Optimizing the life of ore passes in a deep-level gold mine

by P.R. Brenchley* and J.D. Spies*

Synopsis

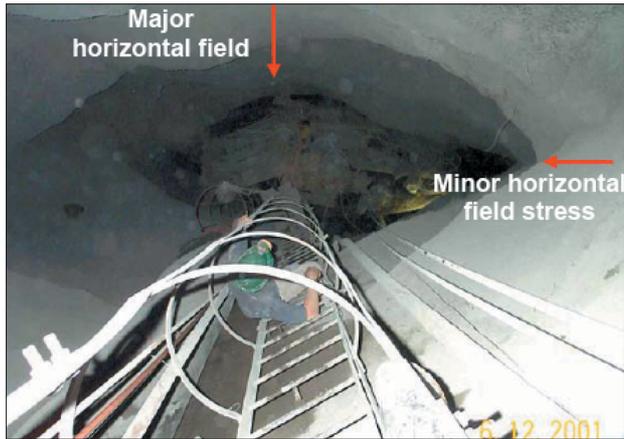
Figure 1—Stress damage

Scaling of ore passes occurs when one of the horizontal field stresses exceeds the strength of the rock mass, and the original shape of the ore pass, typically circular, changes to an oval shape. The extent of the scaling depends on the strength of the rock mass and the ratio of the horizontal stresses. The closer the ratio of the horizontal stresses is to unity, the more even the stress damage and the greater the extent of the scaling that takes place perpendicular to the major horizontal stress direction, as shown in Figure 1.

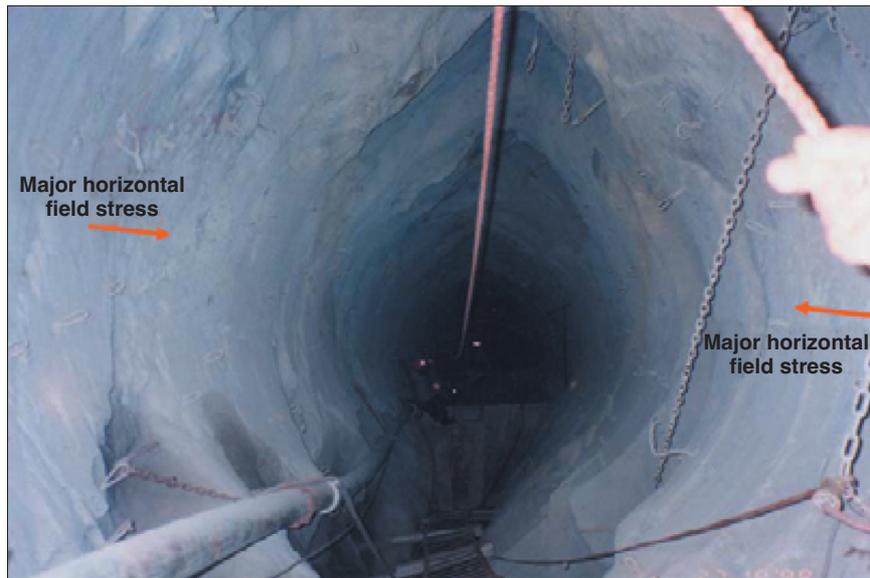
Figure 4—Dog earing

The magnitude and direction of the principle stress will influence the extent and mode of failure. The closer the horizontal stresses are to being equal, the less the extent of spalling or dog-earing. Dog-earing, which is the spalling of rock that occurs under high stress, takes place at 90 degrees to the direction of the major stress. (see Figure 4.) This scaling process (wear) will take place regardless of the chipping and scouring of the ore material; however, the flow of ore material will aggravate this wear process. Mining in the vicinity of ore passes will also cause stress changes and a stable ore pass could turn into an unstable ore pass in a short period of time. Flat angles, or low angles of intersection between the ore pass and the strata layers create wedges, which break under impact or wear, thus resulting in uneven ore pass walls, causing more impact and deflection zones. (see Figure 5.) Diameter, shape and excavation method are obvious methods affecting the stability of ore passes.

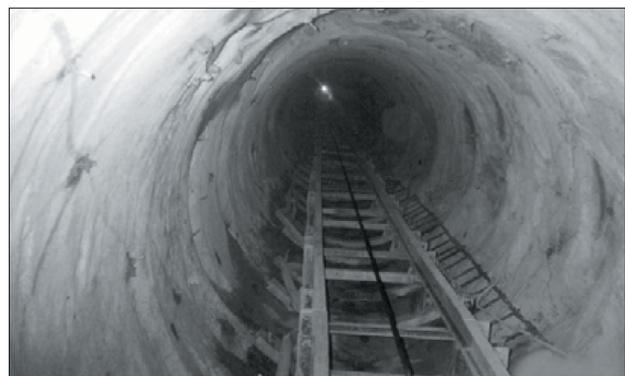
Figure 15—Channel tracks

In long and steep ore passes, a licensed winder is installed to facilitate transport of men and material to and from the working platforms. Channel tracks are installed to carry the conveyance, which transports material and equipment to the site. The safety and working platforms are also positioned by this conveyance. The channel tracks, as shown in Figure 15, are installed when the ore pass is longer than 40 metres vertical height and, or if the ore pass is steeply inclined. Equipping platforms can have several stages as shown in Figures 16 and 17. This will allow for separate work to be done simultaneously thus reducing the time without compromising on safety.
