Internal corrosion of slurry pipelines caused by microbial corrosion: causes and remedies

by C. Ringas*

Synopsis

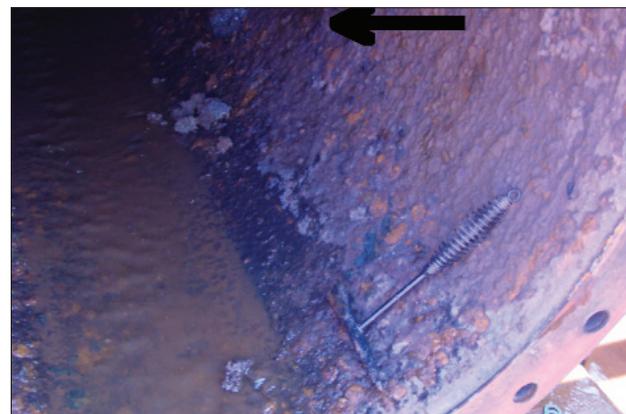
by the presence of tubercles of varying size and shape. Once broken, the centre of the tubercle usually contains soft black products. Beneath the tubercle there is an adherent thin black layer, which can be easily removed. Once the black layer is removed, the shiny grey metal surface is revealed, which has been undergoing corrosion. This typical morphology is shown in Figures 1 and 2.

Figure 1—SRB tubercles, shown by black arrow, inside pipeline

It is difficult to remove SRBs once they have become established. Simply injecting biocides into the slurry will not work because the bacteria are located beneath the tubercles. In order to get to the bacteria, the scale and tubercles need to be removed. This can be achieved using hard pigs and the degree of abrasion can be designed to suit the application.

Once the scale and tubercles have been removed, it is possible to pump appropriate chemicals through the pipeline to kill the bacteria.

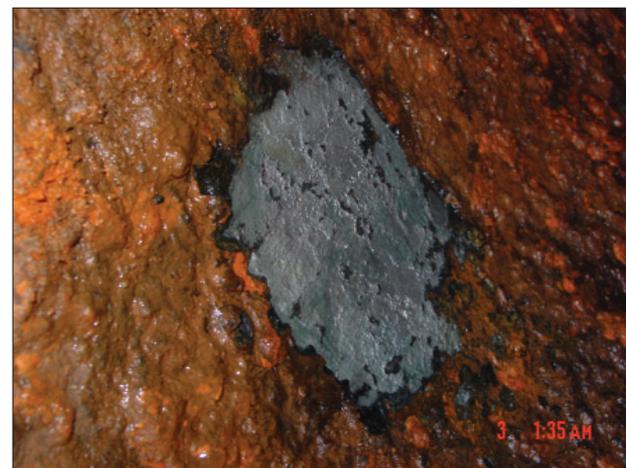
Figure 2—Typical morphology once tubercles have been removed

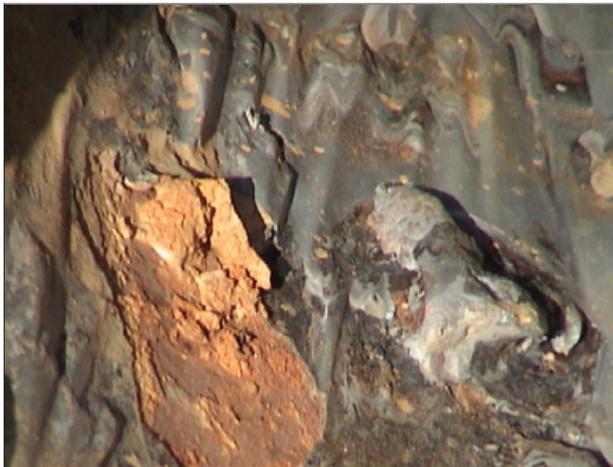
What was common in all lines was the presence of tubercles caused by SRB. This occurred irrespective of whether there was a thick scale layer or not. It would appear that the bacteria are able to locate themselves at the base of the scale layer and after a certain period, the tubercles will increase in size. This is shown in Figures 3 and 4.

Figure 3—SRB tubercles growing within a grey scale

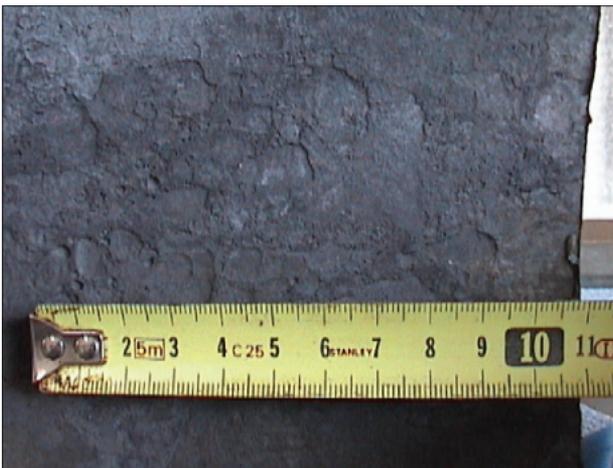
Figure 4—Internal metal surface after scale and tubercles have been removed. Note circular metal loss in the form of pits

Once the tubercles have been removed, there is localized corrosion in the form of pits on the metal surface, directly beneath where the tubercles were located, as shown in Figure 4.

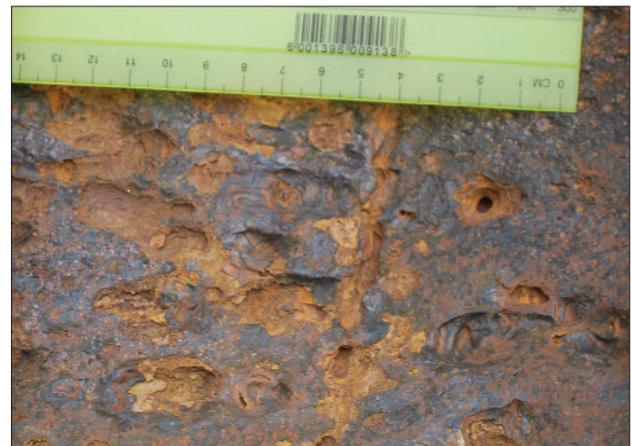
Recently, we undertook a detailed investigation using long-range ultrasonic testing (LRUT) of a slurry pipeline and detected severe metal loss. Spool pieces were removed for further evaluation and the typical morphology of the corrosion is shown in Figures 5 and 6.

Figure 5—Internal corrosion, leading to perforation of slurry line caused by SRB

It is technically far superior to use long-range ultrasonic testing (LRUT), sometimes referred to as guided-ultrasonic testing (GUL), which allows the complete pipeline length to be analysed so that all the regions where the pipe wall has thinned can be located. Each individual pipe length is tested and the wall thickness of the whole pipe surface area evaluated. For example, on a 356 mm diameter pipeline with pipe lengths of 9 m, using conventional ultrasonics with a 1 cm² diameter probe, taking readings at the two ends and in the middle and four readings at each location, i.e. 12 readings in total, results in 0.00012% of the total surface area being tested, whereas LRUT would test 100% of the total surface area.

In the example mentioned above, the pipeline owner used the conventional non-destructive testing (NDT) methodology to replace any pipe lengths that showed a wall thickness below 4 mm. When a sample of 100 pipe lengths was tested with the LRUT technique, 28% of the pipe lengths showed thicknesses below 4 mm, with many having a wall thickness of 2.5 mm. The pipeline owner thus had an incorrect sense of security using the conventional ultrasonic methodology and was in fact at risk of pipeline failure without being aware of this.

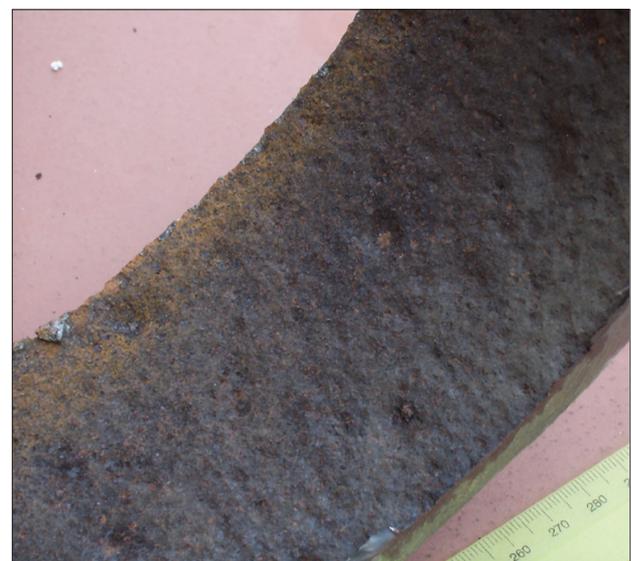
Figure 6—Localized corrosion in the form of pits of slurry pipeline caused by SRB
