# The use of pigs in the Samarco pipeline to allow transportation capacity rehabilitation and integrity programme implementation

by J.C.M. de Souza\*

## Synopsis

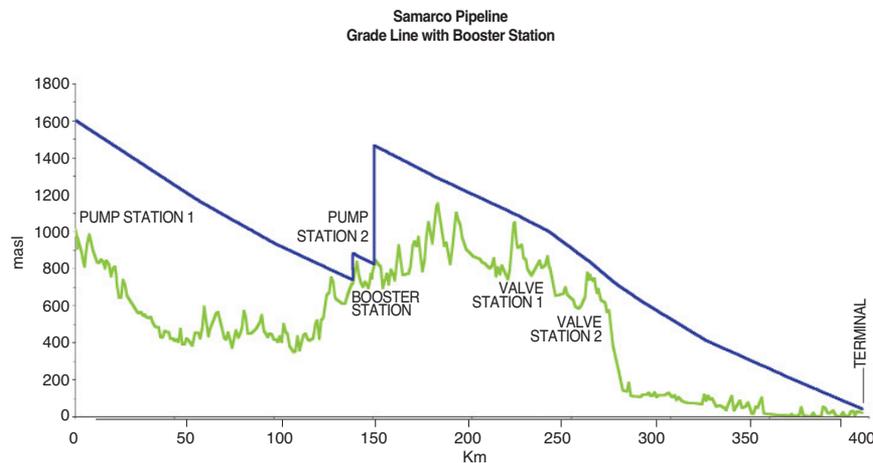
Figure 1—Hydraulic gradient after new booster station added upstream of PS2

The booster station consists of two trains of two centrifugal pumps in series, one operating, and one standby.

Figure 1 shows the hydraulic gradient line of the new configuration.

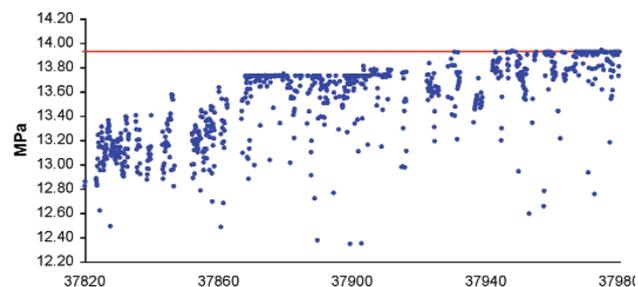
Figure 2—PS2 discharge pressure

During the development of the booster station project, an increase in the discharge pressure of Pump Station 2 was noted, and the following possible reasons were considered:

Figure 2 shows the increased discharge pressure in PS2.

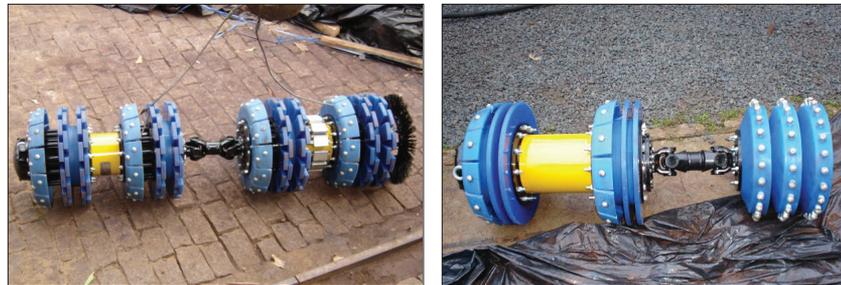
Figure 3—Types of cleaning pigs

Figure 3 shows some of the types of pigs used in the runs from Pump Station 2 and the Terminal.

- *Investigation*—single pig, with caliper plate, without bits
- *Smooth removal*—double pig, in the configuration disc/cup/disc/cup/bits, with the bits adjusted to 100% contact with the internal wall of the pipe and low attack pressure
- *Transport*—double pig configured with disc/cup/brush/disc/cup/magnet. Whenever possible, use the jet spray option to improve the performance of the assembly

- *Aggressive removal*—double pig, in the configuration disc/cup/ disc/ cup/ bits. The bits must be adjusted to 100% of contact with the internal wall of the pipe and progressive attack pressure
- *Transport*—same configuration as outlined above
- Repetition of the sequences until the head loss reached the established values. Perform at least two runs in the aggressive configuration, with maximum adjustment of attack pressure. These also have the function of rectify/burnishing the inside walls of the pipes
- After the first cleaning phase, the subsequent runs would preferably be carried out with pigs configured without hard coated bits, in order to preserve the anti-corrosion protective coating.

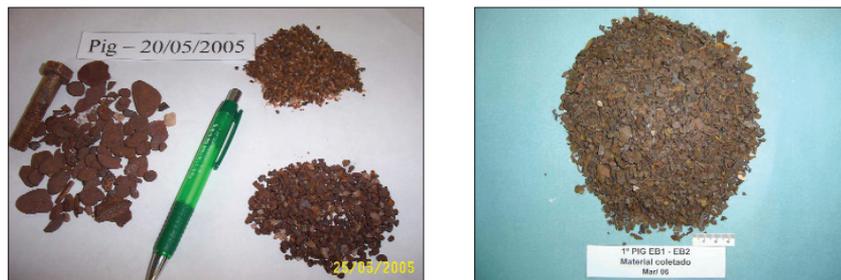
Figure 4—Samples of material collected

During the runs, samples were collected to evaluate the material removed and transported. These samples revealed the following:

- Insignificant presence of calcium carbonate
- Significant quantity of biogenic magnetite, indicating an occurrence of microbiological corrosion
- Presence of coarse particles that had settled along the pipeline due to unplanned variations in the production process, low efficiency of the protection systems, and possible changes in the mineralogical characteristics of the processed ore
- Based on these findings, it was confirmed that bacteriological corrosion arising from the addition of sea water to the main pumps and the presence of coarse particle deposits were the underlying causes of the problem.

Figure 4 shows examples of the material collected during the runs.

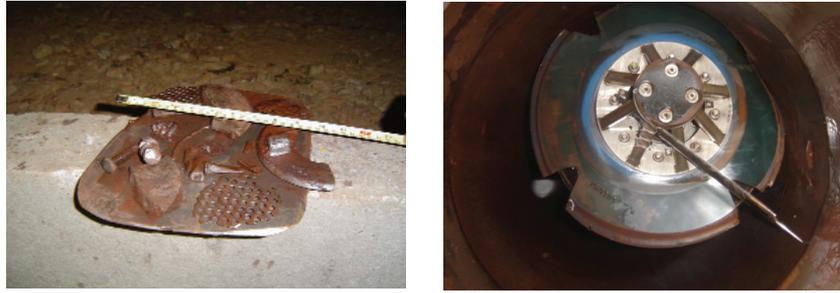
Figure 5—Samples of unusual objects

In addition to the expected materials mentioned above, various tramp items, such as screws, bolts, a bearing outer ring, a file, grinding media, very coarse particles, gate of valve, etc. were collected from the pipeline. These can only be explained by operating accidents occurring over the life of the system.

Figure 5 shows examples of these samples.

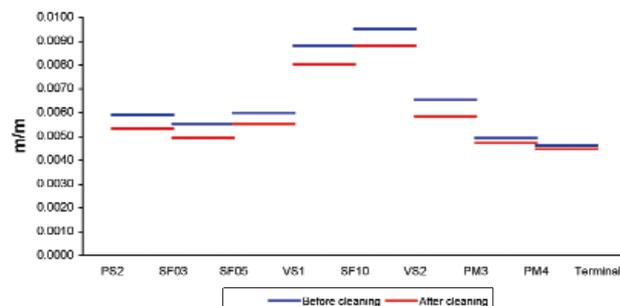
Figure 6—Head loss reduction

- Removal of corrosion products adhered to the pipe
- Removal of existing scale
- Removal of coarse particles and materials settled on the bottom of the pipe
- Reduction in the head loss as a result of the internal cleaning of the pipes
- Increase in the flow rate of the system due to the reduction of the head loss.

Figure 6 shows the reduction in the head loss after the cleaning phases were completed.

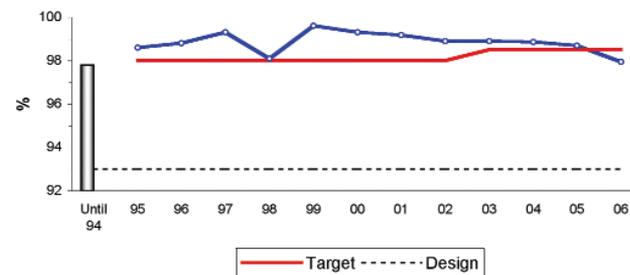
Figure 7—Availability

Figures 7 and 8 show the change of the Availability and MTBF factors.

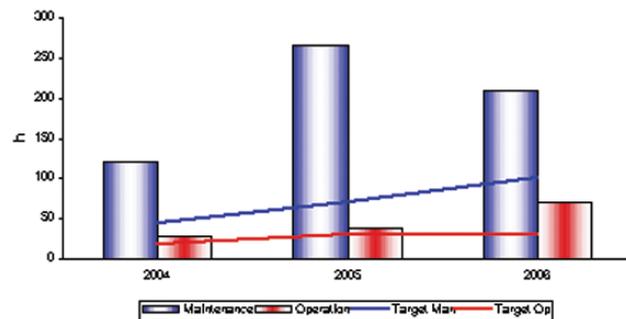
Figure 8—MTBF

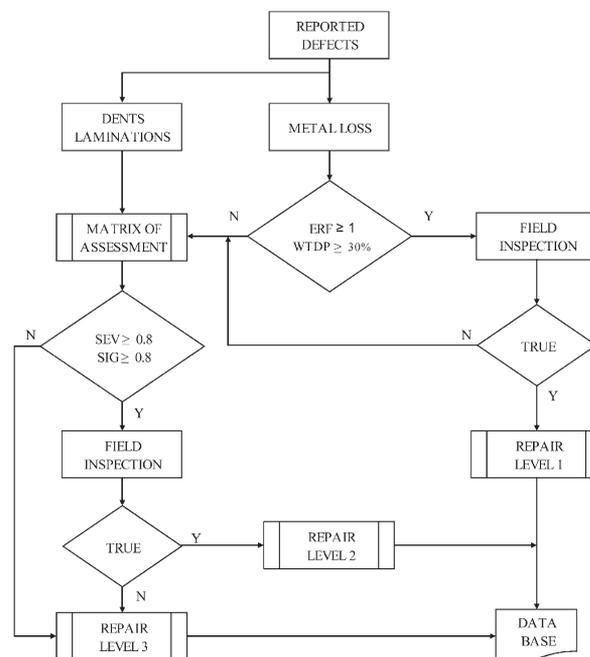
Figure 9—Flowchart: treatment of defects

The reported defects were treated according to the flowchart in Figure 9 that prioritizes the sequence of repairs according to how critical they are.

The defects classified as  $ERF \geq 1$  and/or  $WTDP \geq 30\%$  were repaired immediately with the application of welded sleeves. Due to the high rate of defects found in the first few kilometres after PS2, the decision was made to replace 2.1 km of piping in that section.

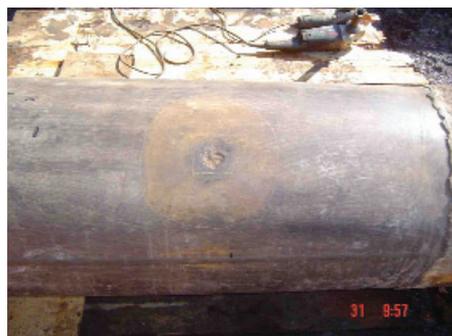
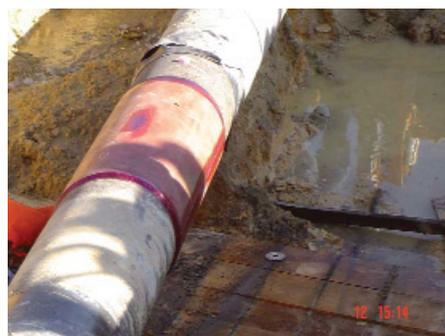
Figure 10—Examples of repairs

Table III shows the number of repairs made. Figure 10 provides examples of repairs.

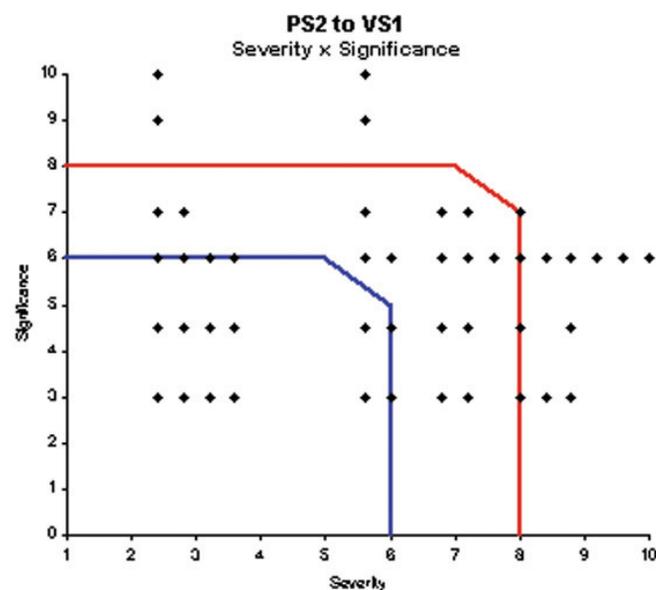
Figure 11—Severity and significance

Defects that were not treated according to the criteria adopted above were classified according to their criticality, resulting in a repair plan for short, medium and long term. Criticality is calculated using the formula:

$$\text{Criticality (C)} = \text{Severity (SEV)} \times \text{Significance (SIG)}$$

Figure 11 shows an example of the distribution of the points in the section between PS2 and VS1. The results plotted in the graph represent overlapping points with the same classification
