# Durban Harbour tunnel—first use of a slurry tunnel boring machine in South Africa

by J.A. Hindmarch\*, A.L. Griffiths†, A.K. Officer‡, and G. Wittneben‡

## Synopsis

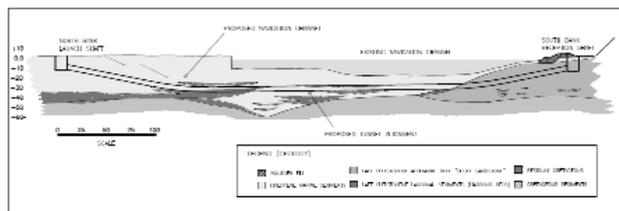
Figure 3—Tunnel long section and geology

Figure 3 shows a section through the harbour channel showing the existing and proposed entrance channels. The cover for the replacement bored tunnel below the existing seabed was chosen as a minimum of 9 m (two tunnel diameters). After the dredging of the deepened harbour channel (after tunnel construction) the minimum cover chosen was 5 m, which occurs at a pinchpoint on the north side of the harbour between the new harbour channel and 20% gradient of the new tunnel. These depths also allow for any over dredging when the harbour widening works take place. Though the removal of the extra cover over the new tunnel would increase the risk of flotation, there was still a sufficient resistance to flotation with the reduced cover.

Eleven boreholes were drilled as part of the geological and geotechnical investigations, two of which were within the existing shipping channel. Figure 3 shows the idealized geology of the harbour, which is largely Holocene and Pleistocene marine and lagoonal sediments. This is mostly classified as dense fine cohesionless sand with a clay/silt content in the order of 10%. However, lagoonal sediments comprising mostly silt and clay were identified, which could occupy up to 50% of the tunnel face. Approximately 420 m out of the 515 m total tunnel drive would be through these sediments. The strata changes to aeolianite reef sandstone on the south side of the harbour, forming the harder geology of the 'Bluff' and the tunnel drive would pass through this geology for the remainder of the drive. The sandstone on the south side was uniformly grained but heavily laminated with a strength varying between 0.5 and 50 Mpa.

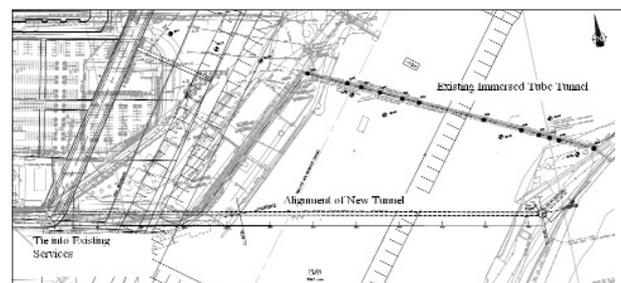
Figure 4—Connection of existing services through new tunnel

At present a number of water, sewer, power and communication utility services are carried across the harbour entrance in an 350 m long, 3.6 m diameter immersed tube tunnel. The major services are twin 1 000 mm diameter wastewater pipelines and a 450 mm diameter potable water pipeline. This tunnel was built in the 1950s and is located at a shallow depth beneath the harbour. Before the widening and deepening of the harbour entrance channel can take place, it is necessary to divert these existing services into a deeper bored tunnel, which requires the first use of a full face slurry tunnel boring machine (TBM) in South Africa.

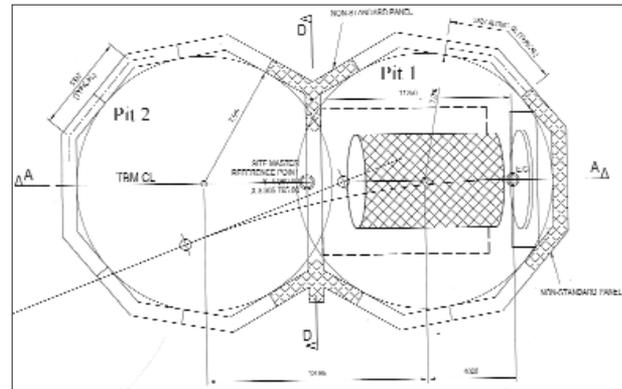
Figure 5—North shaft plan

The North Shaft was designed as a twin cell structure, with a central diaphragm wall to transfer loads exerted by the surrounding ground and external water table. This wall had an opening allowing installation of the TBM shield and first

gantry, to enable launch of the TBM. Pit One was designed to accommodate the TBM support works during tunnelling, while Pit Two allowed the contractor to commence early with construction of the cut and cover civil works, once the TBM and its backup had moved into the tunnel. (see Figure 5).

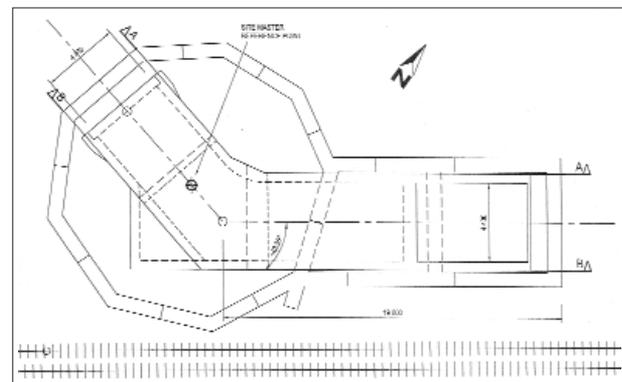
Figure 6—South Shaft plan

The south shaft required a different configuration, incorporating a single cell reception shaft and rectangular inclined shafts to accommodate the cut and cover civil work constructed at an angle to avoid the railway tracks running immediately adjacent to the site as well as the steep rise up the Bluff (see Figure 6).

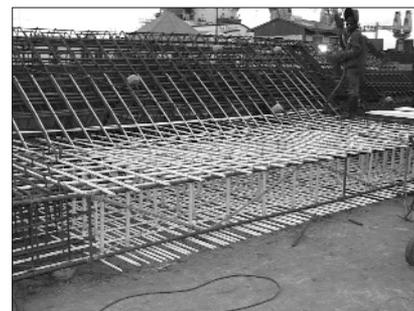
Figure 7—Soft eye formed using glass fibre bars

shafts were constructed using glass fibre reinforcing bars, to enable the TBM to pass through the eye walls without damage to the cutterhead (see Figure 7).

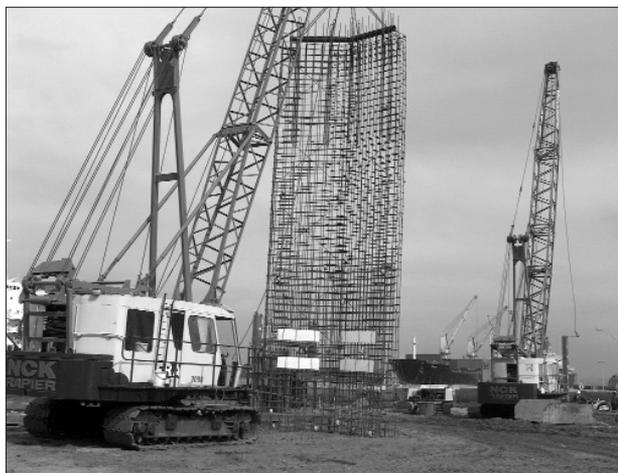
Figure 8—Shaft diaphragm wall reinforcing panel being lifted into position

- Steel stop-ends were installed at each end of the primary panel.
- Reinforcing cages were then lowered into the slot, incorporating 75 mm roller blocks to ensure the correct cover and to allow the cage to move freely down the slot (see Figure 8).

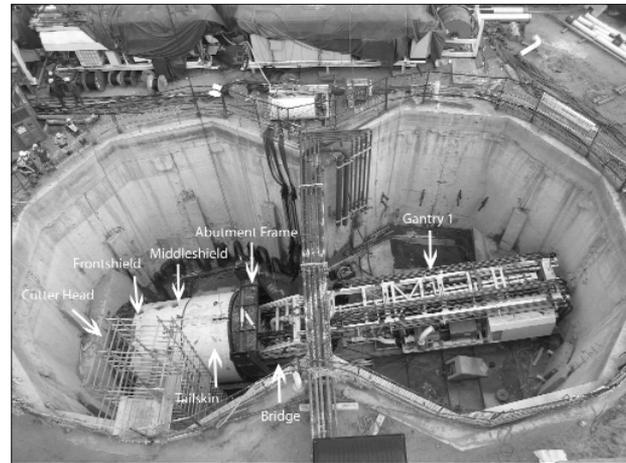
Figure 9—TBM established in the north shaft prior to launch

Following completion of the North Shaft and construction of the TBM support works, the TBM was established at the base of the shaft (see Figure 9).

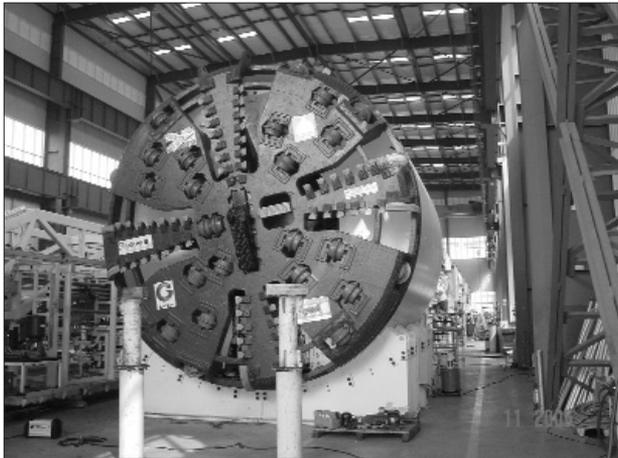
Figure 10—TBM cutterhead

The cutterhead consisted of 50 scrapers for the sand and clays and 24 disc cutters capable of excavating through the sandstone on the south side of the harbour (See Figure 10).

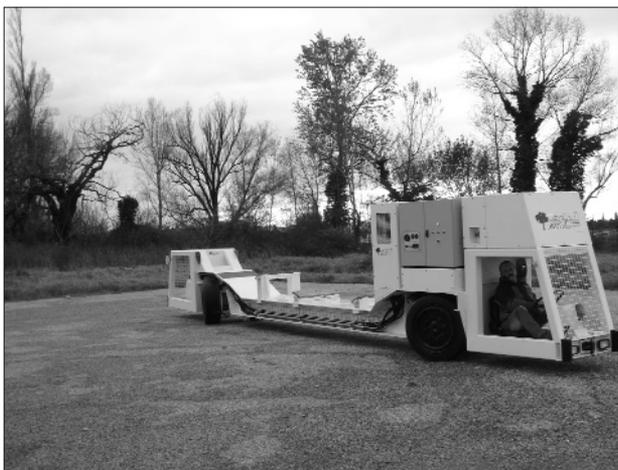
Figure 11—Multi-service vehicle

Due to the steep 20% decline and inclines in the tunnel, a trackless system of transport was developed for the operation of the TBM that was specially designed to carry the tunnel segments and grout mix and fit under the backup sledges. This multi-service vehicle was specially designed and fabricated by Techni Métal Systèmes (TMS) in France for the project, and tested using simulated conditions for full load operations on a 20% slope (see Figure 11).

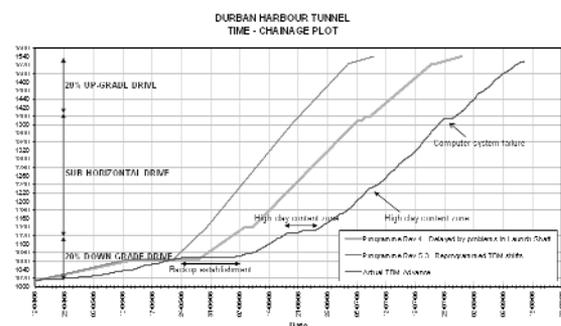
Figure 12—Time-chainage plot

had been negotiated, the rate of advance through the sub-horizontal section and on the 20% up-grade drives were essentially as originally planned, albeit on an extended shift basis (see Figure 12).

With a tunnel of only 515 m length, the challenge would always be to get past the learning curve as quickly as possible. In the case of the Durban Harbour tunnel, this learning curve took place on a 20% down-grade in soft ground conditions—a tall order. The initial rate of advance was slower than originally planned, which persisted through most of the down-grade drive. The rate of advance started to recover when the TBM moved into the subhorizontal drive, but was then affected by encounters with significant quantities of clay, in two main areas, largely as a result of interventions required to clear blockages and problems

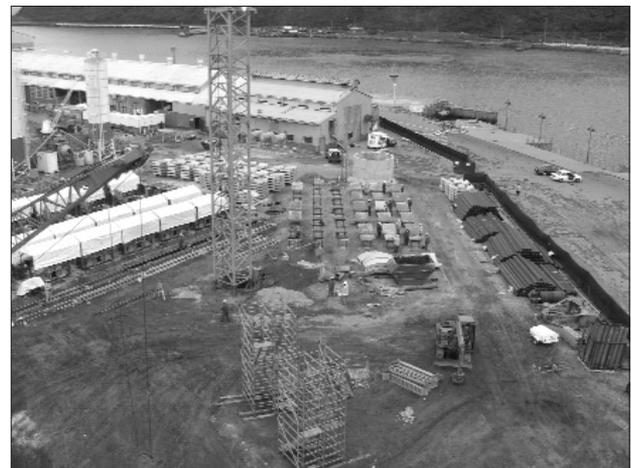
Figure 13—View along tunnel alignment showing segment production area

The manufacture of the lining segments took place on site close to the North Shaft (see Figure 13). With the limited production requirement for the short length of tunnel, and the generally favourable weather in Durban, the use of an indoor production facility was not felt to be warranted. However, portable screens were provided to protect the molds from sun, wind and rain. The molds were retrofitted with form vibrators to assist with compaction of the concrete.

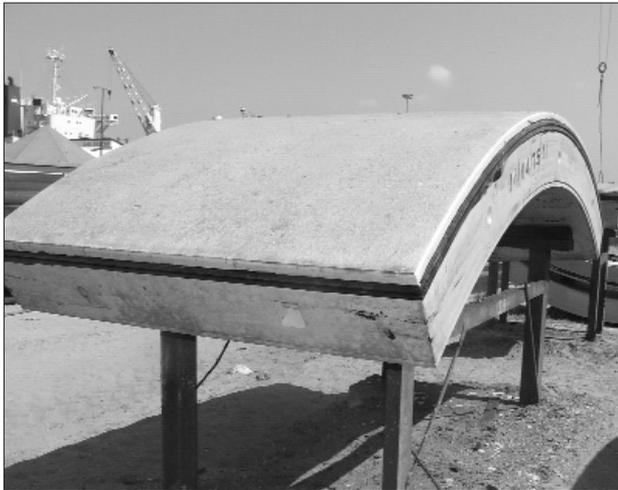
Figure 14—Typical segment in finishing yard

Segments were demolded at approximately 18 hours using a vacuum lifting device, and removed to a finishing yard where they were stored on specially fabricated steel frames (see Figure 14). At this stage minor repairs and crack sealing were carried out, and the EPDM Phoenix gasket was fitted. The segments were then moved to a storage area, and stacked in complete rings. Each segment was also given a

unique code, identifying the date of casting, the segment type and the ring number. This code was logged through the life of the segment, including all pre- and post-installation repairs.
