THE FLOODING AT THE WEST DRIEFONTEIN MINE*

By **R. R. M. Cousens**†, B.Sc. (Eng.) (Rand) (Member) and
W. S. Garrett‡, B.Sc. (Eng.) (Cape) (Visitor)

SYNOPSIS

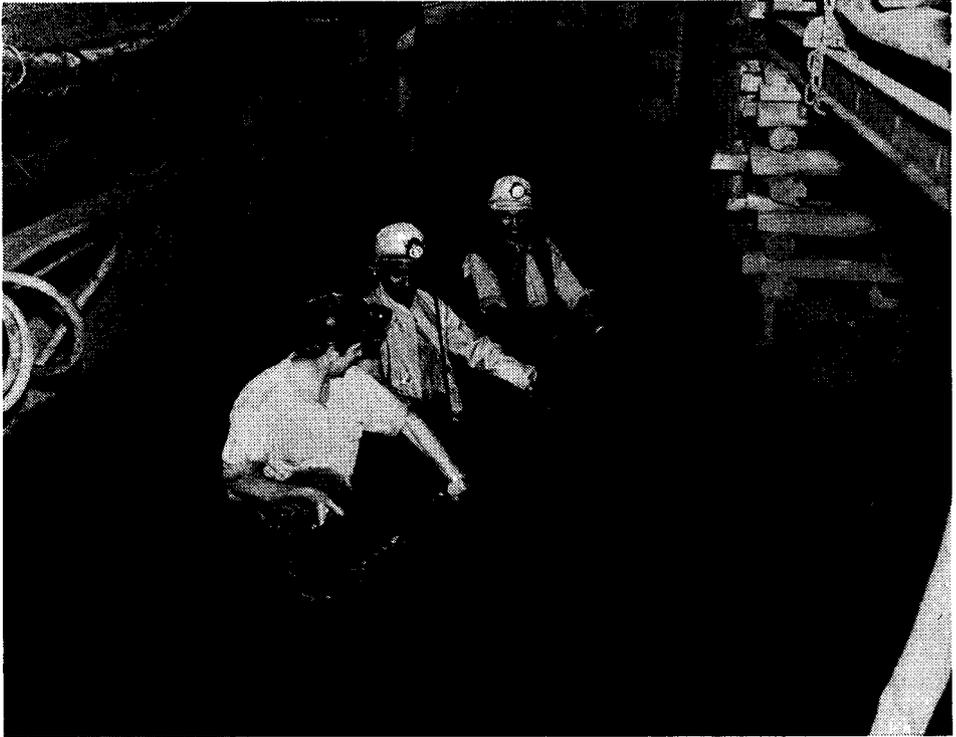
Fig. 13—Flow of 50 million gallons per day on 10 Level
