The abatement of pollution from abandoned gold-residue dams

by G. E. BLIGHT* and J. A. CALDWELL†

This paper describes the development of geotechnical measures for the abatement of air and water pollution from abandoned gold-residue dams in the Witwatersrand area. The measures include the stabilization of the surfaces of the dams to prevent wind and water erosion, the terracing of slopes to minimize erosion, and the construction of catchment walls and dams.

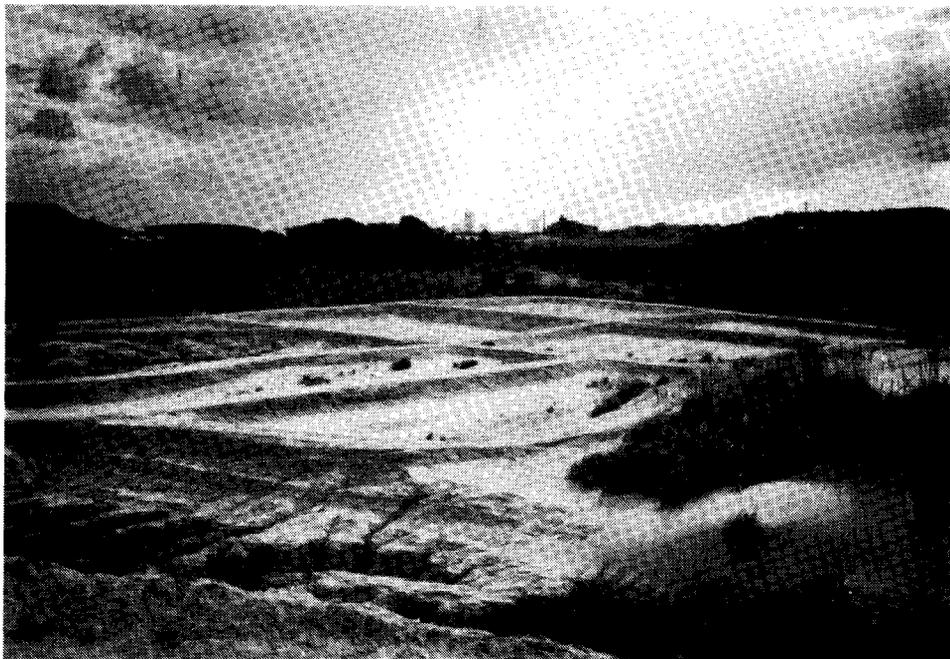
Fig. 3—Abandoned tailings dam provided with crest and dividing walls

Fig. 2 shows diagrammatically some of the features mentioned above, while Fig. 3 shows the crest and dividing walls on the top of an abandoned dam. (Note the urban development surrounding the dam and the severe surface erosion in the foreground.)

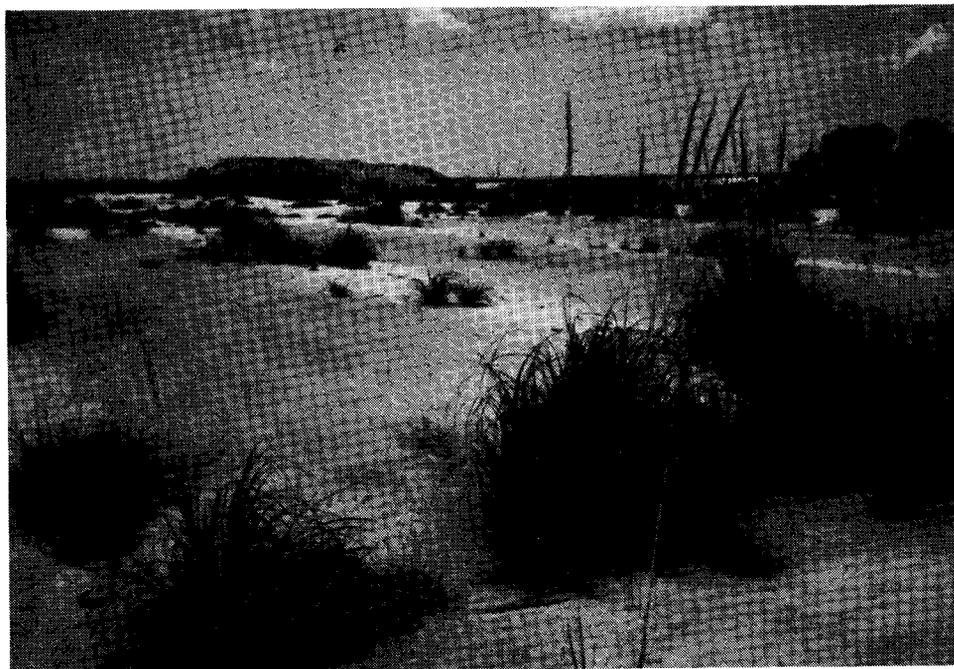
Fig. 5—Appearance of test panels of stabilized gold residue three years after laying

produced by a pneumatic compactor appears to deteriorate less than the rough, indented surface left by a tamping compactor. Fig. 5 shows the surfaces of the original test panels three years after being laid. The unstabilized strips between the panels show up as a result of their lighter colour. Even though the Comet resistance of the panels is low, they now stand proud of their surroundings, showing that they are more erosion-resistant than the unstabilized surfaces.

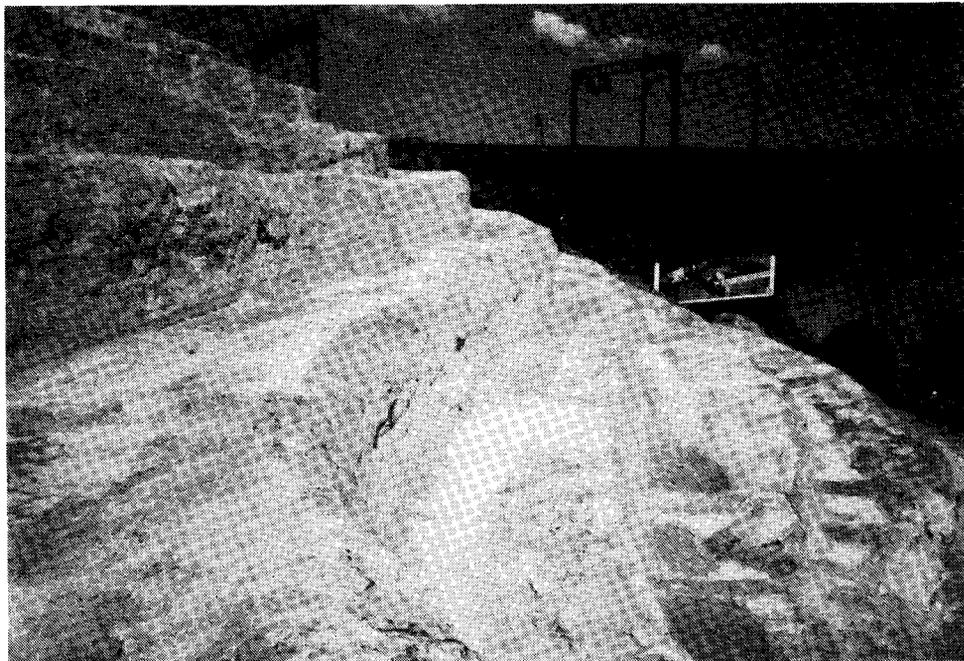
Fig. 8—Experimental terraced slope three years after the terraces were cut

tailings deposits; these faces appeared to be unaffected by erosion. The same phenomenon has been observed in natural vertical slopes. It was therefore decided that an experiment should be carried out in which the slope of a tailings deposit is terraced into a series of vertical faces separated by approximately horizontal steps or berms. To retain the precipitation, the berms are sloped back towards the dam, and are sub-divided at intervals by cross-walls so that all the precipitation on the berms is held and allowed to evaporate. Fig. 7 gives a design section of a terraced slope, and Fig. 8 shows an experimental terraced slope three years after the terraces were cut.

The state of these terraces is extremely good. In all cases very little erosion of the vertical faces has occurred, and in many cases a hard, dry crust has formed on the vertical face. Some eroded slime has accumulated in the paddocks formed by the back-sloping benches, and in a few instances exceptionally heavy rain has resulted in

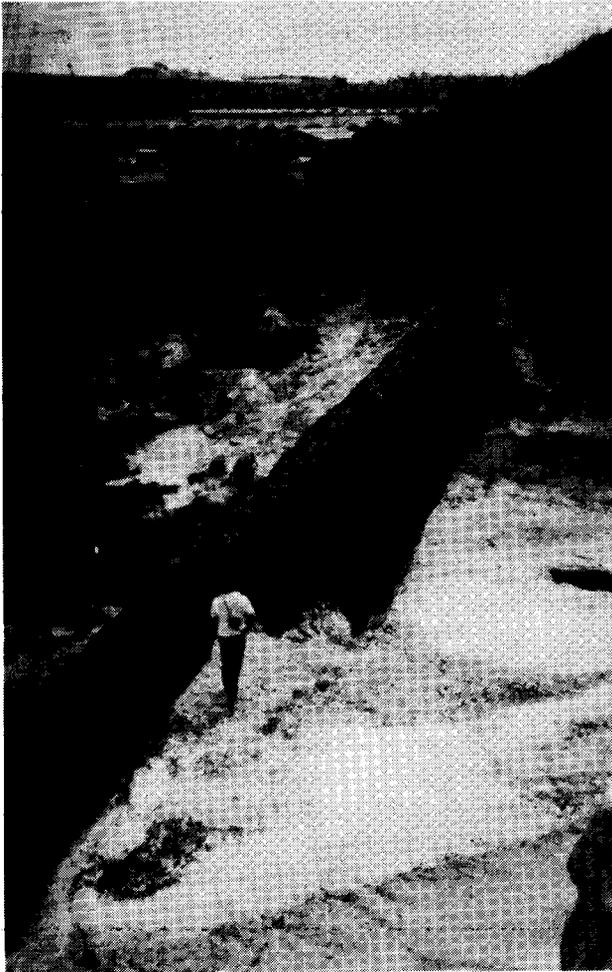
Fig. 14—Geofabric-reinforced dam after the formation of a pipe through the foundation. The entrance to the pipe can be seen to the right of the dam

Fig. 13 shows the design of a fabric-reinforced gravity-section embankment. This embankment has been built and is illustrated by Fig. 14. The dam spans a valley between two tailings deposits down which a natural stream flows. The stream has been by-passed through a

When first filled, an erosion pipe large enough for a man to crawl through formed through the lower part of the dam abutment. The entry to the pipe is clearly visible in Fig. 14. The fabric-wrapped embankment bridged over the pipe with some deformation but was otherwise undamaged, as the photograph shows. The failure was repaired by the placing of a filter blanket over the hole on the upstream side and plugging of the hole with compacted tailings from the downstream side. The authors consider that any less flexible construction would have failed completely.
