Application of shotcrete at Oryx Mine

by D.P. Venter and L.J. Gardner*

Synopsis

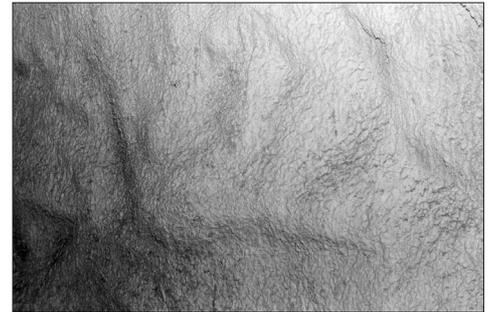
Figure 1—Typical shotcrete application in development end

25 mm layer of shotcrete to the newly-exposed hanging- and side-walls of the excavation, then applying a second 25 mm layer to the area that had been supported the previous day. Where necessary, areas where fallout or blast damage had occurred were also resprayed. The shotcrete was supplied in 25 kilogram bags as a sand mixture with a separate small bag containing cement, which had to be mixed together before application. As there was insufficient space in the development ends for screw feeder/mixers, the two ingredients were simply mixed on the footwall using shovels before being tipped into the shotcrete machine hopper.

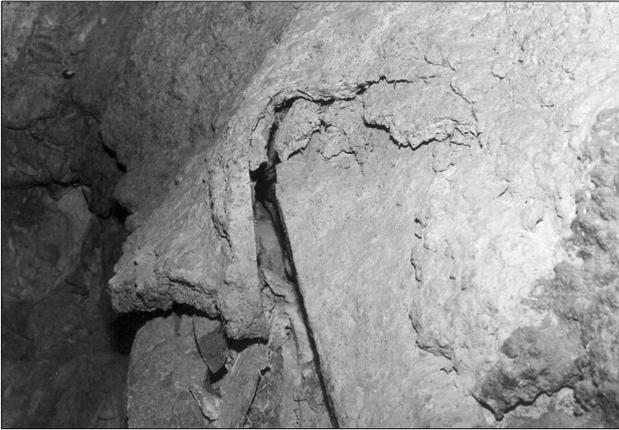
Figure 2—Example of poor shotcrete adhesion to the rockwalls

- ▶ *Poor adhesion of the shotcrete to the rockwalls.* Some time after the development end shotcreting had begun, it was noticed that in numerous places the shotcrete was falling off the rockwalls. No signs of stress-induced rockwall slabbing were observed in these areas, but closer investigation revealed excessive dust on the underside of the fallen shotcrete slabs. A check on the work in progress also showed that the rockwalls were not being washed down before shotcreting began, obviously preventing proper adhesion of the shotcrete. A change in the work procedure to ensure the washing down of the rockwalls before shotcreting begins and strict supervision has virtually eliminated this problem. Although it may sound as if the shotcrete support system is nothing but a series of ongoing problems, most of the items mentioned above were merely teething problems and were quickly remedied. At present, Oryx Mine supports approximately 5000

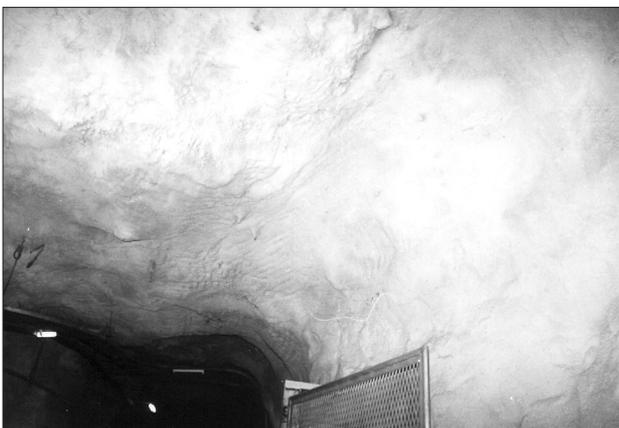
Figure 3—Area in return airway supported with mesh reinforced shotcrete

The basic procedure in this case was to apply a 25 mm layer of shotcrete to the rockwalls and leave this until dry. Diamond mesh would then be stapled to the shotcrete using a spring loaded Hilti gun. Finally the mesh would be sealed by a second 25 mm thick layer of shotcrete, ensuring no exposure of the mesh and thus no corrosion.

Although the mesh reinforced shotcrete appeared to be fairly effective as a support system, it was extremely time consuming to apply, as it required triple the amount of work of normal shotcrete. Uneven areas in particular proved to be a problem as the mesh would not lie flat against the first layer of shotcrete and excessive shotcrete had to be used for

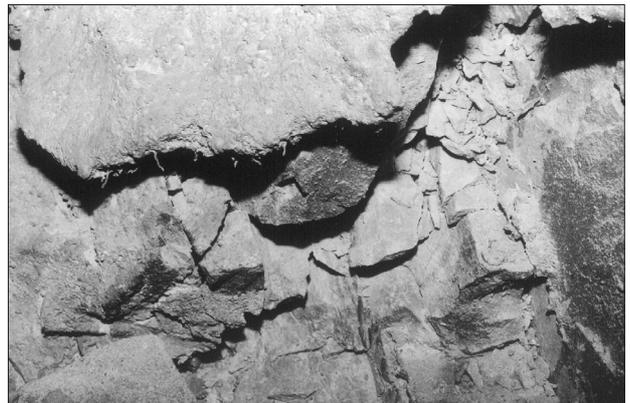
Figure 4—Example of steel fibre reinforced shotcrete - note steel fibres protruding from applied shotcrete

In an effort to increase the strength and deformation capability of the shotcrete, steel fibres were used as reinforcement. Major problems were encountered in this application, as listed.

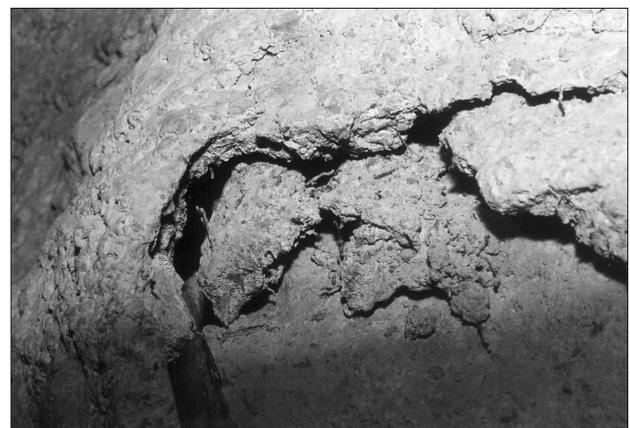
Figure 5—Area where corrosion of steel fibres has resulted in shotcrete breaking up

Subsequent visits to the project sites revealed an abnormally high corrosion rate of the steel fibres. The expansion of the fibres caused by the corrosion, resulted in the shotcrete cracking up in places. In other areas the fibres had corroded through and were no longer contributing to the integrity of the support system. This phenomenon was also observed in another area where steel fibres had been used as a reinforcement above the settler dams. It is therefore recommended that future users of steel fibre reinforced shotcrete bear this in mind when shotcreting areas with high moisture and humidity levels.

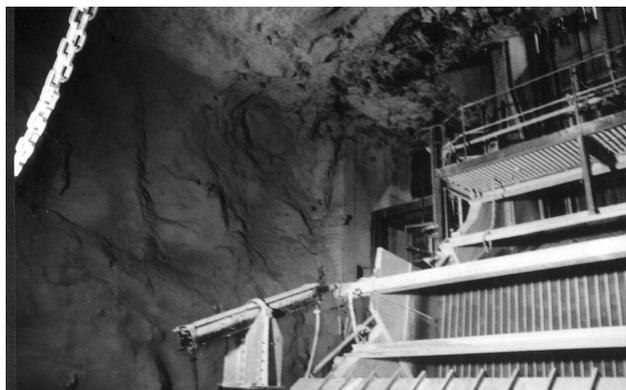
Figure 6—Shaft headgear bin chamber supported by shotcrete reinforced with polypropylene fibres

Shortly after the tests had begun, management requested that the loading bin chamber in the sub-vertical shaft be supported, as it was showing signs of deterioration. The size and shape of the chamber ruled out the possibility of using meshing and lacing, so the choice of support fell to shotcrete. Because of the size and complexity of the job, it was decided to hire a larger shotcrete machine from one of the members of the SRK shotcrete working group, MASH Engineering. This machine had been designed for use with polypropylene fibres and incorporated a number of unique features, including a built-in pre-mixer/feeder. It had previously been used for testing purposes by the working group. MASH Engineering also supplied the pre-bagged shotcrete mix.

Both the machine and the polypropylene fibre reinforced shotcrete performed very well under the circumstances. There were no major breakdowns, rebound from the specific shotcrete mix was lower than that of normal shotcrete and virtually no dust was created during the shotcreting process.

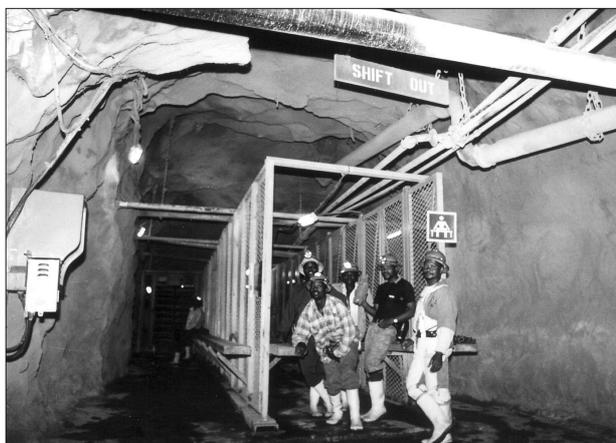
Figure 7—Shaft waiting place supported using polypropylene fibre reinforced shotcrete

longer than expected and the machine had to be returned. A second scheduled job, the support of a large waiting area, could not be completed. As there were still a number of bags of MASH Engineering shotcrete mix left over we decided to try them with the standard shotcrete machines, rather than waste them. To our surprise the combination worked perfectly and we were able to finish the job using the polypropylene fibre reinforced shotcrete.

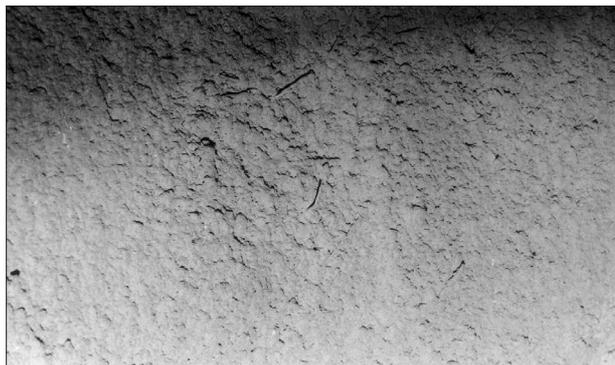
Figure 8—Section of applied polypropylene fibre reinforced shotcrete

Following the disappointing results obtained with the steel fibres and the successes obtained by the SRK working group with monofilament polypropylene fibres, these were investigated as shotcrete reinforcement. Tests were done on the mine with the standard shotcrete machines using needle fibres and more flexible multifilament fibres. Better distributions were obtained with the needle fibres, provided the fibre length was restricted to no more than 60% of the delivery hose diameter.
