A critical evaluation of the installation equipment of in-stope rock bolts and the effectiveness thereof in the Merensky stoping areas

by G.M.J. van Heerden* Paper written on project work carried out in partial fulfilment of B.Eng (Mining Engineering) degree

A critical evaluation of the installation equipment of in-stope rock bolts

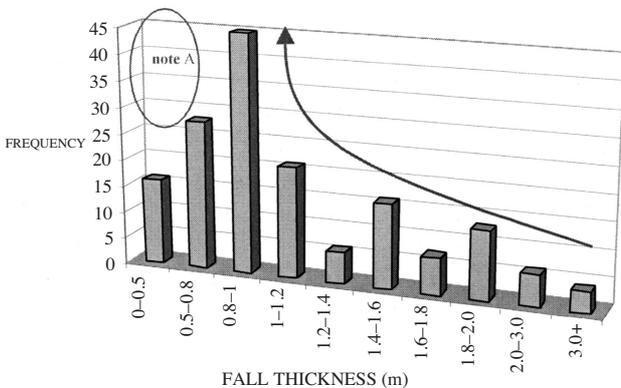
Figure 1—Fall of ground thickness in the Merensky stopes

way since a minor adjustment will be critical for this evaluation. The data represented the recorded major falls which were responsible for an incident, i.e. injury, fatal, lost time, etc. It is believed that numerous smaller falls were not recorded and hence the statistics were negatively affected. (Refer to note A - Figure 1)

There were 162 reported falls of ground during the stated period. The prominent source of the falls of ground was the hangingwall, with little sidewall and face failures. 68% of all the reported falls of ground had a thickness of less than 1.2 m and 96% of all the falls of ground occurred within 5.0 m from the face. A definite tendency was identified (Refer to Figure 1 and Figure 1a)

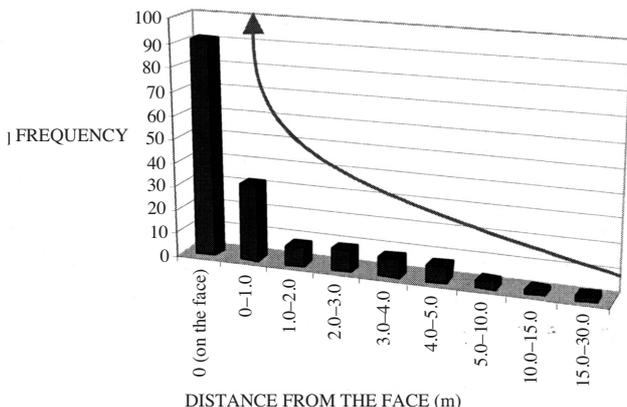
Figure 1a—Falls of ground relative to the face in the Merensky stopes

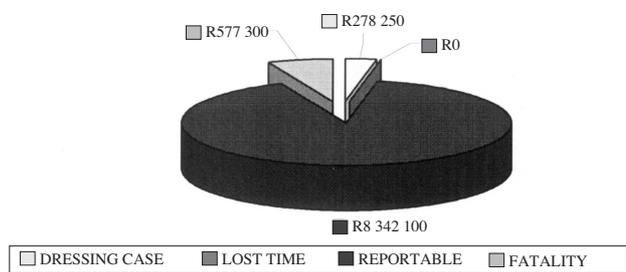
Figure 2—Cost of incidents related to falls of ground within the Spud Business Area

During the period 1/1/2000 to 15/12/2000, ± R9.2 million were spent on incidents related to falls of ground within the Spud Business Area. (Refer to Figure 2) It was difficult to determine the **lost time** during the stated period. For this specific exercise the lost time was taken as zero.

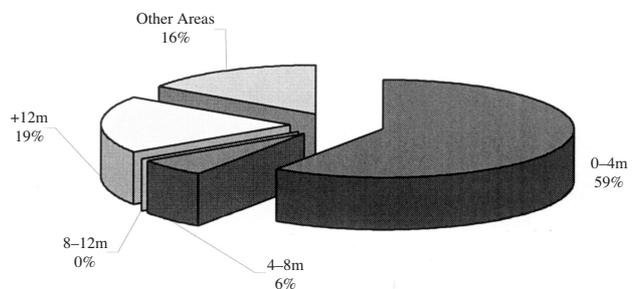
Figure 2a—Fall of ground distance from the face within the Spud Business Area

In the stoping areas, the first 4 m were responsible for 59% of all the injuries occurring in the stopes. (Refer to Figure 2a)

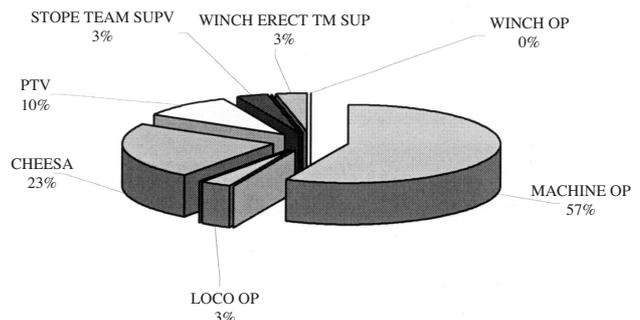
Figure 2b—Occupation (injuries due to falls of ground) within the Spud Business Area

Of all injuries, 57% occurred to the machine operators and 23% to the blasting assistants (Cheesas). In total 80% of the injuries happened to those people who spend most of their day in the area between the face and the first row of permanent support. (Refer to Figure 2b)

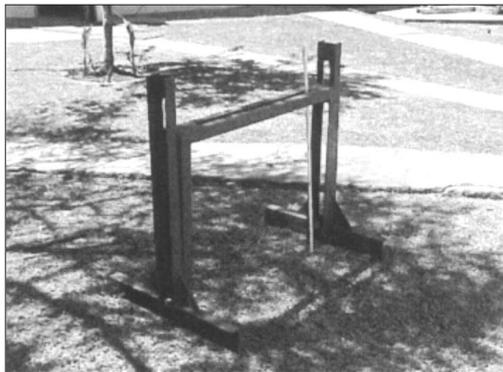
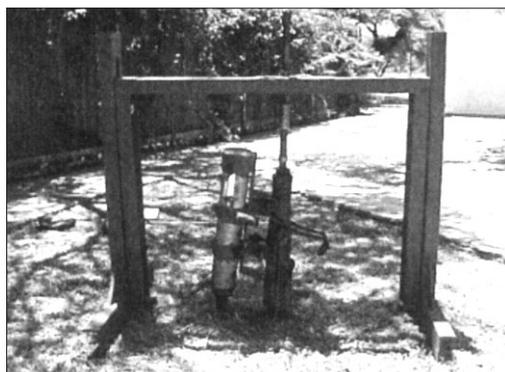
Figure 3—The adjustable testing frame

An adjustable testing frame representing the different stope widths between 75 and 120 cm and different drilling angles between zero and 90° was built to carry out the needed simulation and testing of equipment before sending it underground for further testing. The purpose of the frame was to save valuable time and money. (Refer to Figure 3).

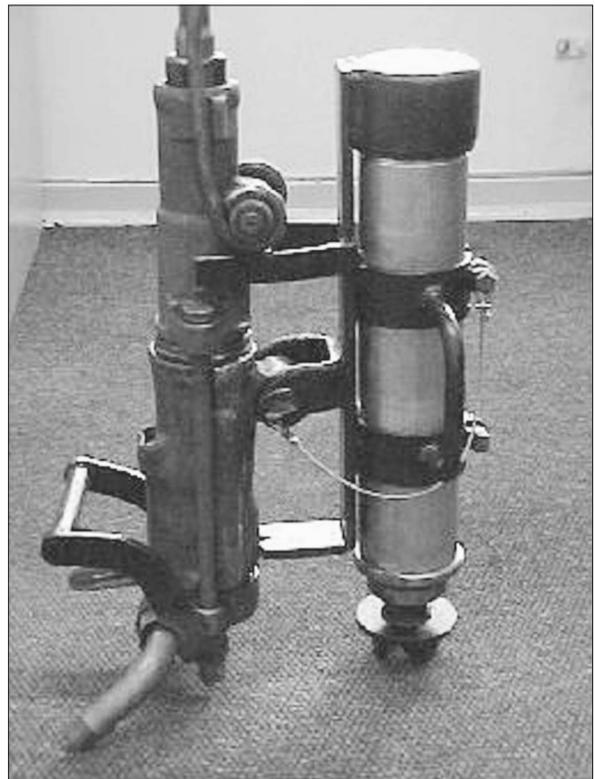
Figure 4—Final coupled equipment after all modification

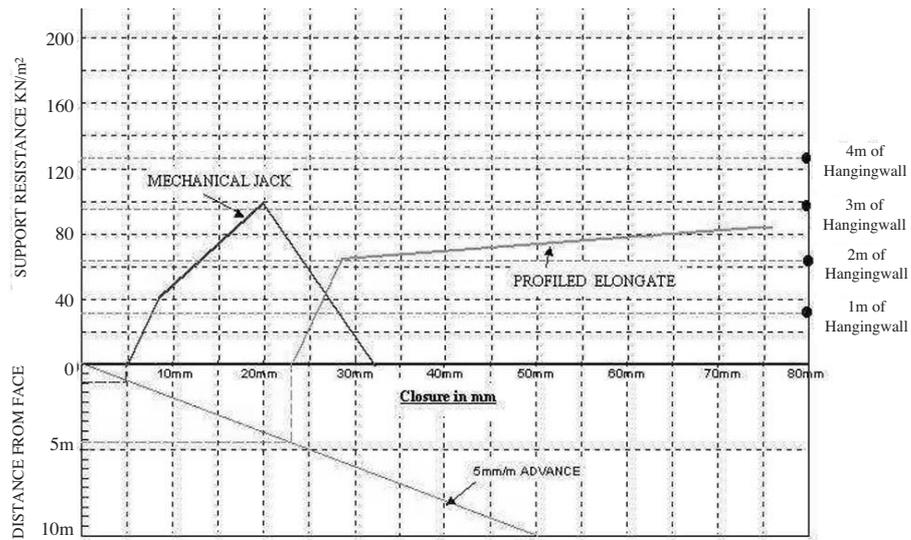
Figure 5—Support resistance curve of the conventional support system

When the mechanical jack (temporary support) is removed before the blast, there is a large unsupported high-risk area in which night shift workers enter to perform their work. Thus, there is a NIL support resistance when the temporary support is not in place. The rock bolts provided the solution. The support resistance of a rock bolt on a 1.2 x 1.5 m pattern is $\pm 45\text{kN/m}^2$ (Support resistance of the rock bolts is $\pm 80\text{kN}$). Thus the installation of the rock bolts will provide an additional support resistance in the initial totally unsupported area (5 m from the stope face).

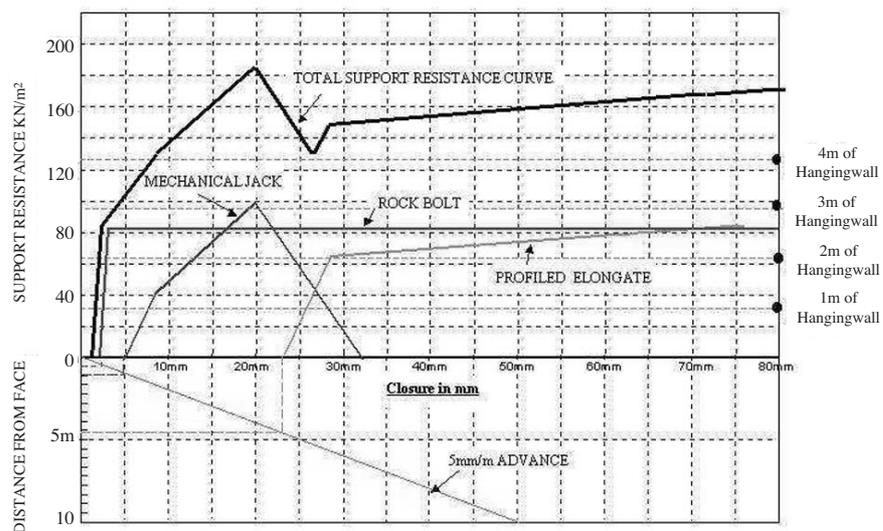
Figure 5a—Support resistance curve of the new in-stope support system

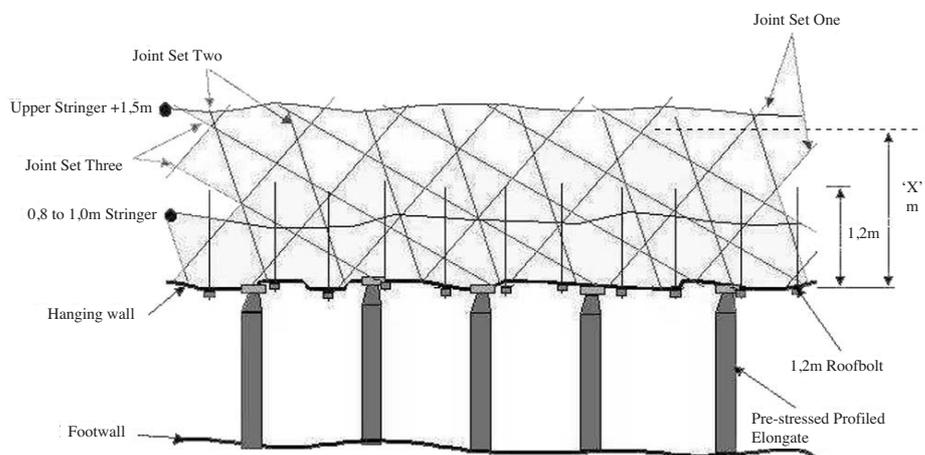
Figure 6—Merensky hangingwall with the in-stope rock bolts

- The rock bolts will provide adequate support resistance.
- 68% of the reported falls of ground had an estimated thickness of 1.2 m.
- $\pm R8$ million was spent on incidents related to falls of ground in the stoping areas during 2000.
- The rock bolts will provide an overall safer working environment, a very significant improvement in overall productivity and an overall revenue increase.
- Further modifications to the equipment will result in a substantial improvement in the drilling angle, even at a low stoping width.
- It can be said with confidence that the rock bolts will support the very important 0.8 to 1.0 m stringer. (Refer to Figure 6).
- The rock bolts will support the wedges formed by the different joint sets. (Refer to Figure 6).

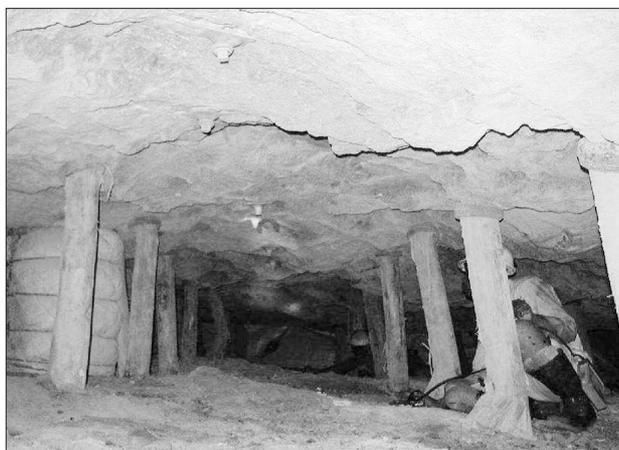
Figure 7—Installed rock bolts within the Merensky stope areas
