Construction of permanent intruded plugs at South Deep Gold Mine

by D.A. Bruce*, M.F. Wells†, and J. Venter‡

Synopsis

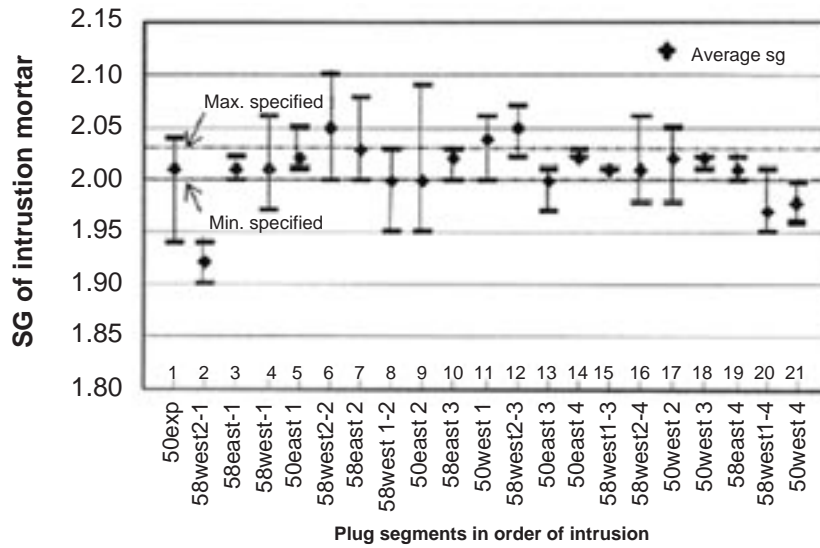
Figure 1—Salter SG values in order of segment intrusion

The compliance of the constituent mortar materials to the method statement was confirmed. For the fluid mortar, Figure 1, shows the specific gravity readings (by Salter Scale) for each segment. Although three segments recorded values below the specified range, other key properties, specifically bleed and strength, were acceptable. The individual computer records generated during batching confirmed compliant water/cement ratios and sand/cement ratios.

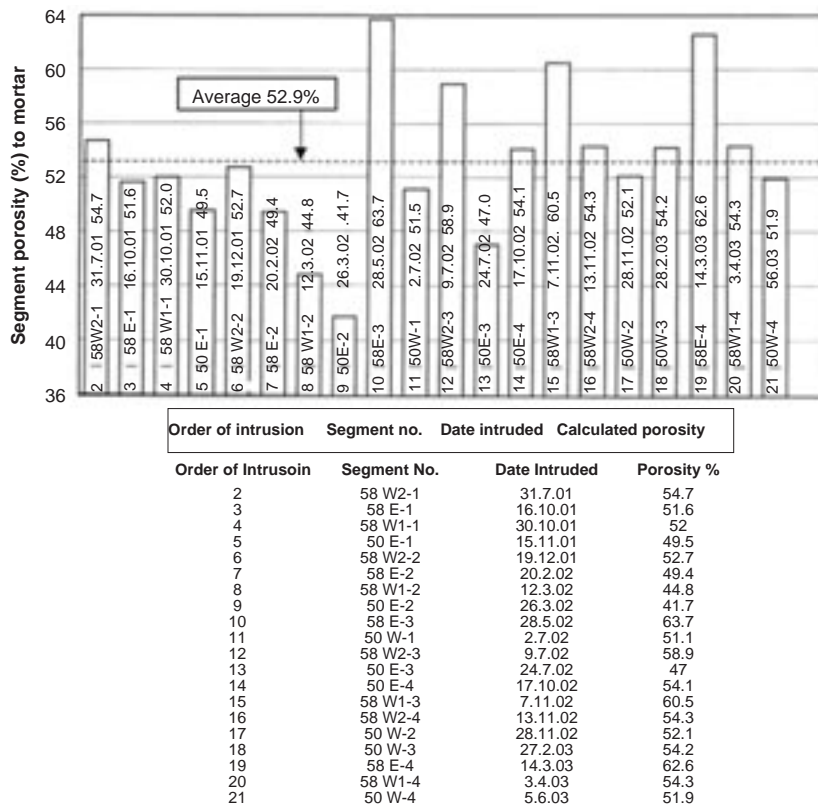
Figure 2. Details of plug porosities by order of segment intrusion (excluding experimental plug)

Figure 2 shows the apparent variation in segment porosity to mortar. The average of 52.9% compares closely with the 52.4% figure calculated from 210 litre drum injections, and the 51.3% obtained in the experimental plug. Significant variations from the average (e.g., as low as 41.7% and as high as 63.7%) were considered due to variations in the plum size gradations and/or in inherent inaccuracies in the calculation of the segment volumes prior to placing the plums.

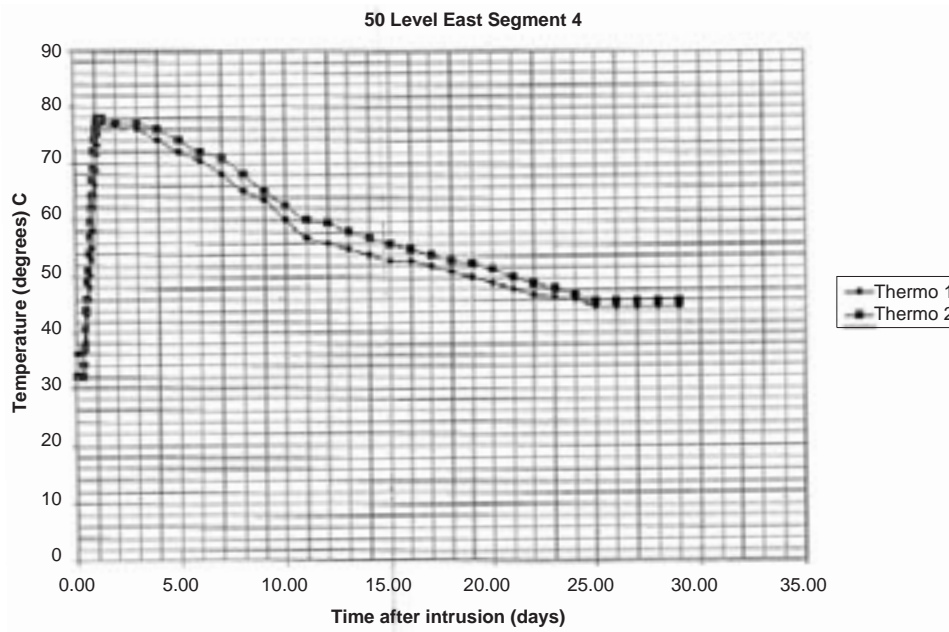
Figure 3—Temperature after intrusion

For all segments, the typical profile was a very rapid temperature rise peaking typically 1 to 4 days after intrusion (e.g., Figure 3), although some segments took several days longer to reach maximum temperature. Initial temperatures within the aggregate ranged from 25 to 39°C, being consistently higher in the Level 58 plugs (33 to 39°C). Peaks of 60 to 82°C indicate a range of temperature rises from 30 to 50°C, average 40°C. Readings between each pair of thermocouples

in each segment were generally in good accordance, with only 3 examples of a significant difference (up to 11°C) in the amount of temperature rise measured by each pair. Such discrepancies most probably reflect instrument malfunction. For comparison, the average increase as measured by thermocouples 1 and 2, was 39.3° and 40.5° respectively.

Day 28 temperatures varied from 28° to 54°C, following slow and steady decline. These represented drops of between 17 and 42°C (average 28.5°C) relative to the peaks recorded. The average difference between peak and 28-day temperatures for thermocouple 1 and 2 was 29.3° and 27.6° respectively.

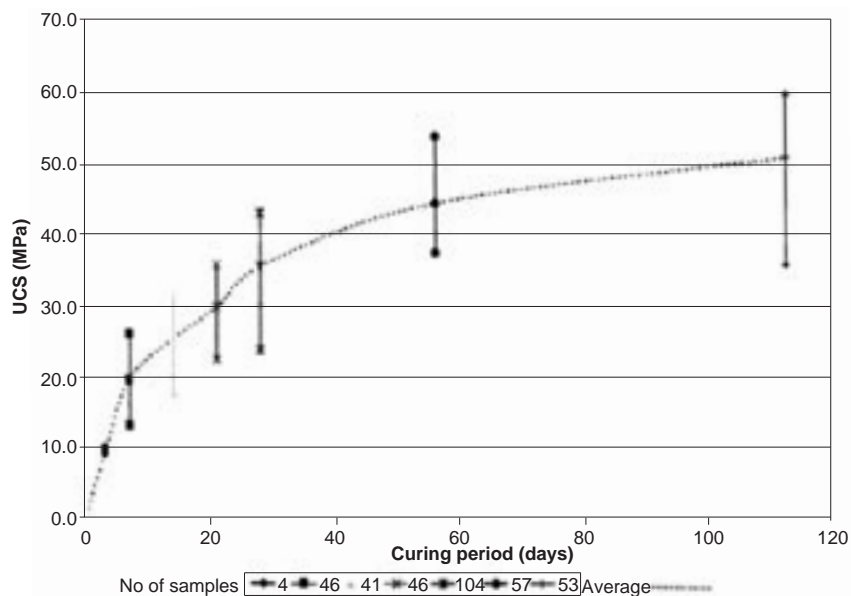
Figure 4—Range and average of mortar cube strengths based on individual segment averages

Overall, the mortar cube strength development with time can be summarized as shown in Figure 4. The key acceptance criterion—a minimum of 25 MPa at 28 days—was met, on average by every segment of every plug, the overall average being 35.6 MPa. The average figures are based on the testing of at least three cube samples.

It may also be observed that the 28-day strengths of the first 7 segments intruded (excluding the experimental) ranged from 25.5 to 40.8 MPa (average 32.9 MPa), whereas the corresponding data for the subsequent segments ranged from 32.3 to 41.4 MPa (average 37.1 MPa). This is indicative of progressively improving standards of batching with time and a progressive reduction in the water/cement ratio.
