# The stress-strain behaviour of in-stope pillars in the Bushveld Platinum deposits in South Africa

by B.P. Watson\*, M.K.C. Roberts\*, M.M. Nkwana\*, J. Kuijpers\*, and L. van Aswegen†

## Synopsis

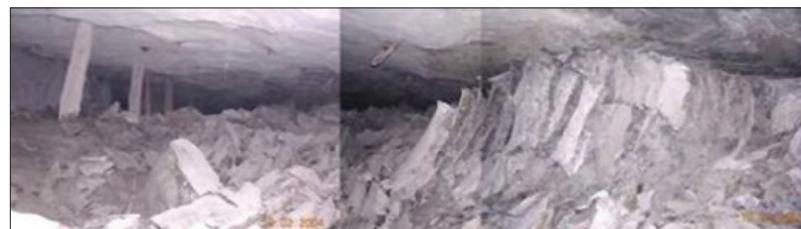
Figure 22—Panoramic view showing the up-dip end of a burst pillar. Note the gully is full of rock fragments from the pillar burst

Three pillar bursts were investigated on the same mine where the stress measurements were undertaken. All the pillar bursts occurred on the first or second pillar back from the down-dip face, as shown in Figure 21. One of these bursts created a magnitude 1.2 seismic event, resulting in violent ejection of rock, as shown in Figure 22. This pillar was located 10 m to 14 m behind the face at the time of the burst. A high degree of fragmentation was observed throughout the pillar, and rock fragments were thrown into the ASG.
