# Investigations into the residual strength of a 2.5 m wide Bushveld Merensky Reef crush pillar

by B.P. Watson\*, S.M. Mosomane\*, J.S. Kuijpers\*, and D.P. Roberts\*

## Synopsis

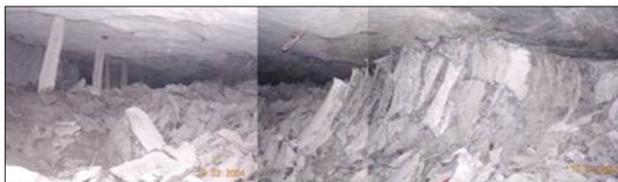
Figure 2—Panoramic view showing the up-dip end of a burst pillar. Note the gully is full of rock fragments from the pillar burst

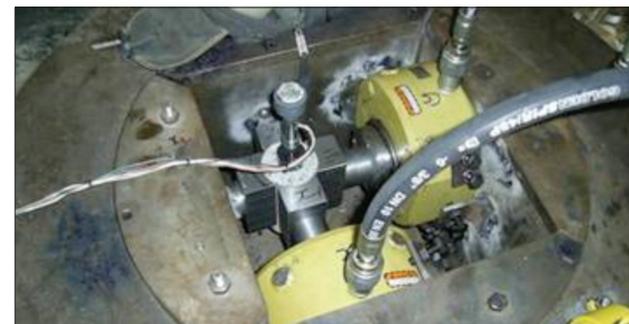
Figure 9—Mechanical biaxial test apparatus for doorstoppers

Further analysis and microscope work established that the behaviour was influenced by open micro-cracks. Thus, in theory, once the cracks are closed the material should behave in a normal, linear elastic manner. However, in the case of the UCS tests, the onset of failure occurred before the cracks were fully closed. The doorstoppers were, therefore, evaluated using a biaxial test, performed on specially prepared doorstopper samples, as shown in Figure 9 and Figure 10 respectively.

Unfortunately the coupling between the sample and the loading jaws was not good, which resulted in additional strain for the applied load at very low stress. The final solution incorporated a combination of both the biaxial and UCS tests.

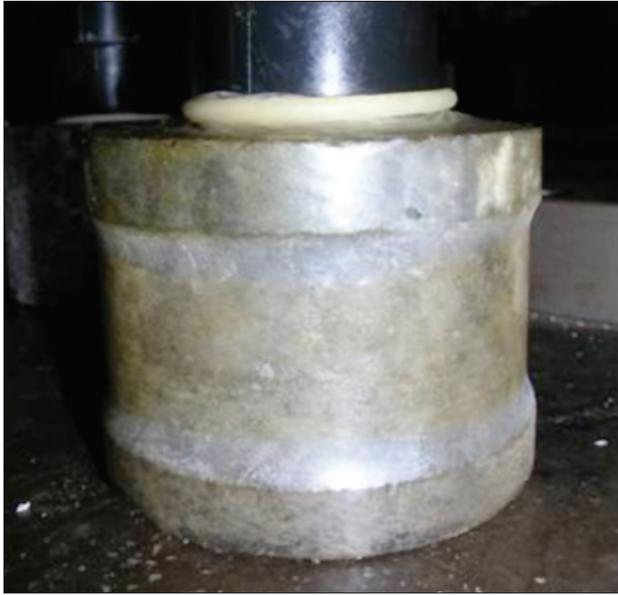
Figure 10—Specially prepared doorstopper sample

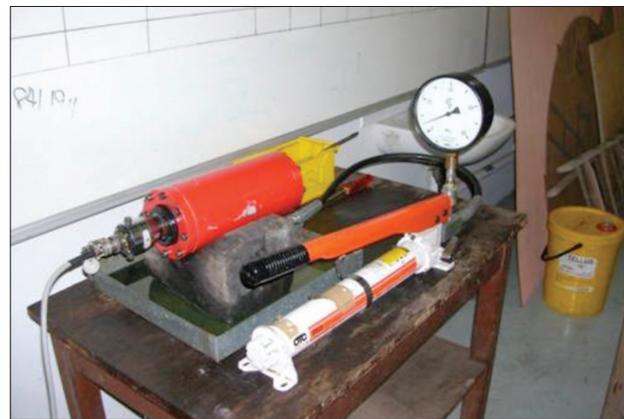
Figure 11—Test apparatus for loading triaxial cells

The triaxial cells were evaluated using the biaxial test apparatus shown in Figure 11. The stress concentrations on the inside of the hollow cylinder used in the tests meant that the radial and axial strains had to be evaluated separately for the non-linear material. A list of all the stress results is shown in Table I. The triaxial cell results are in bold.

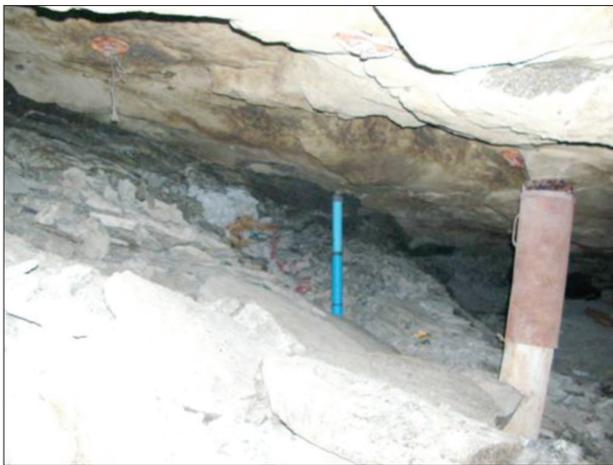
Figure 13—Down-dip side of the instrumented pillar. View away from face

The reference point used for the evaluation of the stress measurements was the centre of the down-dip edge of the pillar (the bottom edge in Figure 12). The matrix inversion of the 'adjusted' stresses provides the estimated stress distribution across the pillar. While other measurements made around the pillar showed that it had failed, the Boussinesq evaluations suggest that the central core of the pillar is still carrying 2 100 MPa. This high stress is unlikely as the physical conditions surrounding the pillar suggested a reasonably low stress environment after failure, with a stable hangingwall adjacent to the pillar (Figure 13).

However, stress change was measured on the evaluated pillar from before pillar failure. The stress had dropped to the measured value 12 months prior to the profile measurements and remained unchanged while further mining took place. In addition, the observed pillar condition (Figure 13), the stable hangingwall adjacent to the pillar and the significant closure measured up-dip and down-dip of the pillar show that the pillar is in an advanced stage of failure. It is therefore concluded that the pillar is in or very close to the residual condition. The location of the pillar when the siding was cut and good blasting appears to have resulted in an unfractured siding. This solid siding may have contributed to the unexpectedly high residual strength of the pillar.

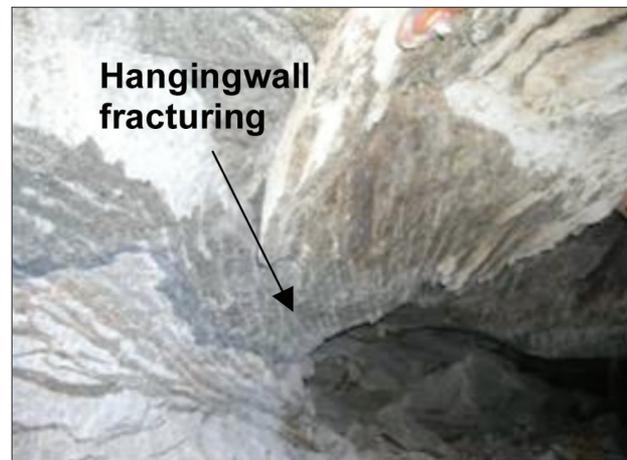
Figure 16—Up-dip side of the instrumented pillar. View towards face

Both the peak and APS stresses are high for a failed pillar of width:height ratio 2.1:1. However, the pillar height was less than 0.5 m high in places on the up-dip side (Figure 4), which may have caused the pillar to carry a higher load on this side (Figure 16). The low height of the 2.5 m wide siding may have affected the effective width:height ratio, thus accounting for the high residual strength. The high density of fracturing in the hangingwall suggests that the pillar was carrying a high stress, probably at some stage before the siding was cut. Similar fracturing was observed on the down-dip side where the fractured sidewall of the pillar had fallen away.
