A critical evaluation of haul truck tyre performance and management system at Rössing Uranium Mine

by T.S. Kagogo*

Paper written on project work carried out in partial fulfilment of B. Eng. (Mining Engineering)

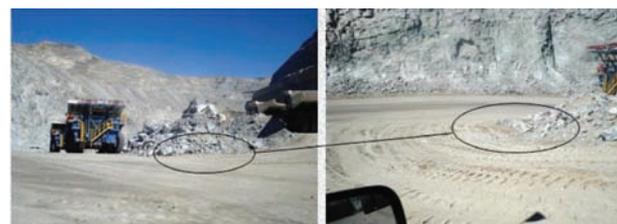
Figure 6 illustrates loose rocks on the shoulder of a berm at a traffic circle and in a turn, which are a source of sidewall cuts. Figure 7 shows partially buried rocks in a turn, which are also a source of sidewall cuts and are not easily visible. The turning radius of the corners is within the mine standards, but the main concern is the loose rocks in the corners as the mine lost six tyres in 2012 due to sidewall cuts. The corners need to be constantly dressed with sand and loose rocks removed, and operators should take care not to cut corners and expose the tyres to rocks.

Figure 6—An example of loose rocks in a turn, with a truck about to cut a corner

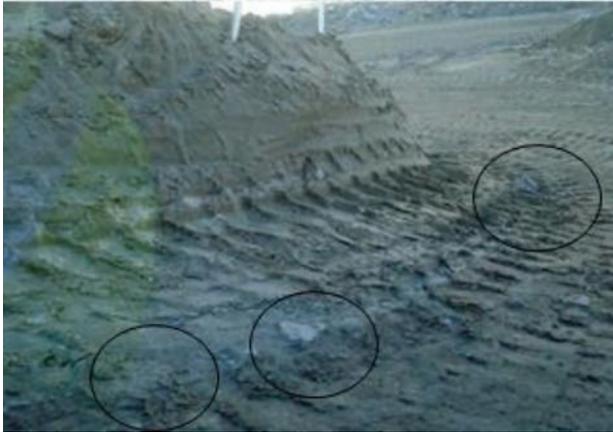
Figure 7—Sidewall cut rocks in a turn

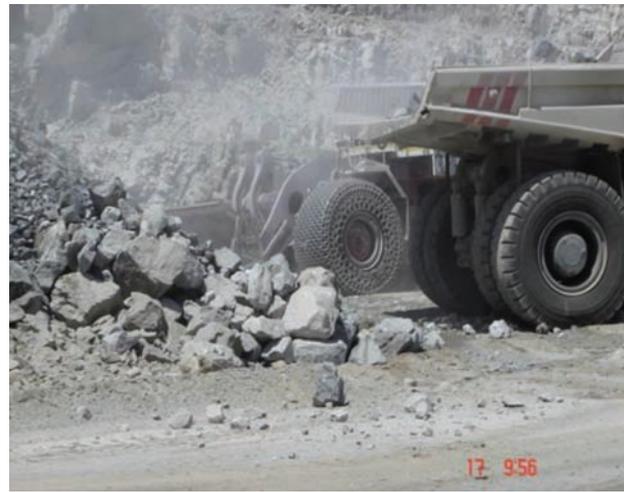
Figure 8 shows a typical loading area condition at Rössing with loose rocks. Loose rocks are inevitable in the loading area, but should be cleaned up regularly and truck operators should not reverse into a loading area that contains loose rocks. Due to operational constraints, auxiliary clean-up equipment is not always available but effort should be put into keeping the area clean. The shovel operator should also practice a culture of cleaning the area regularly when the clean-up dozers are not available.

Figure 8—Loading area with loose rocks

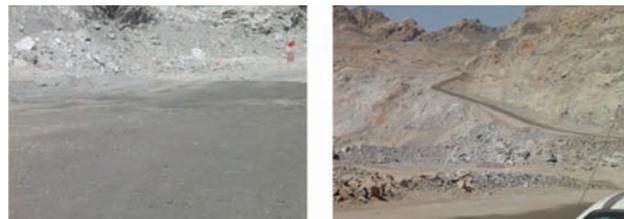
Banking and hammering are of less concern as they have ratings of 3, which is good in the current state as tyres are subjected to shock less than 10% of the time and less than 50% of the roads have banking. Undulation is the biggest concern, with a rating of 1 due to the presence of undulations every 3 m. Undulations on the haul road causes payload spillages as well as a slight heat build-up in the tyre. Figure 9 shows an undulating portion of an in-pit haul road, clearly illustrating the severity of the situation.

Figure 9—Undulation of in-pit haul roads at Rössing

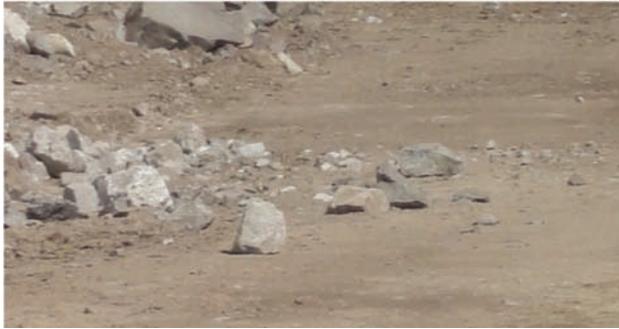
Figure 10 shows an example of spillage on the in-pit haul road, which also is a major problem as it is a source of loose rocks that cause operational failures such as cut penetration.

Figure 10—Example of spillage on the in-pit haul road
