Wear of magnesia-chrome refractory bricks as a function of matte temperature

by M. Lange*, A.M. Garbers-Craig*, and R. Cromarty*

Paper written on project work carried out in partial fulfilment of B. Eng. (Metallurgy)

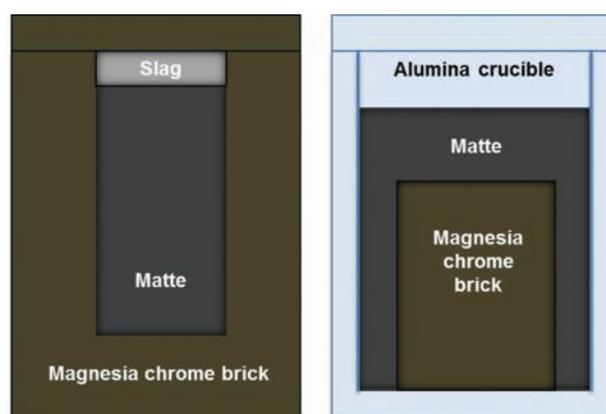
Figure 1 – Crucible design 1 (left) and 2 (right)

- The first design consisted of crucibles and lids made from the supplied magnesia-chrome brick. Matte and slag were placed into a cavity drilled into a core cut from the refractory brick (Figure 1). It was intended to investigate the interaction between the matte and the refractory brick crucible. In this design the refractory crucible was in direct contact with the graphite susceptor

- In the second design, matte was contained in a closed alumina crucible. A cylindrical sample of refractory brick was inserted into the matte (Figure 1). There was a limited volume of refractory in contact with the matte, and the refractory sample and matte were isolated from the graphite susceptor.

It was subsequently decided to change the design to a set-up in which a small piece of refractory, surrounded with a large amount of matte, was placed in a large alumina crucible (Design 2). The crucible was closed with an alumina lid to limit the sulphur losses from the matte. No slag was used in this design as the slag tended to react with the alumina crucible. Alloy formation in the matte was not observed when Design 2 was used.

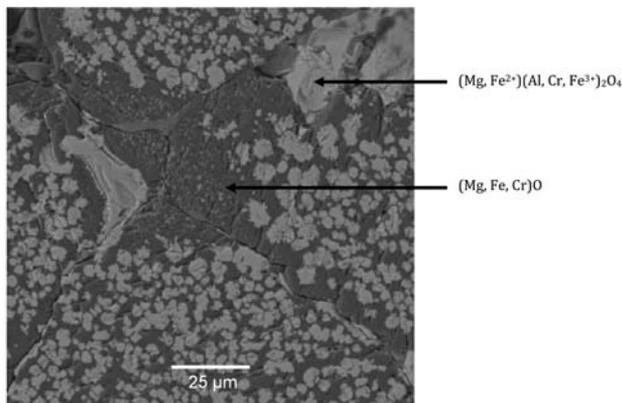
Figure 2—Backscattered electron image of the microstructure of the as-received magnesia-chrome brick

The as-supplied magnesia-chrome brick consisted of large magnesia grains (dark grey phase), which contained small amounts of iron and chrome in solid solution (Figure 2). Finely exsolved spinel crystals (light grey phase) were observed in the magnesia grains. The spinels on the grain boundaries had roughly the same composition as the spinels within the magnesia grains.

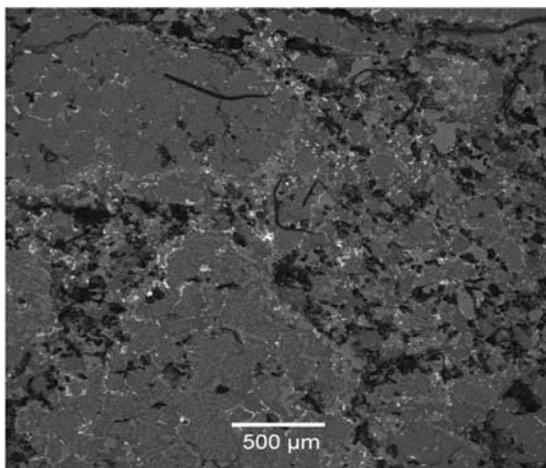
Figure 3—Backscattered electron image of matte penetration (white phase) into the magnesia-chrome crucible at 1300°C

Design 1 (magnesia-chrome crucible, filled with matte and slag) was used for tests at 1300°C and 1500°C . This design, however, resulted in the refractory soaking up all the matte, leaving no matte in the crucible for analysis. The microstructure of the magnesia-chrome brick with soaked-up matte is shown in Figures 3 and 4.

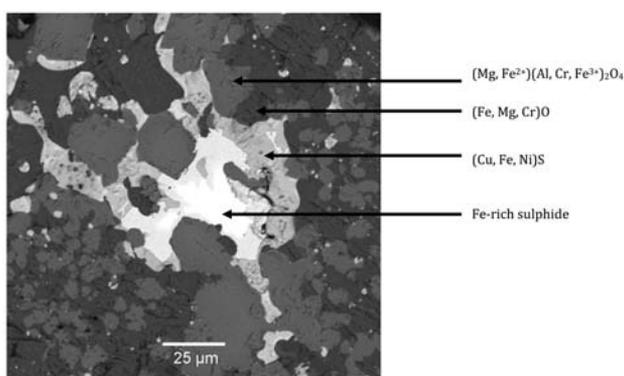
Figure 4—Backscattered electron image of matte penetration into the magnesia-chrome crucible at 1300°C (high magnification)

The white phase is a penetrated Fe-rich sulphide phase, while the very light grey phase represents a Cu-Fe-Ni-based sulphide (Figure 4). The light grey phase in Figure 4 is the typical chromite spinel that is found in the refractory, with the dark grey phase surrounding it consisting of mainly

magnesium oxide. The penetration that took place was minimal but uniform throughout the refractory. This experimental set-up presented numerous difficulties as there was no matte left for chemical analysis due to the complete penetration. This design also allowed the refractory to be in direct contact with the graphite susceptor of the induction furnace, thereby exposing it to a very reducing atmosphere. These reducing conditions resulted in the formation of an iron-nickel alloy within the refractory closest to the graphite susceptor.

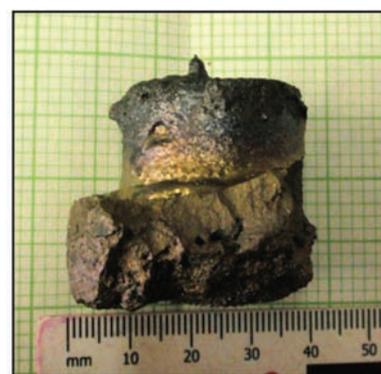
Figure 5—Refractory sample tested at 1400°C

All the examined refractory samples from Design 2 were completely penetrated by matte, similar to samples from Design 1. A penetration profile could not be distinguished as the refractory samples had a 'wicking' effect on the surrounding matte. All the samples had roughly the same outward appearance (Figure 5).

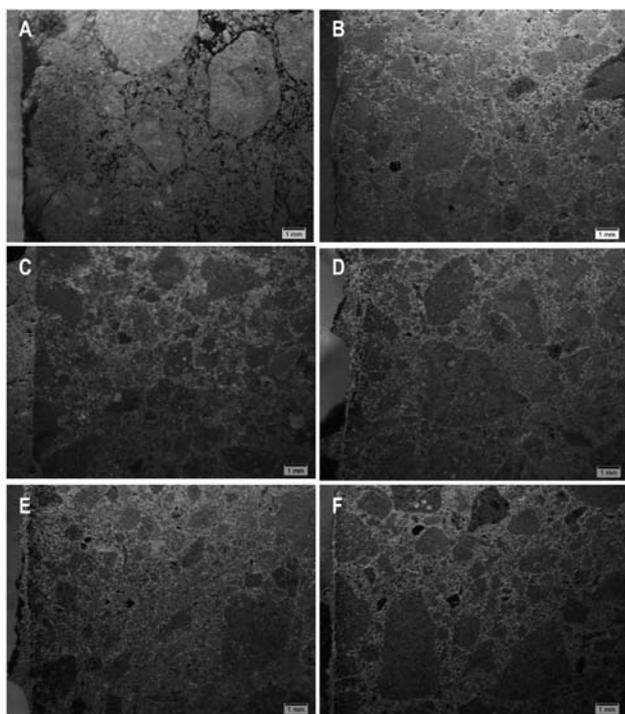
Figure 6—Reflected light micrographs of matte penetration into the magnesia-chrome refractory as a function of temperature. A: Unreacted brick, B: 1300°C, C: 1400°C, D: 1500°C, E: 1600°C, F: 1700°C)

The extent of penetration as a function of temperature can be seen in Figure 6. The porosity of the unreacted brick (A) became completely filled with matte as the refractory piece came in contact with the matte at the different temperatures. The large fused grains began disintegrating as the temperature was raised and finally the matte even penetrated into the fused grains themselves.

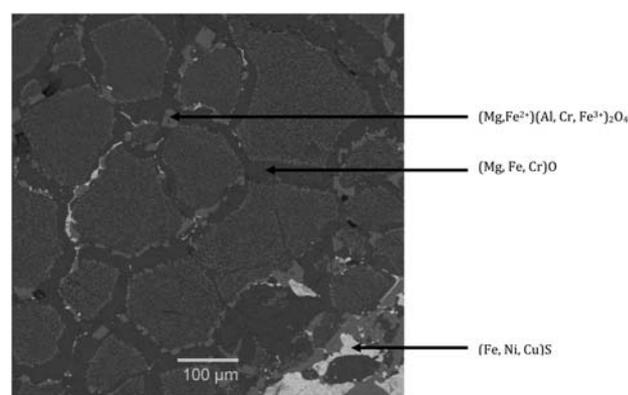
Figure 7—Backscattered electron image of the microstructure of the magnesia-chrome brick reacted at 1500°C

At 1500°C and higher, spinels migrated out of the magnesia grains and collected on the grain boundaries. This left large areas of the magnesia grains exposed as they became depleted in spinels. Furthermore, matte started to penetrate into the fused grains and disintegrated them (Figure 7). EDS analysis of this penetrating matte indicated that it locally contained up to 0.7% Cr, compared to 0.3% Cr in the bulk matte.

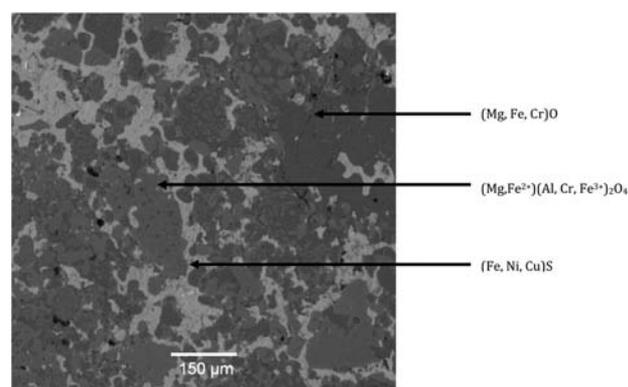
Figure 8—Backscattered electron image of the microstructure of the magnesia-chrome brick reacted at 1600°C

Disintegration of the fused grains was more pronounced in the refractory samples that were reacted at 1600°C and 1700°C (Figures 8 and 9). The spinel crystals migrated out of the magnesia grains, while the matte completely disintegrated the large fused grains. At 1600°C the penetrating matte had a Cr content of 0.5% compared to 0.3% in the bulk matte, which is not a significant increase.

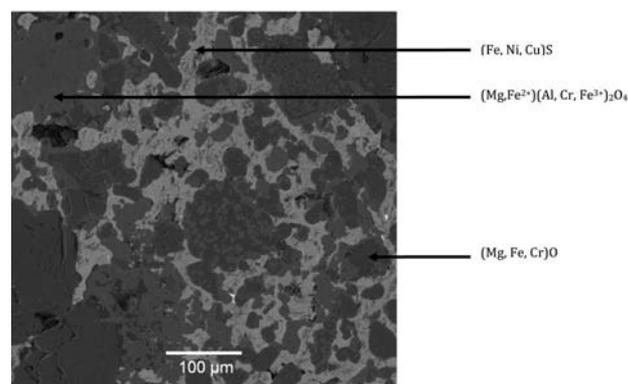
Figure 9—Backscattered electron image of the microstructure of the magnesia-chrome brick reacted at 1700°C

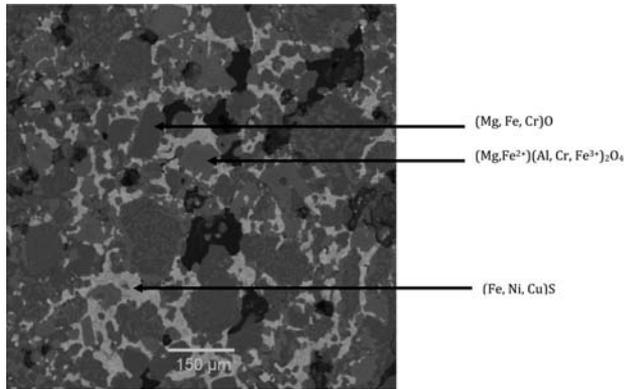
Figure 10—Backscattered electron image of the microstructure of the magnesia-chrome brick reacted at 1750°C

At 1750°C (Figure 10) the penetrating matte contained 0.8% Cr compared with a bulk matte concentration of 0.3%. A sudden increase in porosity was also observed (Figure 10), together with a large amount of sulphur gas evolution during the experiment.

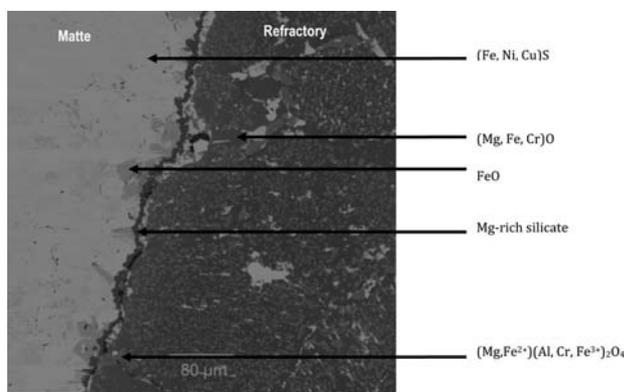
Figure 11—Backscattered electron image of the matte-refractory interface at 1500°C

At temperatures of 1500°C and higher a magnesium-rich silicate phase could be observed to form a boundary layer at the refractory-matte interface (Figures 11 to 13). This boundary phase could have been established through the predicted formation of MgO that reacted with the silica in either the matte or refractory, as both contained small amounts of silica. On either side of the boundary, FeO crystals started to form, together with spinel crystals. The stoichiometry of these crystals started to change from M_3O_4 to MO. Some large spinel crystals could also be observed at the refractory-matte interface, as well as magnesia grains with finely dispersed exsolved spinel crystals.

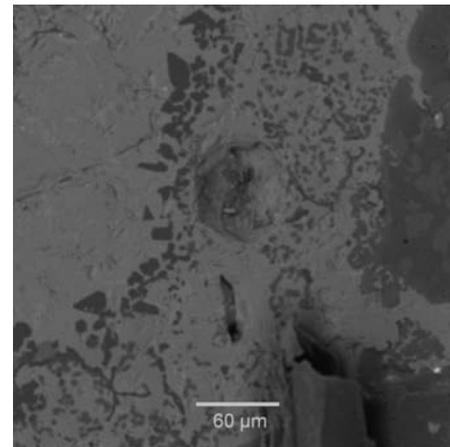
Figure 12—Backscattered electron image of the matte-refractory interface at 1600°C (dark grey phase in the light grey matte is Mg-rich silicate crystals)

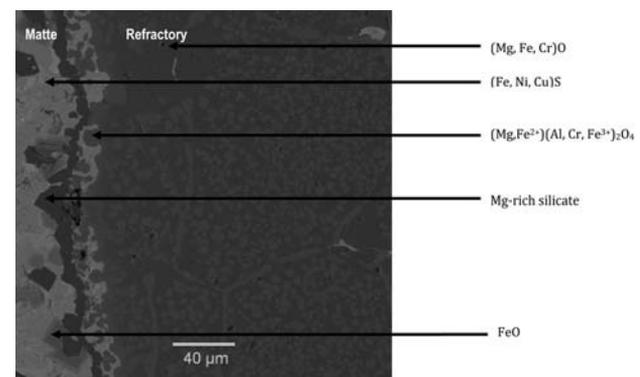
Figure 13—Backscattered electron image of the matte-refractory interface at 1700°C

At temperatures of 1700°C and 1750°C more FeO crystals started to form at the interface, and the stoichiometry of the magnesium-rich silicate phase was calculated to be $(Mg, Fe)_2SiO_4$ (Figures 13 and 14). The extent of spinel segregation out of the magnesia grains close to the interface was also higher at these temperatures. At 1750°C the spinels were completely removed from the fused magnesia grains close to the refractory-matte interface (Figure 14).

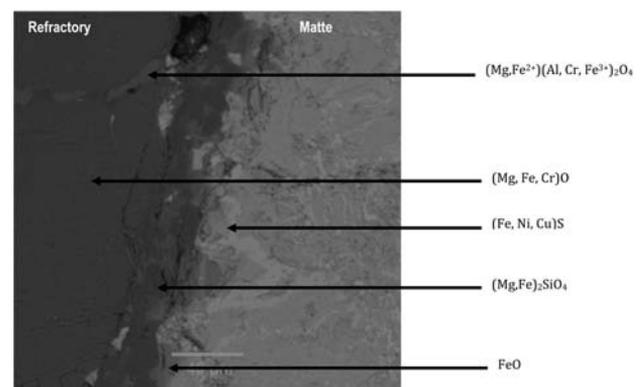
Figure 14—Backscattered electron image of the matte-refractory interface at 1750°C
