Avoiding structural failures on mobile bulk materials handling equipment

by M.J. Schmidt* and B.W.J. van Rensburg†

Synopsis

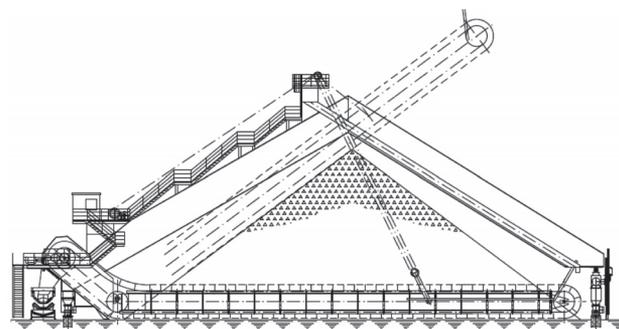
Prior to failure, the machine had been in production use for several months, although commissioning of the collision protection system had not been completed. The general arrangement of a typical portal reclaimer is shown in Figure 1.

Figure 1—Typical arrangement of a portal reclaimer

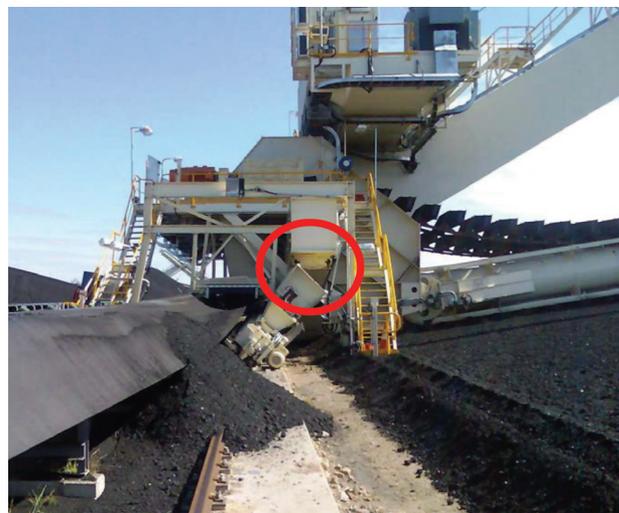
At the time of the collapse, the designed reclamation rate was exceeded by approximately 30%. The stockpile proximity probes appeared to not be working, resulting in unexpectedly high digging forces which led to the failure of major structural connections as shown in Figure 2.

Figure 2—Failure of the bogie on a portal reclaimer

The lateral resistance of the machine was insufficient to withstand the forces generated within the structure when excessive digging was experienced. Proximity probes, detecting the stockpile height, are fitted to ensure that the digging depth of rake buckets is maintained within the prescribed limits. These devices did not function properly or had not yet been commissioned, so were switched off, resulting in excessive digging forces (Anon., 2007; Krige, 2012).

Electric drive motors are equipped with protection relays to limit the electrical current that can be drawn during operation, *i.e.* the applied system torque can be limited. Industry practice suggests that the overload protection is set to a value of 5–10% above the peak system design load (Bateman, 2013). The protection study report, compiled subsequent to the failure, indicated that the motor protection relay setting on the reclamation drives was at a default value of 2 instead of 1.05 (Anon., 2007). Furthermore, the mechanical design for the scraper drive system dictated an installed motor power requirement of 154 kW, which implies that the next size up of 160 kW was specified. During procurement, 185 kW motors were supplied due to the unavailability of the 160 kW motors. This decision was made without consultation with the relevant design engineers.

Upon investigation, it was also found that the fluid couplings installed between the drive motors and reducers were rated at service factors such that a reclamation drive torque could be delivered that was only marginally below the maximum electric motor torque. Torque transfer through fluid couplings can be limited according to the design requirement by reducing the percentage oil fill, which is normal practice. The commissioning data revealed that the fluid coupling was overfilled by approximately 15%. Small amounts of oil at high percentage fill levels will lead to a significant increase in torque transfer capacity (Anon., 2007).

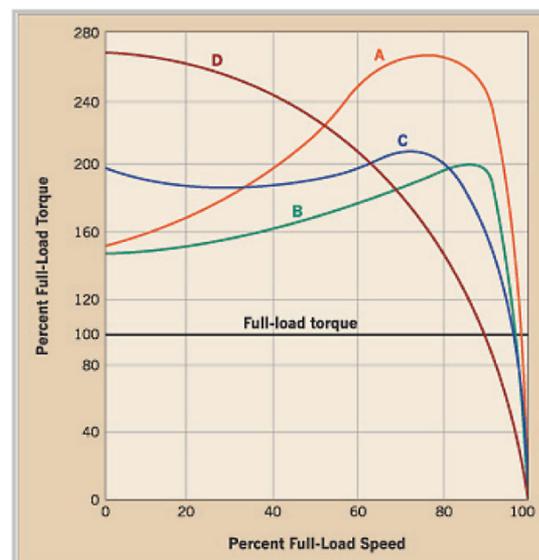
The machine could not withstand the motor starting torque as prescribed for the abnormal digging resistance criteria as outlined in ISO 5049-1 (1994). Depending on start-up torque control, the motor torque during start-up could exceed twice the operating torque on the motor, depending on the motor type selection, as shown in Figure 3. (Curves B and C represent a typical conveyor drive selection).

Figure 3—Characteristic start-up curves for different electrical motors (Baldor, 2004)

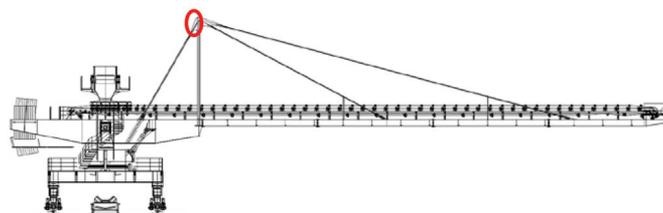
year before collapsing completely. An incident in which the boom conveyor belt was overloaded preceded the failure event. The failure of a critical tie-beam connection, which is highlighted in Figure 4, initiated the collapse of the boom and ultimately ruined the entire machine.

Figure 4—General arrangement of slewing stacker. Critical connection highlighted

Loading conditions were underestimated because an incorrect material bulk density was used in the design. The incorrect commissioning of the speed switch settings associated with the boom belt contributed to the structural overloading of critical tie-beam connections when slippage of the boom belt occurred.

Based on the design requirements of ISO 5049-1 (1994), critical tie-beam connections were overloaded, although the ultimate carrying capacity exceeded the most severe design load combination. The design of these connections is therefore considered to be marginal. The tie-beam connections utilized bolts in double shear in such a way that fastener threads intercepted a shear plane. Furthermore, high-strength electro-galvanized fasteners, which are susceptible to hydrogen embrittlement (Erling, 2009), were used in this critical tie-beam connection. The topic of corrosion and embrittlement is discussed at length in the American Institute of Steel Construction (AISC) Guide to design criteria for bolted and riveted joints (Kulak *et al.*,

1987). From laboratory tests referenced, Kulak *et al.* note ‘... it became apparent that the higher the strength of the steel, the more sensitive the material becomes to both stress corrosion and hydrogen stress cracking. The study indicated a high susceptibility of galvanized A490 bolts to hydrogen stress cracking.’ It is ultimately concluded that ‘galvanized A490 bolts should not be used in structures. The tests did indicate that black A490 bolts can be used without problems from brittle failures in most environments.’ (A490 bolts are the direct equivalent of the Class 10.9 bolts used in South Africa). High hydrogen contents were confirmed by the metallurgical examination of the fasteners, while surface cracks were noted at the thread roots of some specimens. Through the application of fracture mechanics, it can be demonstrated that the load carrying capacity of the tie-beam connection fasteners may have been reduced by hydrogen effects to a value far below what would be required to sustain a boom load associated with the luffing operation of an overloaded stacker boom (Schmidt, 2014).

Design deficiencies contributed to a marginal design of critical connections, which was further exacerbated by defective bolts, adversely affecting the carrying capacity. The absence, malfunctioning, and incorrect commissioning of machine protection systems allowed an overload condition to develop, which led to the catastrophic collapse of the stacker.

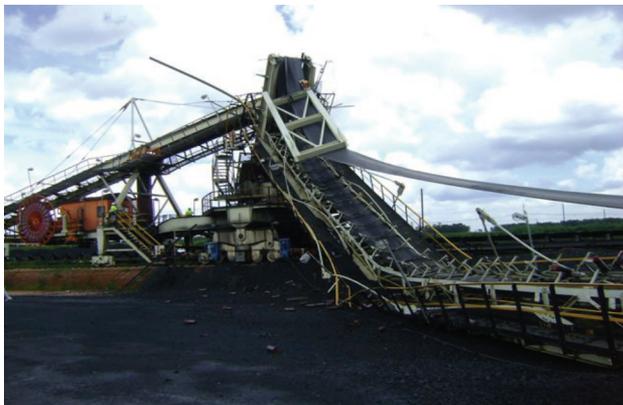
The extent of the damage can be seen in Figure 5.

Figure 5—Collapsed stacker

Supervisory control and data acquisition (SCADA) recordings revealed that the boom loading significantly exceeded the intended design parameters prior to the collapse. The alarm set-point to alert a boom overload condition was specified at a level that was too high to prevent structural overload. The machine could therefore be exposed to severe loading conditions without any operator abuse. The probability that operator abuse contributed to the failure could not, however, be ruled out altogether.

The protection systems on the machine were found to be inadequate to ensure that structural loading remained within the intended design parameters. At the time of the collapse, the machine had not been formally handed over to the operations team.

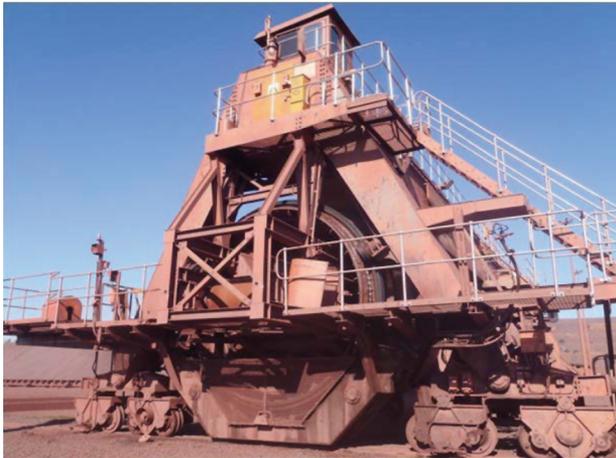
The overall machine control system was originally configured without interlocks between the independent long travel drive systems located on adjacent bogie wheel sets. When the control system for the drives at the one end malfunctioned, the drives on the opposite end continued with the long travelling sequence until the drives tripped on overload as a consequence of the skewing of the machine. Severe local damage and permanent deformation were caused to the boxed plate structural section of the fixed legs. The machine, as shown in Figure 7, had been in service for decades.

Figure 7—Side elevation of drum reclaimer

Skew control can be achieved by comparing signals from incremental encoders on both sides of the machine (McTurk, 1995). Skew should occur only if one side of the machine cannot travel for accidental reasons, *e.g.* an obstacle on the rails, and if this happens a signal must trigger the immediate shutdown of the machine. The control systems associated with the long travel of the machine were not fail-safe. Abnormal loads, not anticipated in the original structural design, were subsequently exerted on major structural members. The equipment was nevertheless operated successfully for many years prior to the skewing incident. Insufficient design integration existed between the OEM’s structural, mechanical, electrical, and control and instrumentation engineering disciplines during the detail design phase of the original project. The damage could have been avoided by the incorporation of additional protection instrumentation for negligible additional capital cost.

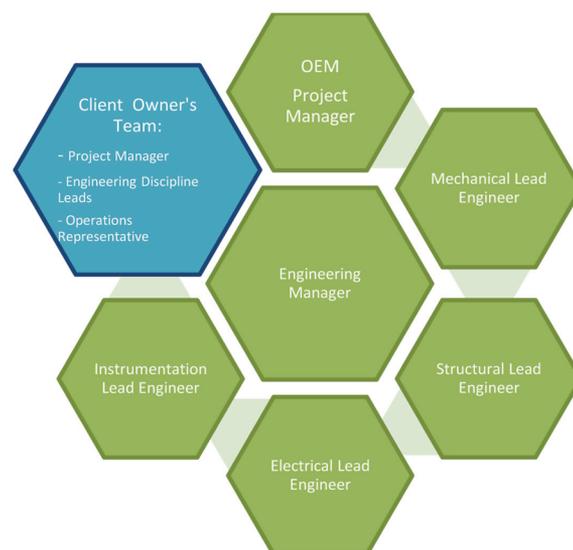
A typical integrated design team organization structure that is conducive to a high level of design integration with a systems design approach is depicted in Figure 8. The

following aspects characterize such a team structure:

- Within the OEM's design team organizational structure, there is a free flow of information *directly related to design interfaces* between engineering disciplines *without interference in discipline-specific matters*

- Design interfaces are approached as an *integrated system* with input from relevant role-players as a team effort across engineering disciplines
- The respective engineering disciplines have a sound understanding of how equipment selection and systems dictated by engineering counterparts influence their individual designs

- The client owner's team participates in the design scope definition and design risk assessment with specific reference to machine protection and controls. Engineering input, oversight, liaison, and progressive review are provided by relevant representation from the client

- Specific design requirements are agreed between the OEM and client owner's team within the agreed contractual arrangement
- There is a free flow of information between the discipline-specific engineers from the owner's team and their OEM counterparts responsible for the design, without compromising the latter party's intellectual property rights.

Figure 8 – Ideal design team organisational structure for facilitating design integration

A design team organization structure is proposed to facilitate an integrated systems design approach.
