Investigation of the 'tiger skin' defect on indefinite chill rolls

Synopsis

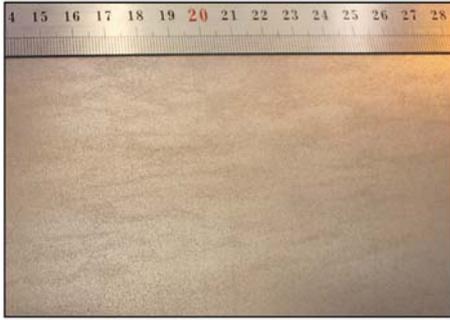
Figure 1—Visual appearance of the tiger skin (TS) surface defect on an IC work roll

TS appears only within the roll area that is in contact with the strip during rolling. The surface can be ground to remove the TS, but the defect commonly reappears when the roll resumes service. If TS is detected on a roll, a sufficient amount of shell material will be removed (based on recommendations from the roll supplier), reducing the roll diameter. The roll will then be returned to service and monitored closely to detect whether the defect reappears. If the defect has not been eliminated, the procedure is repeated until the defect is no longer present. The lost roll material results in loss of production and operational expenses for the mill (Columbus Stainless Steel, 2009). It has been postulated that TS may be related to a variation in graphite distribution over the roll surface. The general assumption was that TS must be roll-related, given the characteristics of occurrence, with the mill type and conditions also contributing to the prevalence (Columbus Stainless Steel, 2009; vander Voort, 1999).

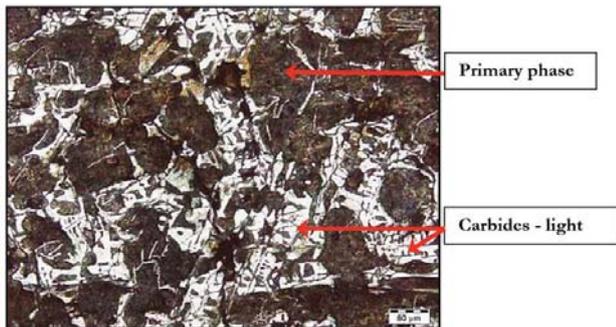
Figure 2—Micrograph showing the carbide (light) and primary phase (dark) on the working surface of a roll from service containing the TS defect

Visual examination showed that the TS defect could be clearly identified as a pattern of alternating lighter and darker shaded areas on the working surface. The difference in surface appearance could not be properly photographed, as none of the macro etchants highlighted the TS defect. Optical microscopy of the cleaned surfaces also showed no significant variation of microstructural features (carbide exposure, carbide distribution *etc.*) on the working surface related to the TS appearance, as shown in Figure 2. The average height difference between the protruding carbides and the depressed primary phase was not consistently higher or lower when comparing the light and dark TS areas, as shown in Table I.

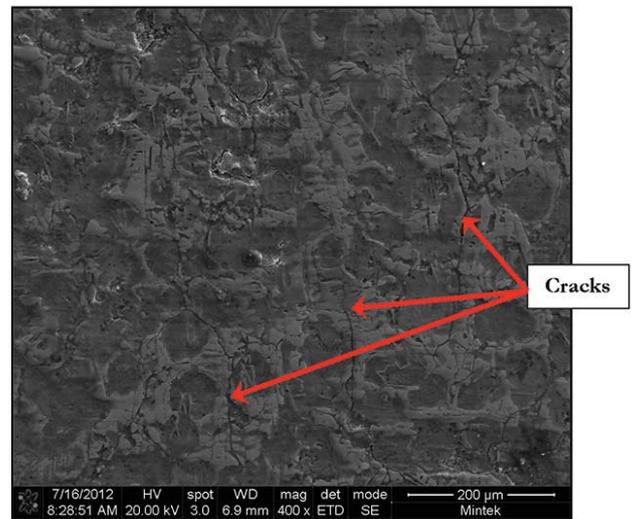
SEM analysis showed widespread cracking of the roll surface which appeared to propagate through the carbide networks, as indicated in Figure 3. The carbides appeared to have been crushed during rolling, as indicated by smaller cracks that were limited to the carbides (Figure 4). However, the cracking did not appear to be related to TS, as the cracking was uniform across both the light and dark areas of all the samples. Oxide was observed on the primary phase, which is expected for a roll taken from service.

Figure 3—Secondary SEM image of the surface of a roll from service containing the TS defect, showing cracking along the carbide networks

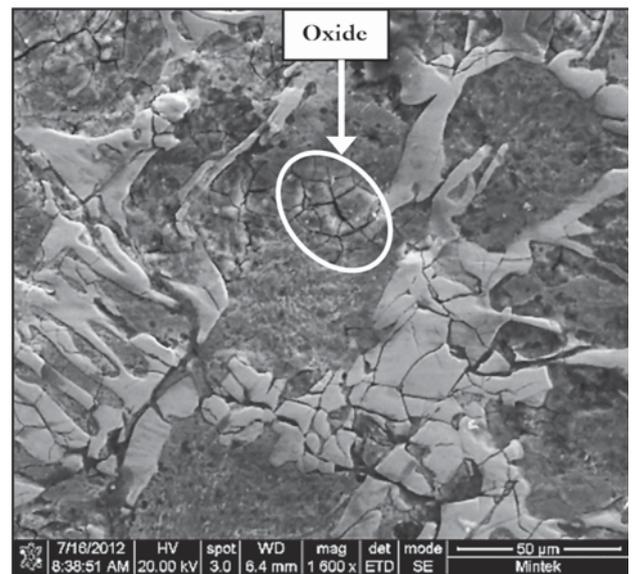
Figure 4—SEM image showing cracking of the carbides and oxide at the primary phase regions on the surface of a roll from service containing the TS defect

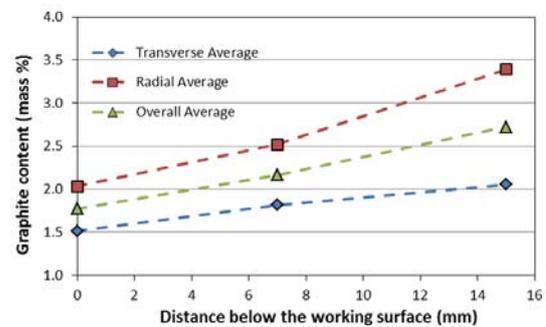
Variation in the measured graphite content was observed between the transverse and radial sections of all the samples. The average graphite content showed a consistent increase with increase in depth below the surface, as shown in Figure 6. The increase in graphite content was probably due to the slower cooling rate associated with greater depths below the surface during solidification.

Figure 6—Variation in graphite content over the shell depth

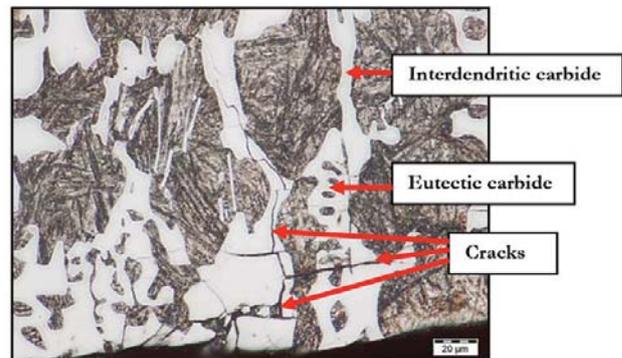
The general microstructures of all the samples were similar, consisting of free graphite and primary carbide networks within a martensitic primary phase. The primary carbide was found as interdendritic and eutectic structures, with the interdendritic being the most abundant. The arrangement of the two carbide structures did not correspond to the TS pattern. Figure 7 shows that the surface cracks propagated predominantly through the carbides, confirming the crushing of carbides identified during SEM analysis. The cracks were mostly limited to a depth of 100 µm below the surface.

Figure 7—Micrograph showing the cracks extending along the carbides at the working surface

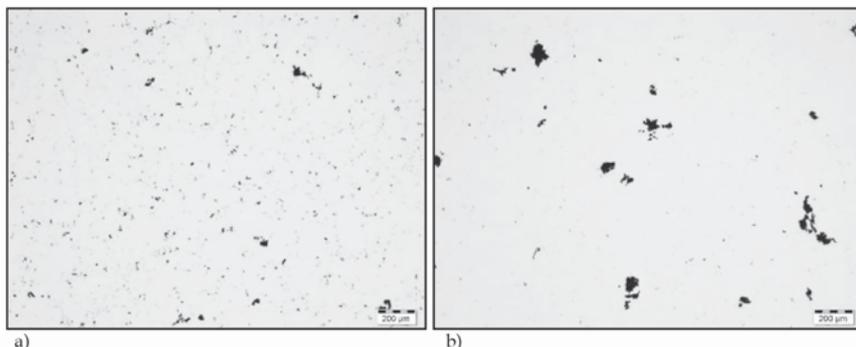
The polished sections showed coarse graphite with a uniform distribution and morphology on both the transverse and radial sections of most samples. The only exception was on one of the radial TS samples, where a variation between regions of predominantly fine, well-distributed graphite (Figure 5a) and coarse graphite particles (Figure 5b) was seen. These variations could influence the lubrication effect of the graphite during rolling, leading to variations in friction coefficient and slippage resistance across the roll and thereby cause a surface effect such as TS (Mees, 2002). Unfortunately, as the working surface had already been ground off on the as-received material, it could not be confirmed if the variation in graphite distribution correlated with the TS surface pattern.

Figure 5—Micrograph of a radial sample in the polished condition, showing (a) finely distributed graphite and (b) coarse graphite

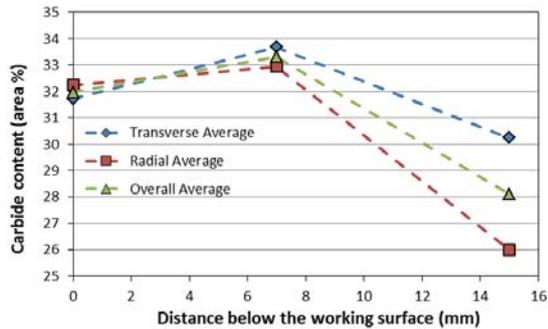
The Nital-etched samples were used to determine the carbide area fraction. The amount of carbide was slightly higher at a depth of 7 mm and lower at a depth of 15 mm than at the surface (Figure 8). The carbide contents of the light and dark areas of the TS were found to be similar.

Figure 8—Variation in carbide amount (area percent) with shell depth from the surface

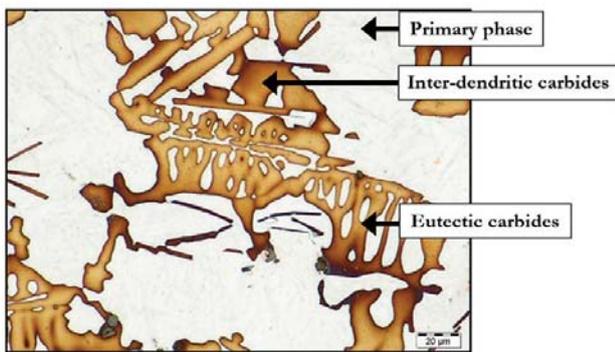
Only two etchants from the range tested were able to distinguish the carbides. The 10% APS etchant outlined the carbides, while the alkaline sodium picrate (ASP) etchant outlined and coloured the carbides, as shown in Figure 9. The combination of the etch response confirms that the carbides are of the M₃C type (vander Voort, 1999). The samples showed a uniform carbide type at the three depths examined

Figure 9—Micrograph of the surface sample etched with ASP

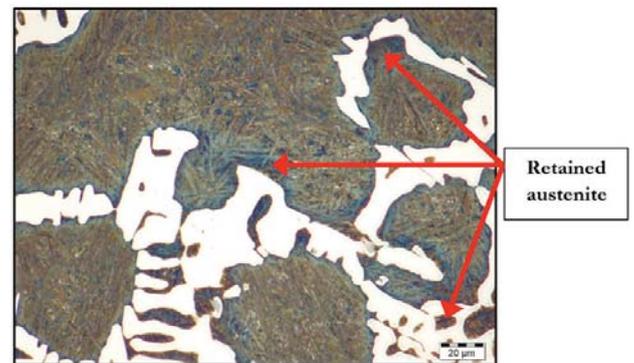
Beraha’s sulfamic acid solution tinted traces of RA blue in all of the samples. However, the etchant did not show sufficient contrast between the RA and the martensite to enable accurate quantification. The RA appeared to be concentrated around the carbide networks, especially the eutectic carbides (Figure 10). There was no noticeable variation in the amount of RA between the light and dark TS areas, but quantification could not be performed to confirm the observation. In general, RA is identified only when it is in excess of approximately 10–15%, suggesting that the samples may all contain more than 10% RA (vander Voort 2009). However, it must be noted that the 10–15% RA observation was made on wrought tool steels, which have significantly more homogeneous structures than white cast iron (WCI). The more segregated and inhomogeneous cast structure of the IC rolls could lead to high local amounts of RA, despite bulk RA amounts significantly lower than 10%.

Figure 10—Micrograph of sample etched with Beraha’s sulfamic acid etchant, showing RA (blue) adjacent to the carbide networks

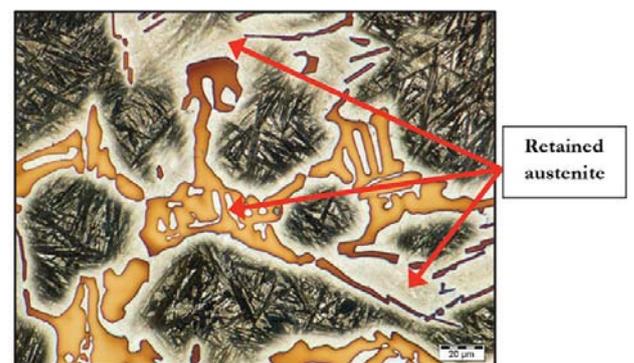
The sodium metabisulphite tint etch also confirmed the presence of RA associated with the carbide networks (Figure 11). The etchant appeared to show larger percentages of RA than Beraha’s sulfamic acid etchant. The difference in etch response suggests that SMB may be more sensitive to RA than Beraha’s sulfamic acid etchant and could reveal RA at smaller amounts. There appeared to be no difference in the amount of RA between the light and dark areas of the TS, similar to the response with the Beraha’s sulfamic acid etchant. However, there was insufficient contrast between the

Figure 11—Micrograph of sample etched with SMB and ASP, showing RA (light) adjacent to the carbide networks

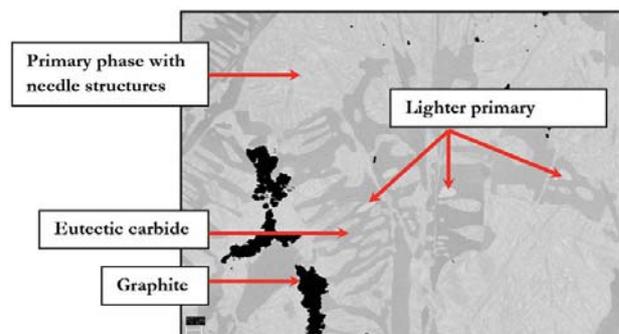
The SEM backscattered electron (BSE) images showed no clear distinction between the light and dark TS regions. However, in BSE mode the primary phase regions in the eutectic which were completely isolated by the eutectic carbides were a slightly lighter shade of grey compared to the darker grey remainder of the primary phase, as highlighted in Figure 12. These were the same areas identified by optical microscopy as being rich in austenite and this confirms the association of the eutectic carbides with the retained austenite. The shading variation suggests that there could be a slight compositional variation between these regions. The primary phase also showed needle-like phases, which are probably martensite and austenite, as identified during optical microscopy. The variation was found on all the samples analysed. The results from the EDS analysis showed no measurable variation in chemical composition of the primary phase between the light and dark areas of the TS. There was no measurable variation in chemical composition of the primary phase between the surface and 7 mm below the surface. There was also no measurable variation in chemical composition of the carbides or the primary phase between the light TS area, dark TS area, surface and 7 mm below the surface.

Figure 12—SEM-BSE image at 7 mm below the surface, showing lighter primary phase regions isolated by carbides

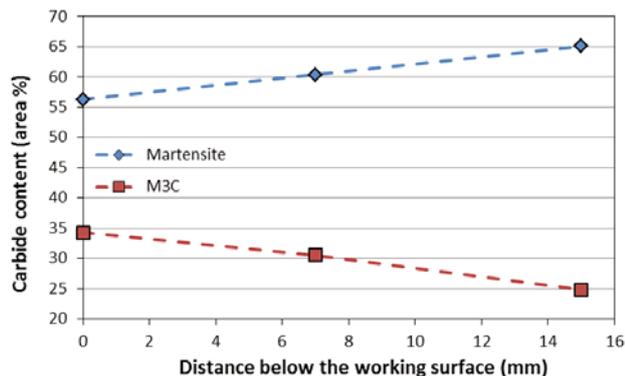
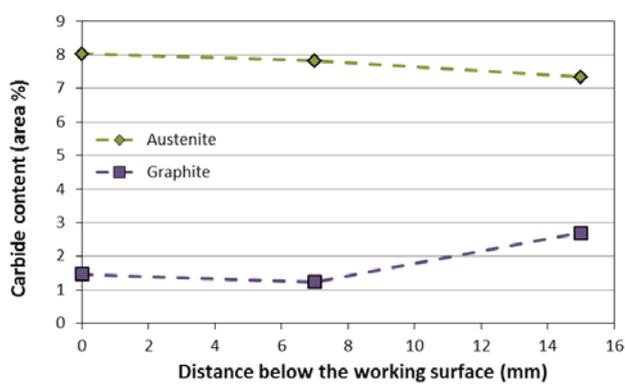
Figure 13—Variation in martensite and carbide content over the shell depth

Figure 14—Variation in austenite and graphite amounts with shell depth

It was generally found that the martensite and graphite content increased with depth below the surface, while the carbide content decreased (Figures 13 and 14). There was no significant variation in the amount of retained austenite from the surface to 15 mm below the surface.
