# Mining with crush pillars

by M. du Plessis\* and D.F. Malan†

## Synopsis

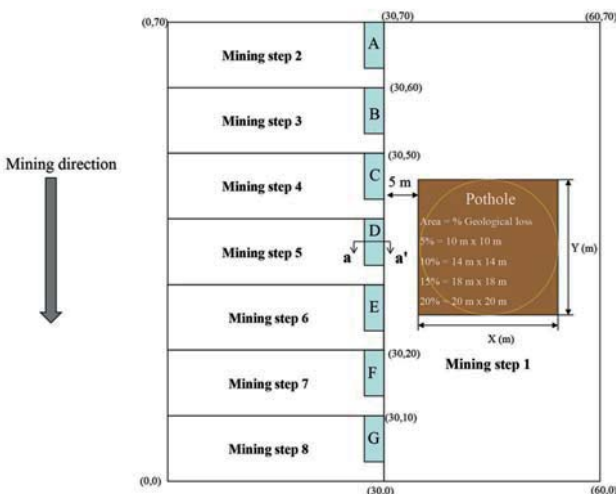
Figure 2—Idealized crush pillar layout used to simulate the effect of unmined ground adjacent to a pillar on pillar crushing

To quantify the effect of a pothole adjacent to a line of crush pillars, an idealized crush pillar layout (Figure 2) was simulated. The layout consists of a 30 m × 70 m stope panel with a second panel being mined in a sequential fashion adjacent to this first panel. The layout was simulated as eight mining steps with seven crush pillars being formed during this process. The unmined block was simulated as a square block, the dimensions of which [(x m) × (y m)] were selected to simulate the percentage reef locked up in the area defining mining step 1 [e.g. pothole area (10 m × 10 m)/(30 m × 70 m) ≈ 5%]. For the second panel, the size of each mining step was 10 m and the sizes of the crush pillars were 4 m × 6 m. A 2 m mining height was used (w:h = 2:1). The element sizes were 0.5 m.

The parameters used for the simulations were as follows: Young's modulus 70 GPa, Poisson's ratio 0.25, contact friction angle 35°, intact and residual material strength 5 MPa, mining depth 600 metres below surface (mbs), and reef dip 0°. These values were chosen arbitrarily. The intent was to establish trends regarding the pillar behaviour, even though the parameters selected may not fully represent the underground environment. A sensitivity analyses was conducted to determine the effect of each input parameter on the behaviour of the model and simulated pillars in the layout. The results indicated that the choice of parameters produced qualitative agreement with observed crush pillar behaviour and historical underground measurements.

To investigate the impact of a lagging siding on crush pillar behaviour, the simulated mining sequence of the layout in Figure 2 was adjusted. The mining loss indicated in step 1 was excluded. A 2 m wide siding was added to the layout by initially simulating the pillars as being 6 m wide ( $w:h = 3$ ). The siding was then mined by simulating the additional 2 m portion of pillar as being mined. The length of the oversized pillar resulting from a lagging siding was controlled by the delayed mining of the pillar holings. Initially a 6 m wide by 20 m long pillar was formed. The siding was mined, reducing the pillar width (at the pillar position) to 4 m ( $w:h = 2:1$ ). The final pillar (2 m  $\times$  4 m) was created only when the pillar holing was developed. This took place when the pillar was 20 m in the back area.

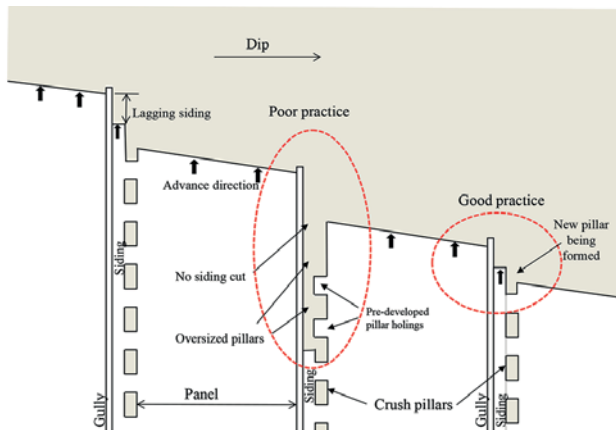
Figure 4—The impact of a large lagging siding on crush pillar formation (plan view). If pillar holings are not pre-developed the problem will be exacerbated

In some cases, sidings lag the face by 20–30 m and are then developed as a single mining face. A lagging siding will impact the width of the pillar being formed at the mining face (Figure 4). Until now, the impact of a lagging siding on the pillar width has not been identified as a contributor to undesired pillar behaviour, or a source of pillar seismicity.

Once the siding of an advancing panel lags behind the adjacent lagging panel face, oversized pillars are created. The pillars will be reduced in size to the required dimension only when the siding is blasted. At this point the pillar might not be able to crush sufficiently, as it is already in the back area of the stope.

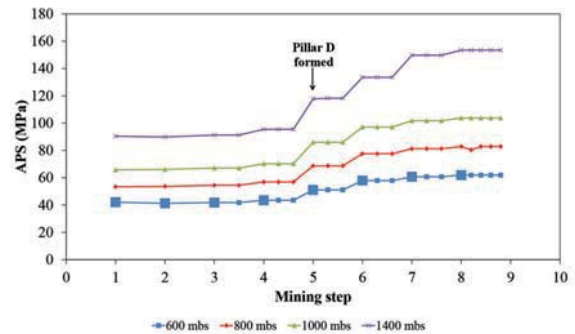
Figure 5—The effect of a lagging siding on crush pillar behaviour (pillar D, Figure 2) at various depths ( $w:h = 2$ ). Note that the pillar does not crush and shed load. Crushing and load shedding of a correctly mined crush pillar is shown in du Plessis and Malan (2014)

The layout was simulated at various depths as shown in Figure 5. All the results presented are for pillar D. Mining depth does not appear to have any impact on the overall behaviour of the pillar (although the pillar is subjected to a higher stress level). These findings illustrate how important it is to achieve pillar crushing while the pillar is close to, or is being formed at, the mining face. The results in Figure 5 can be compared to results presented by du Plessis and Malan (2014), where pillar crushing causes load shedding if the pillars are cut to the correct width.

The results indicate that a lagging siding could impact on pillar crushing. These pillars could therefore become sources of seismicity when located in the back area of a stope.

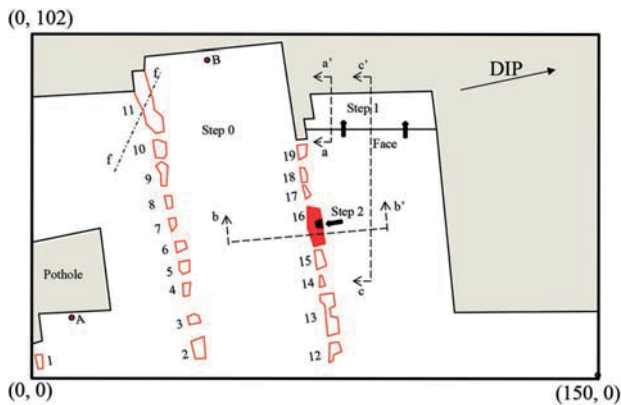
Figure 6—Plan view indicating the simplified pillar layout and mining configuration of the area where the site visit was conducted

As can be seen in Figure 6, actual pillar dimensions varied greatly as a result of poor mining practice. Pillar 19 is approximately the correct dimension (2.5 m  $\times$  3.8 m). Of the pillars cut, 63% had a width to height ratio greater than 2 and only four of the pillar holings were less than 2 m wide. The practice underground is to mine the pillar holings in an up dip direction. The panel siding lag was kept at the 4 m standard. Accurate mining of the lagging panel was required to ensure that the pillars were cut to the correct dimension (pillar width). This was not done. The holings were also not always mined as required, impacting on the pillar length. This resulted in several significantly oversized pillars. Pillars 13 and 16 are examples of this. Pillars 17 and 18 were only split when the pillars were located some distance from the face. Pillars 13 and 16 are further examples of this bad practice. As a result, pillar 16 experienced a magnitude ML 1.9 seismic event. At the time of the event, the pillar holing indicated by the black square (step 2) and the holing between pillars 16 and 17 were being mined. Pillar 16, at this point was approximately 25–30 m in the back area.

- ▶ The edge of the pothole was severely fractured due to the abutment stress (point A in Figure 6).
- ▶ Similarly, the face abutment at point B was also severely fractured. This face was left unblasted for approximately 5 months to rectify the lead-lag sequence.

The layout for the underground investigation site (Figure 6) was approximated using straight line polygons to enable the area to be easily discretised using triangular elements. The mining steps considered were:

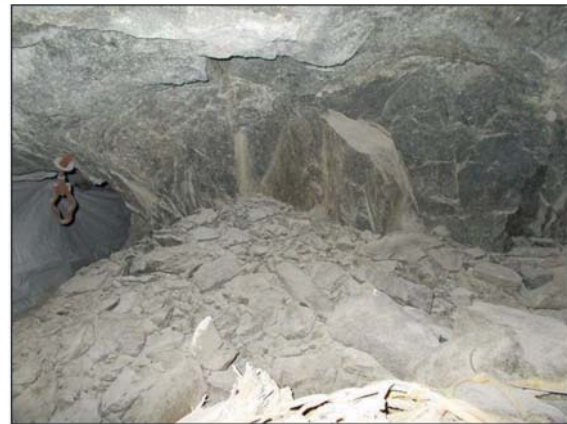
Figure 7—Condition of pillar 1. The pillar was situated adjacent to a pothole, which prevented the pillar from crushing

- ▶ Pillar 1, although adequately sized to ensure crushing (2 m × 4 m), was in an uncrushed state as a result of its proximity to the pothole (Figure 7).

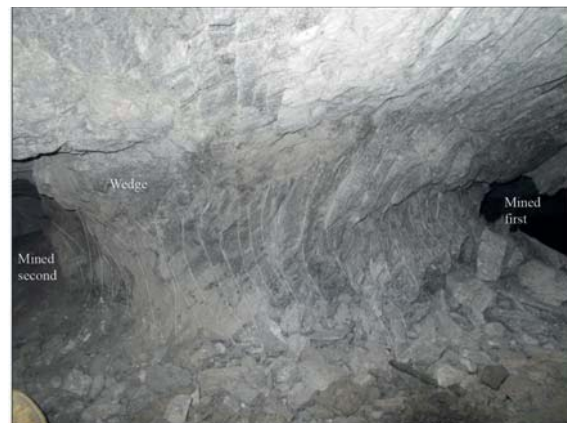
Figure 8—Fracture pattern along the width of failed crush pillar 19

- ▶ Pillar 19, a newly cut pillar, was in a fractured state (Figure 8). The pillar displayed the same fracture profile as described by du Plessis and Malan (2016). As can be seen from the figure, the majority of the fractures propagated towards the side of the pillar which was exposed first. The side of the pillar exposed by the lagging face displayed little to no fracturing. Once the pillar is completely formed and the face advances, the fractures continue to dilate. Where fractures intersect at approximately the centre of the pillar, a wedge-like structure is formed.

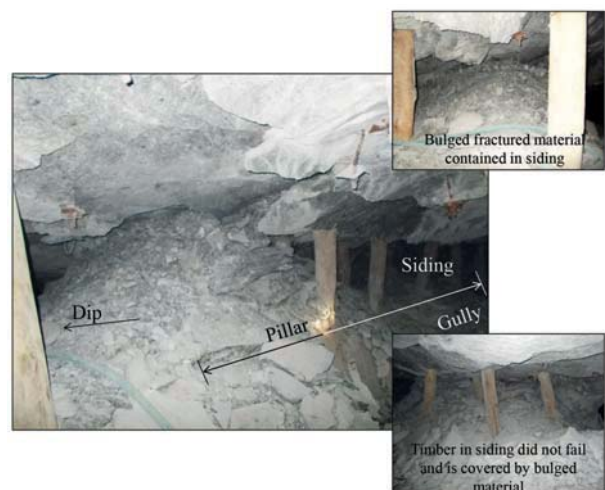
Figure 9—Photograph of the updip side of pillar 16. Note that the elongates did not fail and they are partially covered by the fractured pillar material

- ▶ Pillar 16 was, at the time of the investigation, in a completely fractured state. This was most likely a result of the seismic event. The updip side of the pillar bulged as the fractured material was pushed out (Figure 9). The downdip side of the pillar showed signs of ejected material scattered into the panel below. The footwall experienced heave and the timber support in the panel below the pillar was damaged as a result of the event (Figure 10).

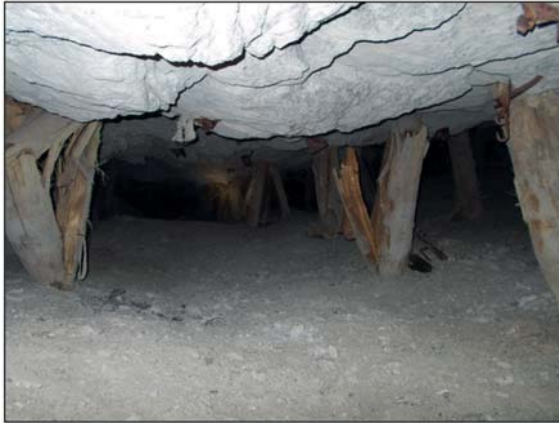
Figure 10—Photograph of the panel along the down-dip side of pillar 16. The elongates were damaged during the seismic event. There were also signs of footwall heave

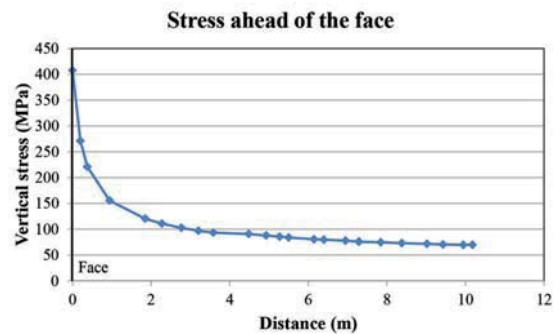
Figure 11—High abutment stress ahead of the mining face. Refer to section a-a' in Figure 6

- The pothole adjacent to pillar 1 prevented the pillar from crushing.
- High stresses were present along the solid abutments (Figure 11). This explains the significant scaling observed along the pothole edge and stopped panel face.

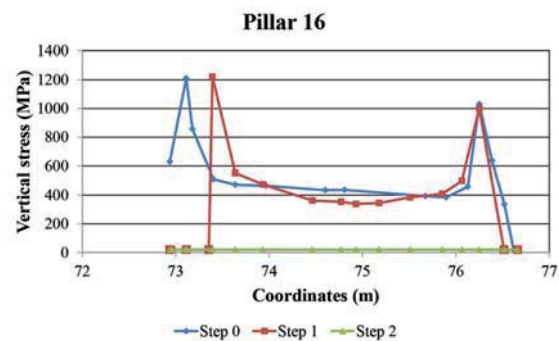
Figure 12—Vertical stress profile through pillar 16. Refer to section b-b' in Figure 6

- The oversized pillars (11, 13, 16) were intact (*e.g.* Figure 12). Pillar 16 only fails in step 2 when the pillar is partially mined by the slot defining the pillar holing.

The vertical stress across pillar 16 (section b-b' in Figure 6) indicated that the pillar had high stress levels on the edge and an intact core. Mining of step 1 caused some additional damage to the pillar edge, as can be seen in Figure 12. The outer 0.5 m of specifically the updip side of the pillar (initially exposed side) assumes a residual state. As the outer edges of the pillar fail, the high edge stresses are transferred towards the core of the pillar. Once the slot along the planned pillar holing is mined (step 2), the pillar fails completely and enters a residual state.

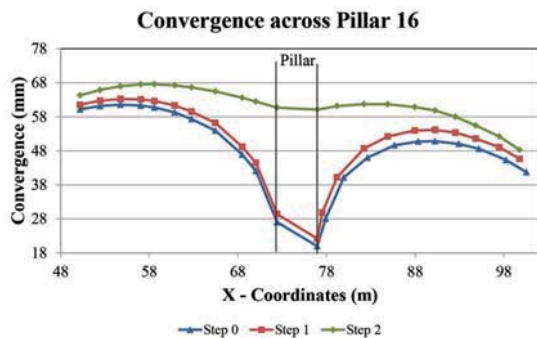
Figure 13—Convergence simulated across pillar 16. Refer to section b-b' in Figure 6

A convergence profile across section b-b' is shown in Figure 13. A significant change in convergence is experienced across the pillar when the pillar fails (approx. 40 mm). Another convergence profile was constructed along section c-c', extending from the face position (including step 1) to 50 m in the back area of the mined-out panel, to also include the effect of pillar 16. The results show that the intact pillar has a significant impact on the convergence experienced in the panel in proximity to the pillar 16 position. Once the pillar fails, the convergence increases (step 2). However, there were other oversized intact pillars in the back area (*i.e.* pillar 13). As a result, a certain amount of convergence is prevented by the intact pillar. The system (pillar and rock mass) is therefore not at a state of equilibrium, and this can potentially result in violent pillar behaviour.

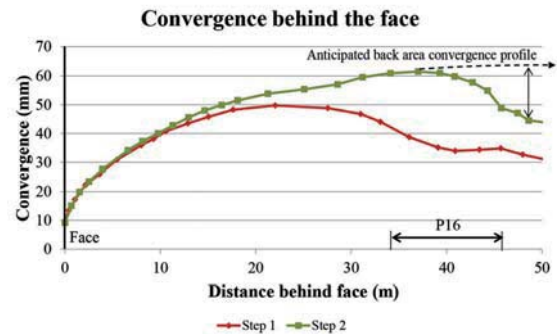
Figure 14—Convergence profile along the mined panel down-dip of pillar 16 (section c-c' in Figure 6). Notice the impact of the oversized intact pillars (13 and 16) in the back area
