Mechanical properties and damage mode of cemented tailings backfill in an acidic environment

Journal of the Southern African Institute of Mining and Metallurgy, vol. 121, no. 6, pp. 317–324.

The properties and deterioration in strength of cemented tailings backfill (CTB) in the underground acidic environment under oxidizing conditions were studied. X-ray diffraction analysis and scanning electron microscopy of the surface of the CTB was carried out, and the sulphuric acid corrosion mechanism elucidated. The properties tested included compressive strength, elastic modulus, cohesion, internal friction angle, variation in the hydrogen ion concentration, and stress-strain relationship in different corrosion periods. The damage model of the CTB was established considering the effects of parameters such as corrosion time and strain on the damage evolution. It was found that the compressive strength, elastic modulus, cohesion (binder effect), and internal friction angle increased at first and then decreased with exposure time. In the long term, the peak stress decreased with corrosion time while the peak strain increased; elastic modulus, and deformation modulus also decreased. The dama

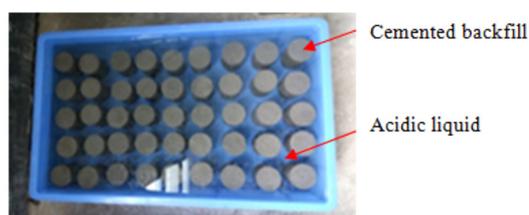
Figure 1—Container for soaking CTB samples

The reagent used in the experiment was 98% concentrated sulphuric acid, and the water was from the laboratory of Jiangxi University of Science and Technology. First, a certain amount of water was filled into a plastic bucket. To ensure that the amount of water was constant in every test, the water level was marked on the bucket. The volume of water in the bucket was chosen so that the solution level in every test was 2 cm above the CTB surface. Then the pH meter probe, calibrated using pH buffer solutions, was inserted into the water. The concentrated sulphuric acid was slowly dripped into the water using a dropper, with continuously stirring using a glass rod, until the pH of the solution reached the required test value. Lastly, the sulphuric acid solution was poured into the plastic frame of dimensions 62 × 36 × 13 cm (Figure 1). Using the method of accelerating the corrosion rate, the sulphuric acid solution was discarded after soaking for 10 days. The acidic solution was replenished five times at 10-day intervals to the 60th day.

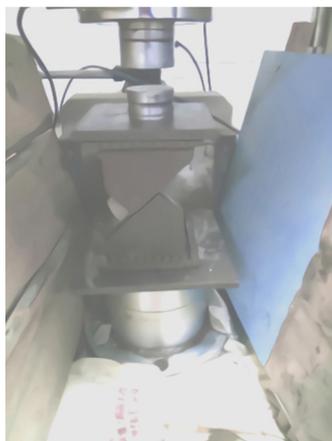
Figure 2—Shear experiment

After the CTB samples had been soaked for the set number of days, twelve samples were taken from each of the different acidic solutions and gently rinsed with tap water. The samples were placed in a drying oven for 24 hours at a temperature of 100°C . An RMT-150C rock mechanics test system was used to test the compressive strength (DZ/T 0276.19-2015, China) and the variable angle shear strength of the samples (DZ/T 0276.25-2015, China). Three samples from a group were tested for uniaxial compressive strength. The shear test was done at angles of 30° , 45° , and 60° (Figure 2). Three samples were tested at each angle. The tests were done on samples with ages of 10, 20, 30, 40, 50, and 60 days.

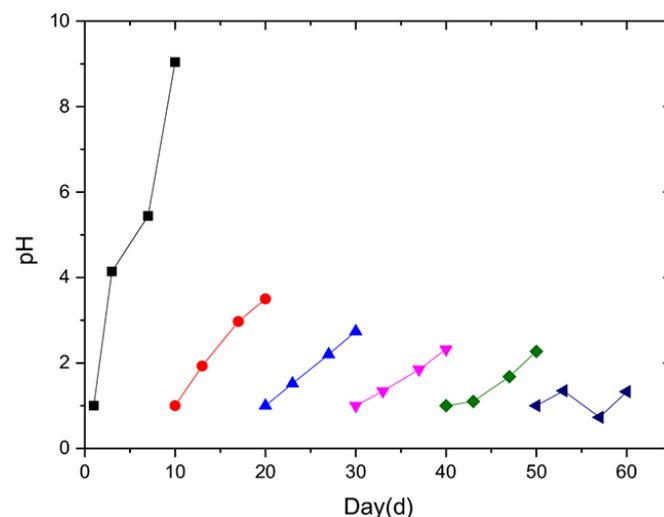
Figure 3—The change in pH of sulphuric acid soaking solution at pH 1

It can be seen from Figure 3 that from zero to 10 days the pH of the solution changes from acidic to alkaline. The pH gradually rises from 1 to 9, and there is a large amount of H^+ consumption, mainly by the $\text{Ca}(\text{OH})_2$ dissolution reaction. From 10~50 days, the change of pH value is like the change rule for 0~10 days, although the solution remains weakly acidic. This suggests that the dissolution rate of $\text{Ca}(\text{OH})_2$ is slowing; the surface of the CTB and the pore structure are covered by gypsum crystals and colloids, hindering the reaction from proceeding inside the CTB, thus the chemical reaction rate is lowered, and the phenomenon becomes more obvious with increasing time.

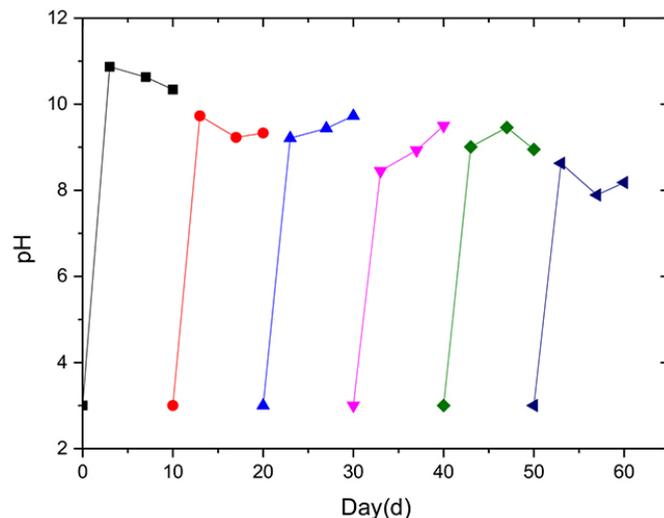
Figure 4—The change in pH of sulphuric acid soaking solution at pH 3

From Figure 4, the pH of the P3 solution changes from 3 to 11 over the first 3 days. Due to the presence of colloidal compounds such as hydrosilicate, tobermullite, *etc.* it is not easy to store in this alkaline environment, which provides a favourable

chemical environment for the formation of colloids. But the colloids are observed in this solution, although the amount is less than for P1, indicating that the rate of chemical reaction in the acidic environment is slowed down. After 3 days, the pH jumps slightly, and the chemical reaction tends to be relatively stable.

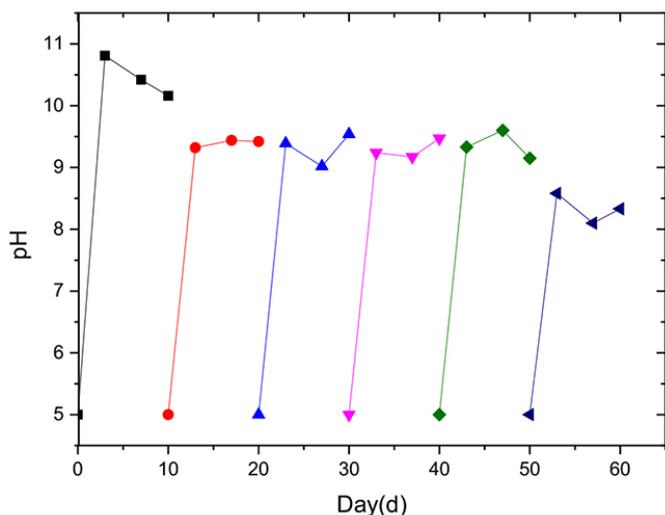
Figure 5—The change in pH of sulphuric acid soaking solution at pH 5

The pH change of the solution under P5 condition is like that of P3. As shown in Figure 5, the pH of the solution becomes alkaline at 3 days, and then tends to be stable. The solubility of hydrogen ions in this environment is weaker than that in the P3 environment. No formation of colloids was observed in this acidic environment.

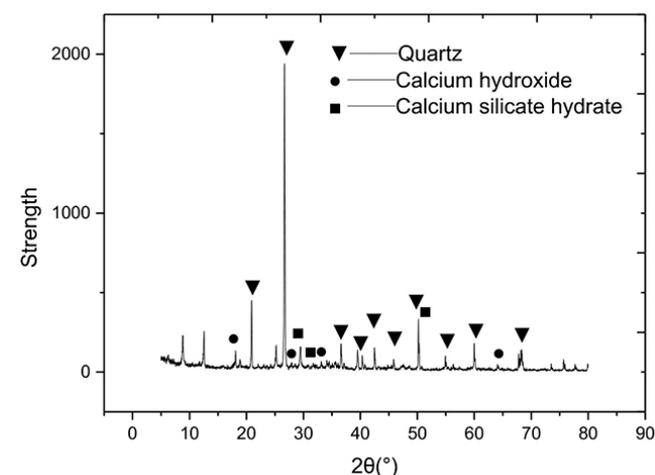
Figure 6—XRD spectrum of the prefilled CTB

For reasons of brevity, only the XRD spectra of the CTB in the P1 environment, for 60 days of corrosion and before immersion, is presented (Figures 6 and 7). Before corrosion, the spectrum depicts mainly the hydration reaction product C-S-H. When the sample immersed in pH 5 sulphuric acid is corroded for 10 days, in addition to the hydration product, there is a diffraction peak of Aft ($6CaO \cdot Al_2O_3 \cdot 3SO_3 \cdot 32H_2O$, Aft). Under these conditions, the amount of ettringite, which filled the micropores of the test piece and optimized the pore structure, was limited. As the etching time increases, the number of $Ca(OH)_2$ and Aft diffraction peaks decreases, and the number of $CaSO_4 \cdot 2H_2O$ peaks increases. The sample immersed in pH 1 sulphuric acid exhibits a very minor Aft diffraction peak. The number of $CaSO_4 \cdot 2H_2O$ diffraction

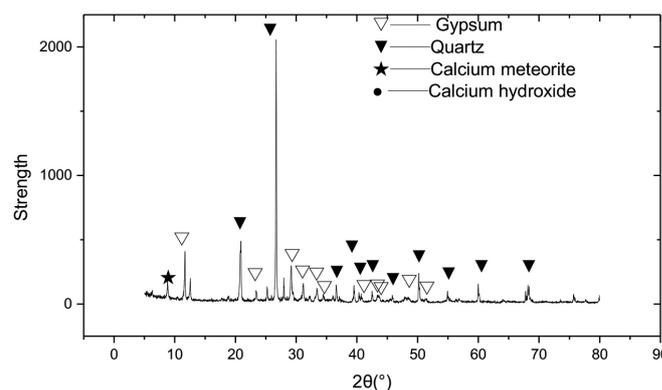
Figure 7—XRD spectrum of CTB after soaking for 60 days at pH 1

peaks decreases, and the sample immersed in pH 3 sulphuric acid shows a similar pattern to that of pH 1. The number of Aft diffraction peaks was larger than that of CTB under the P1 environment, and the number of $CaSO_4 \cdot 2H_2O$ diffraction peaks greater than in the P1 environment. With the progress of corrosion, the amount of gypsum gradually increases, the porosity of the CTB also increases, and the degree of corrosion increases. A large amount of ettringite and gypsum generates expansion stress inside the test piece. When the expansion stress is greater than the internal tensile stress, micro-cracks are formed and the internal pore structure begins to deteriorate.

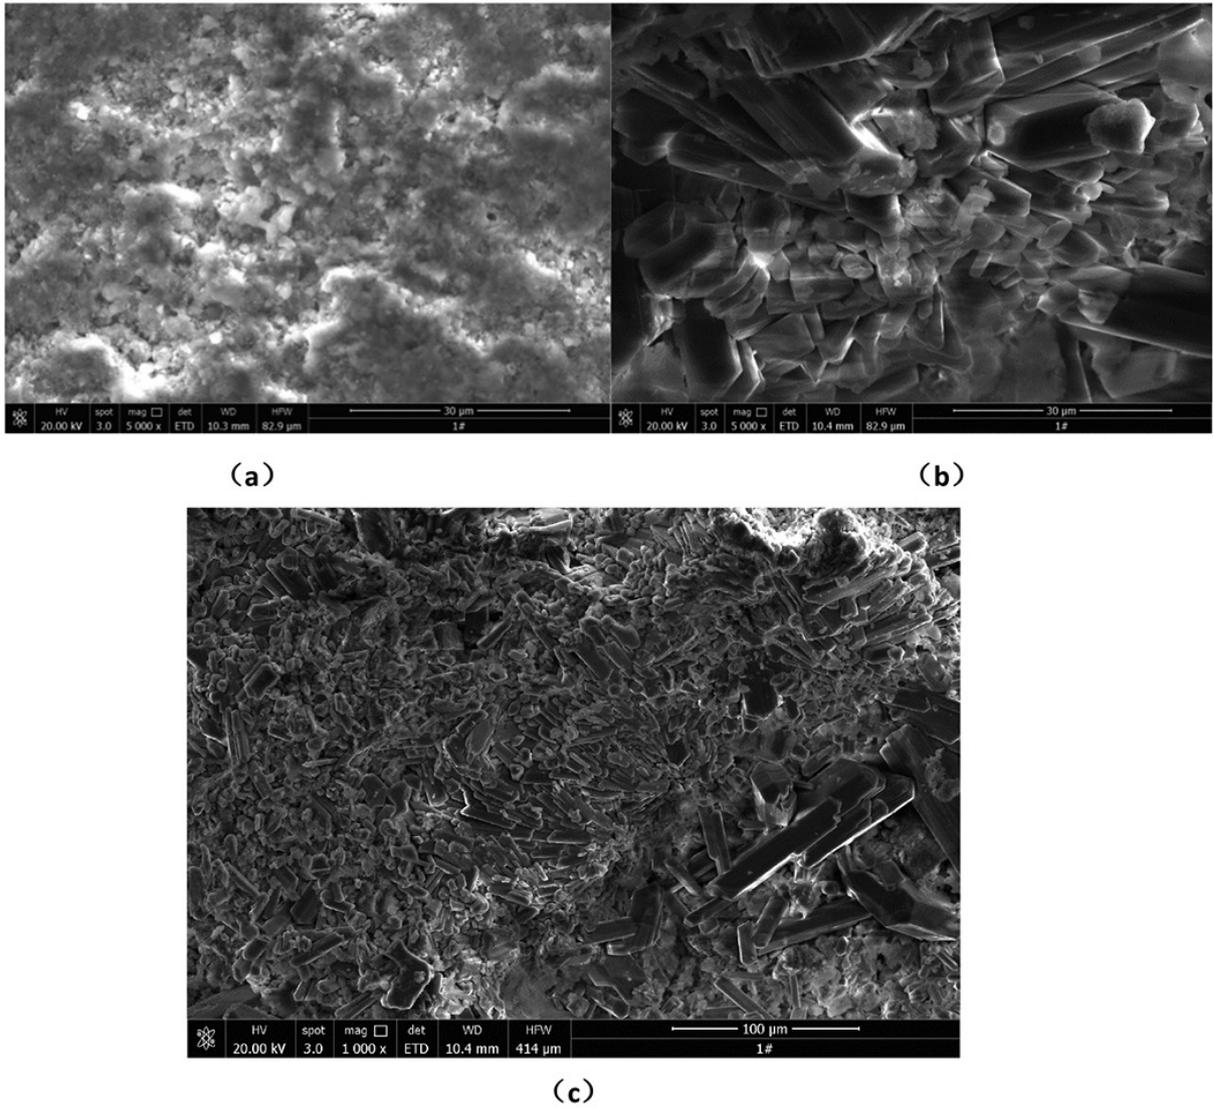
Figure 8—SEM micrographs of corrosion products after soaking in P1 sulphuric acid solution for 60 days. (a) Before etching, 5000x, (b) after etching, 5000x, (c) after etching, 1000x

Figures 8a and 8b are SEM micrographs of the corrosion products. The backfill is dense before corrosion, and several columnar crystals appear after corrosion. According to Qiao *et al.* (2019), the morphologies of ettringite and gypsum are needle-like. Several ettringite crystals are visible in Figure 8c.

It also can be seen from Figure 8 that in an acidic environment, in the long run, the degree of corrosion damage of the CTB is correlated with the corrosion time. That is, the longer the corrosion time, the more serious the deterioration of the sample. In the first instance, corrosion causes the porosity of the CTB sample to increase, hence the effective force area decreases under the load. Therefore, the mechanical strength

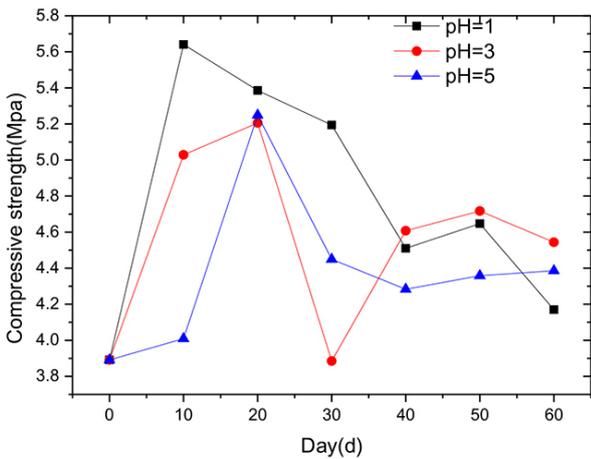
Figure 9—The change in uniaxial compressive strength of CTB with time

Figure 9 shows the change in the uniaxial compressive strength of CTB with time. The trends in the three pH environments are basically similar, rising first and then falling, indicating that the pH has an impact on the strength of CTB. In P1 the CTB reached a peak strength of 5.6 MPa in 10 days, an increase of 45%. In P3 and P5 the CTB reached peak strength of 5.2 MPa in 20 days, an increase of around 34%. This indicates that during the initial stage of corrosion in sulphuric acid the strength of CTB increases. Similar results were obtained by Zhao *et al.* (2016) and Li *et al.* (2014). After 60 days of corrosion, the CTB samples in P1, P3, and P5 increased in strength by 7.1%, 16.7%, and 10.4% respectively, compared with the strength before corrosion. Although there is a slight overall gain in strength over time with exposure to sulphuric acid, the initial increase in strength (during the first 10 or 20 days) deteriorates significantly with time. This is because during the first stages of corrosion the ettringite or gypsum crystals fill the pores, so that the strength of CTB is improved. With increasing of corrosion time, sulphuric acid solution gradually penetrates the CTB, weakening it. In the first instance, the reaction results in an increase in the internal

porosity of CTB, thus decreasing of effective stress area, with a consequent decrease in compressive strength. Compounding this, the amount of gypsum and other expansion products generated by the chemical reaction increases, resulting in expansion

stresses in the CTB, which lead to micro-cracks and a further reduction in strength. The maximum intensity of the three pH environments is different, perhaps due to the aggressiveness of the solution. The aggressiveness of the P1 solution is higher than P3 and P5, hence the rate of chemical reaction is higher, therefore the time to reach the strength peak value is shorter for P1 than for P3 and P5.

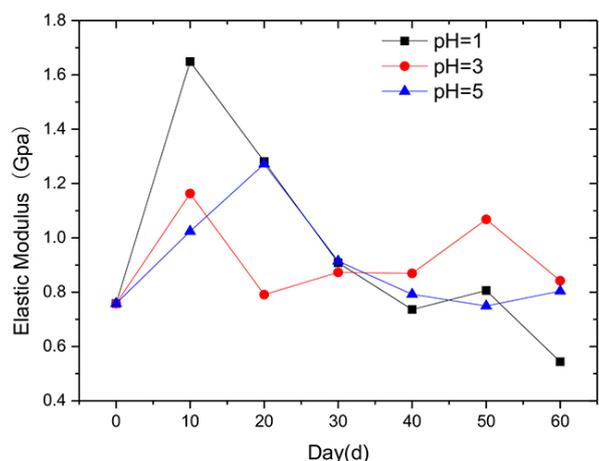
Figure 10—The change in the elastic modulus of CTB with time

Figure 10 shows the change in the elastic modulus of the CTB with time. The basic trend in the three pH environments is an initial increase in the elastic modulus followed by a gradual decrease. In P1 and P3, the elastic modulus reached its peak value after 10 days. The peak value for P1 was 1.6G Pa, an increase of 118% compared with the pre-corrosion value. The peak value for P3 was 1.2 GPa, 40.5% above the pre-corrosion value, and for P5 the maximum elastic modulus was reached at 20 days, with an increase of 67.8% compared with the pre-corrosion value. Although the pH affected the elastic modulus significantly in the early days, there is no positive correlation between elastic modulus and pH. After 60 days of corrosion, the relative changes for P1, P3 and P5 were 28.3%, 8.4%, and 6.1% respectively, indicating that longer exposure had little effect on the elastic modulus of the filling. The modulus of elasticity can

be used as an index for judging the susceptibility of a material to elastic deformation – the larger the elastic modulus, the greater the stress required for elastic deformation, which is basically consistent with the change in compressive strength of backfill. During the initial stage of corrosion, the solution fills the CTB's pores, and the degree of cohesion of the filler particles is high, which makes the elastic modulus increase. The change in behaviour may also be related to the degree of cement hydration of the test piece. With increasing corrosion time the porosity increases, the cohesion between the filler particles decreases greatly, and the elastic modulus of the filler decreases. The test results fluctuate because of the dispersion and the difference in the degree of erosion. The reason may be the different solubilities of the solutions.

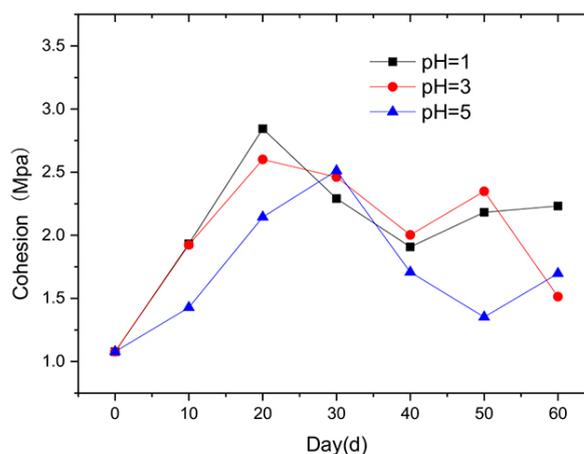
Figure 11—The change in cohesion of CTB with time

Figure 11 illustrates the trend of cohesion of CTB with time. The cohesion increases at first and then decreases for all the different pH solutions. The cohesion of CTB in P1 and P3 reaches its peak at 20 days, with strengths of 2.8 MPa and 2.96 MPa, respectively, increases of 167% and 150% from the pre-corrosion value. The CTB in P5 reaches its peak strength of 2.5 MPa at 30 days, increasing by 132%. After 60 days of corrosion, the cohesion values of the CTB in P1, P3, and P5 increased by 106%, 40.4% and 57.4% respectively, compared to the pre-corrosion value. This indicates that sulphuric acid enhanced cohesion during the early stages, but this effect deteriorated during the later stages. On the one hand, the gypsum produced by the chemical reaction fills the pores of CTB, which increases the compactness of CTB and its overall cohesion. On the other hand, acid corrosion will destroy the hydration products, such as $\text{Ca}(\text{OH})_2$, and destroy the intermolecular cementation. With increasing corrosion time, the damage will intensify, and the cohesion will deteriorate. The cohesion values in P1 and P3 peak earlier than in P5; this is related to the solubility of the ions. The range cohesion values depends mainly related on the dispersion of the samples.

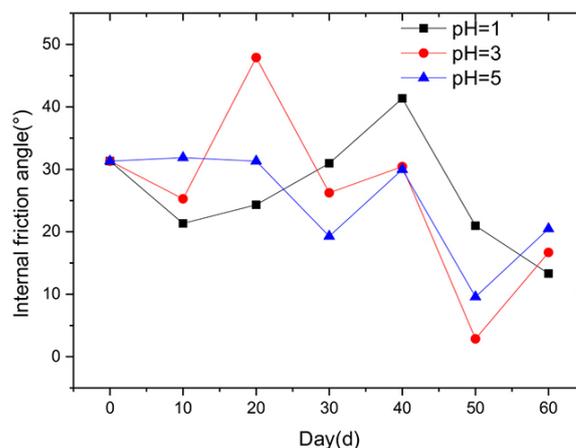
Figure 12—The change in internal friction angle of CTB with time

Figure 12 shows the changes in the friction angle of CTB with time. The internal friction angle, although fluctuating, generally decreases in all the solutions. The change range of the internal friction angle of CTB in P5 solution is relatively small, with a maximum of 31.9° , and a minimum of 9.6° . The change in P1 is a maximum of 41.4° , and a minimum of 13.3° . The

chemical reaction rate in the P5 solution is slow, and the reaction products are few. The chemical reaction rate in the P1 solution is the fastest, and the reaction products are more than in P3 or P5. Therefore the pores of CTB in P1 are filled more completely than in P3 and P5, thus the change range of friction angle in P1 is smaller than in P3 and P5. It appears that the internal friction angle of CTB is related to porosity.

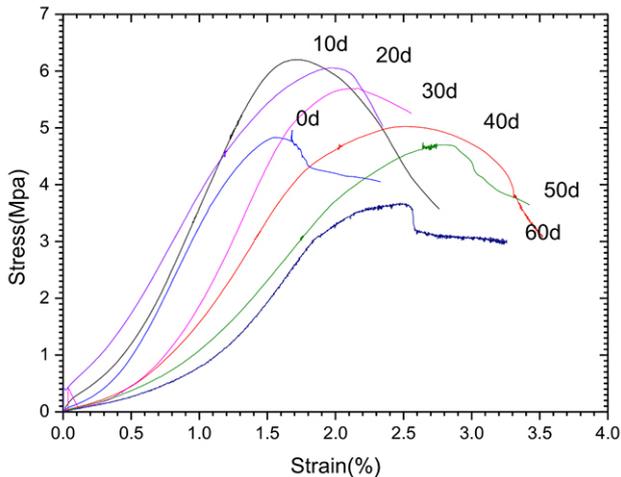
Figure 13—Stress-strain curves for CTB at pH 1 at different ages

Figure 13 depicts the stress-strain curve of CTB in P1 after corrosion for 0, 10, 20, 30, 40, 50 and 60 days. As corrosion progresses, the peak stress f_c of CTB first increases and then decreases. The elastic modulus of the corroded CTB is taken from the slope of the straight line in the elastic deformation stage on the measured stress-strain curve. The peak secant deformation modulus E_p is taken from the ratio of the peak stress f_c to the peak strain ϵ_c on the measured stress-strain curve. Both E_c and E_p at first increase and then decrease. After soaking for 10 days, E_c and E_p increased by 22.2% and 16.1% respectively. After 60 days, the modulus of elasticity decreased to 0.41 times that of the CTB before corrosion, and the peak modulus of deformation reduced to 0.47 times the pre-corrosion value. The peak strain ϵ_c is proportional to the corrosion time; this increased by 66.67% after 60 days of soaking.

From examination of the stress-strain curves, the deformation and failure process of CTB can be divided into four stages:

- The first stage is the initial deformation stage: CTB is in the initial stage of stress-strain, the graph's curved section is slightly concave upward, and the micropores and micro-cracks in the material are compacted. With prolonged corrosion time, the pore content in CTB increases and the compaction process is more obvious in CTB.

- The second stage is the elastic deformation stage, in which the stress-strain curve of CTB is approximately linear, and the steeper the straight line, the larger the elastic modulus. At the initial stage of corrosion, the elastic modulus of CTB tends to increase. As the corrosion time increases, the elastic modulus gradually decreases.

- The third stage is the yield stage, and the slope of the curve segment decreases as the stress increases. In the initial stage of corrosion, the strength of CTB will increase, and the higher the peak strength, the more obvious is the yield deformation process. As the corrosion time increases, the strength of CTB will gradually decrease.

- The fourth stage is destruction. As the deformation increases, the load-carrying capacity of CTB gradually decreases.

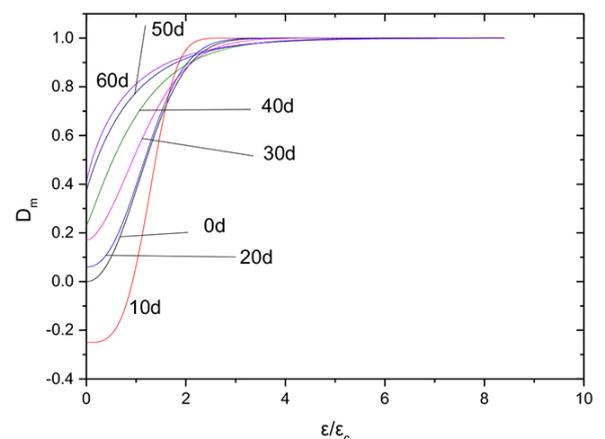
Figure 14—Evolution curve of damage model of CTB corrosion

Assuming that CTB is only corroded, the loaded strain $\varepsilon = 0$; at this time $D_m = D_t$. When only the damage is considered, $E_t = E_0$; at this time $D_m = D$. According to the test data and the result of Equation [7], the evolution curve of the corrosion damage model of CTB samples as shown in Figure 14 is obtained.

properties deteriorate. Compounding this, the amount of gypsum and other expansion products increases due to the corrosion, and when the expansion is greater than the internal cohesiveness of CTB, microfractures are formed. In a corrosive environment, the degree of damage deterioration of CTB increases with increasing strain. At the initial stage of loading, the micropores and defects inside the CTB are 'compacted' (the compaction stage). With the gradual increase of strain, the micropores and micro-cracks in CTB continue to expand and develop into macro-cracks, and the damage is intensified. When the stress on the test piece reaches its peak, the damage is at a maximum.
