# Satellite Synthetic Aperture Radar for Mine and Tailings Dam Monitoring

Neil Pendock

DIRT Exploration, Cape Town, South Africa

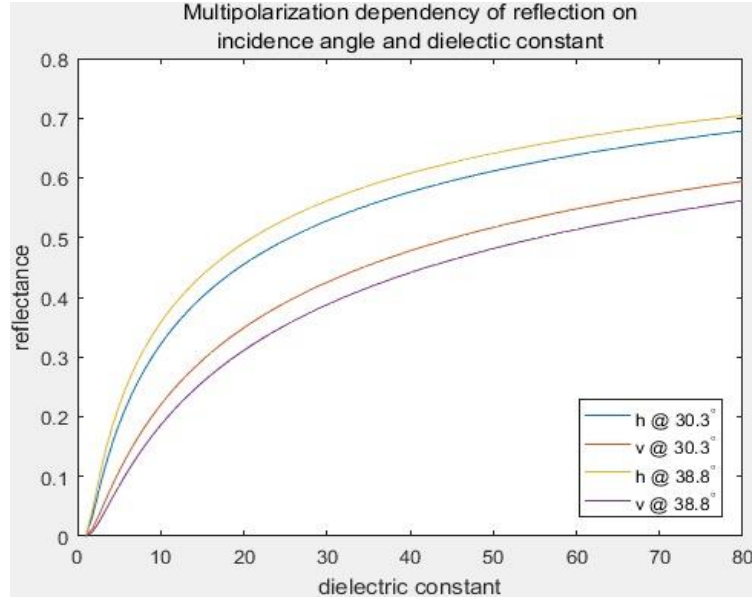
The dependence of incidence angles and dielectric constants for Sentinel-1 SAR images for four scenes collected over the Fundão tailings dam are shown in Figure 5. Incidence angles varied from 30.325° to 38.76° over the scenes.

Figure 5: The nonlinear relationship between SAR reflectance and dielectric constant.
