Bindura Nickel Smelter - from decommissioning, care and maintenance, to plant re-start

A. Mboma and K.D. Chitaukire

Bindura Nickel Corporation, Bindura, Zimbabwe

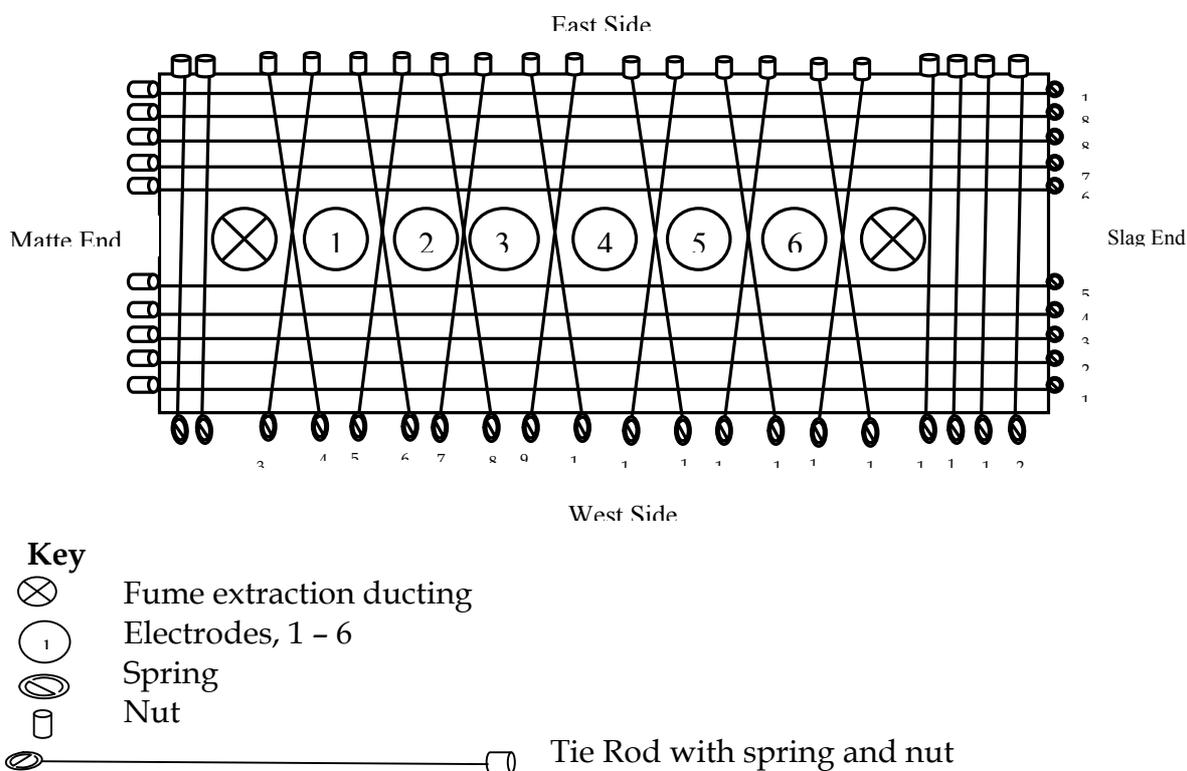
Figure 6: Furnace top springs aerial view arrangement

Top Cross Springs: Major decreases in tensional forces were recorded on springs 11 and 20, which decreased by 4 t each at 21 t, as shown in Figure 8.

Top Long Springs: The biggest drops were on springs 1, 2, 3, 5, and 9, which dropped by 5 t each.

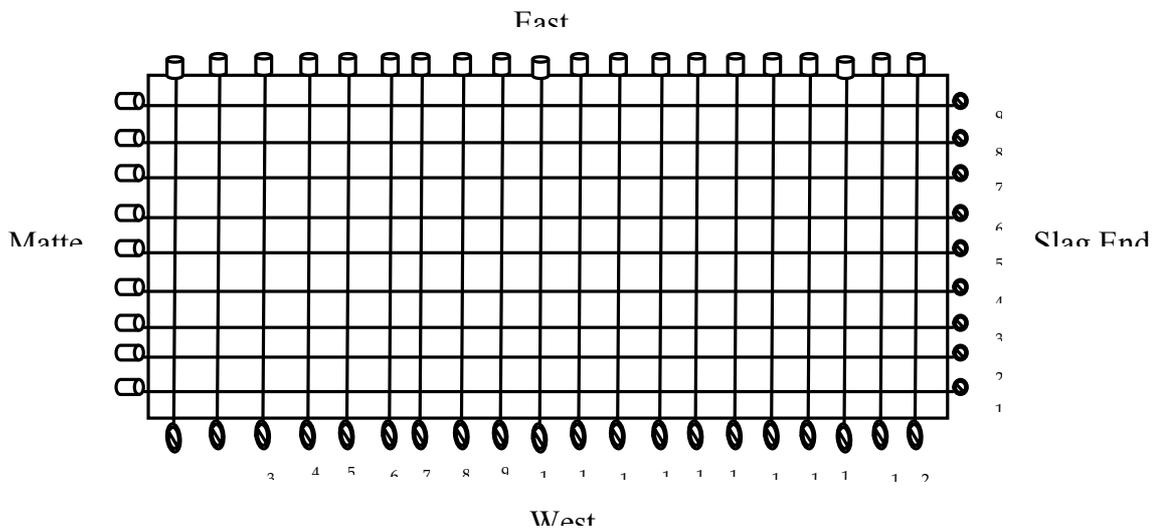
Figure 7: Furnace bottom springs aerial view arrangement

Bottom Cross Springs: At the end of the monitoring period, most of the springs were 2 t above the normal operating tensional forces, which was within measurement error.
