# A fractographic study of corrosion-fatigued specimens of A533B steel

by J.H. BULLOCH\*

This paper describes detailed fractographic analyses of several specimens that had undergone corrosion-fatigue tests at high stress ratios in simulated pressurized water-reactor environments.

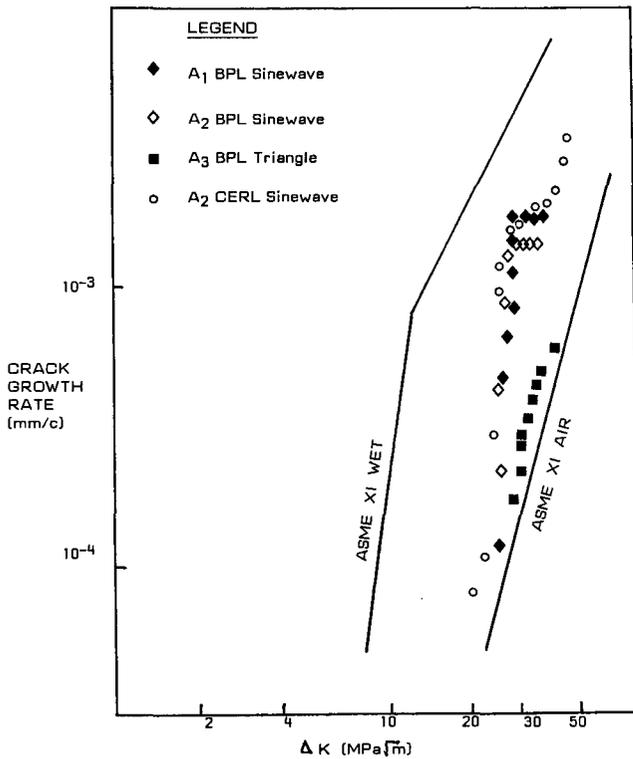
Fig. 1—Fatigue-crack growth in Marrel-Freere A533B steel in a PWR environment under test conditions— $R = 0,7$ ,  $\nu = 1$  cycle per minute

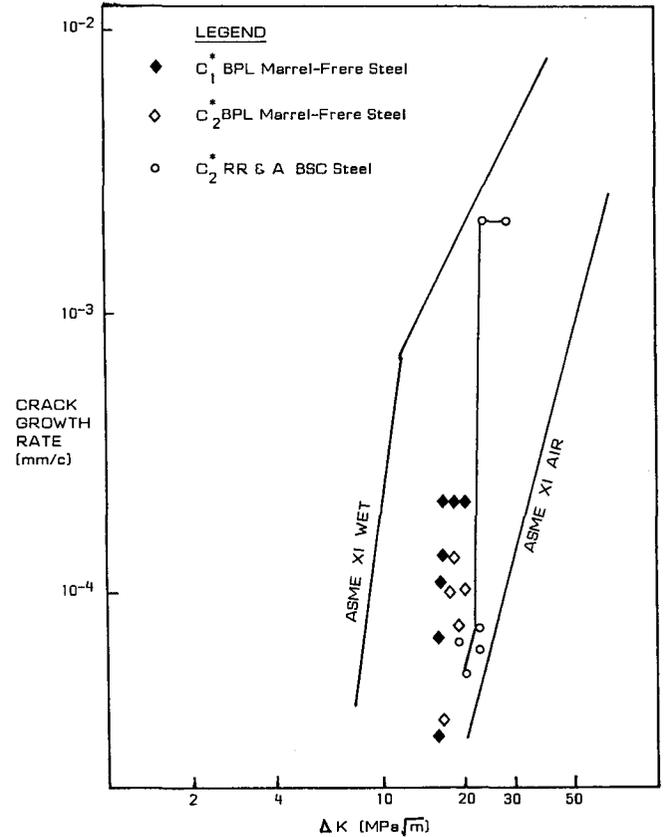
Fig. 2—Fatigue-crack growth in A533B steel in a PWR environment under test C\* conditions— $R = 0,85$ ,  $\nu = 1$  cycle per minute

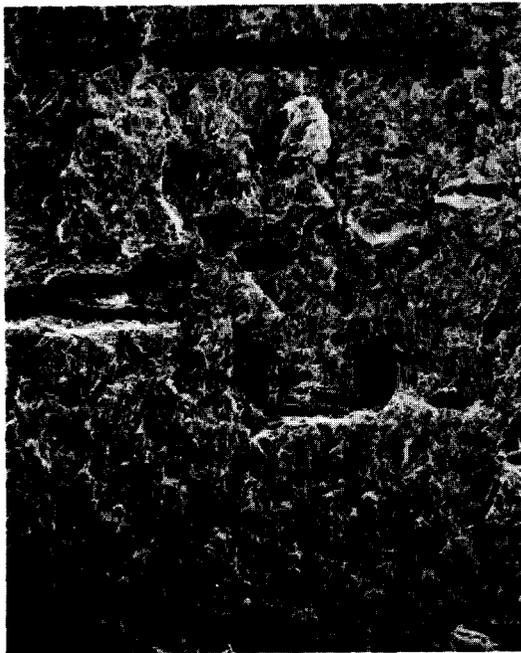
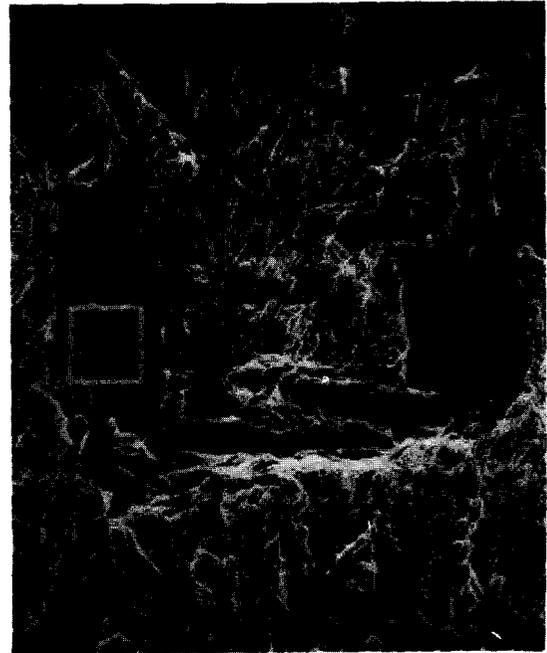
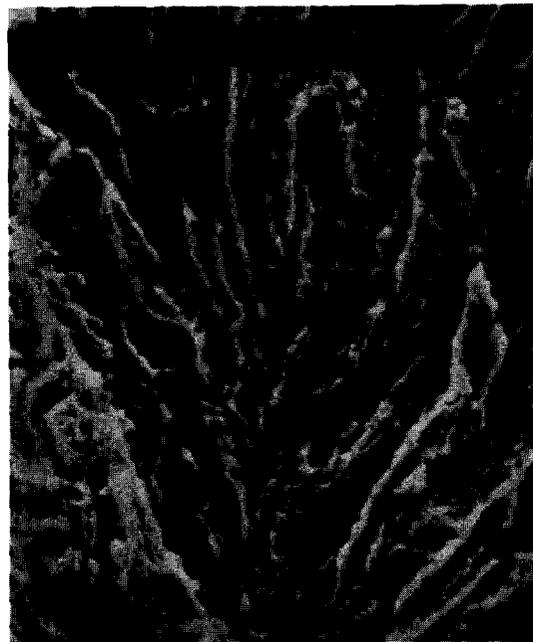
**Fig. 6— $\Delta K$  region immediately before plateau formation**  
**(a) Many incidences of stringer-like inclusion sites**  
**(b) Fan-shaped region emanating from fan-shaped facets**  
**(c) Detail of fan-shaped faceted region**

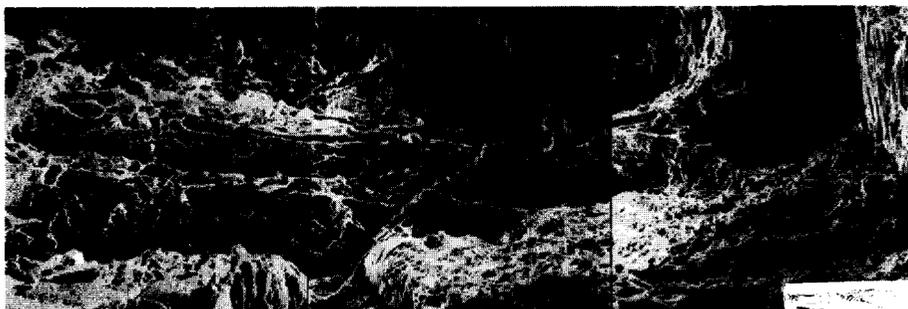
The area around these initiation sites was subjected to detailed examination, but few features of any note were found. However, because of the ridge-type appearance in this region, it was decided to view this region from the precracked region; this is shown in Fig. 28. Figure 28(a) illustrates that the initiation region is associated with a large step in the crack path, while Fig. 28(b), utilizing the tilt facility of the SEM, shows that the step is asso-

**Fig. 28**—Initiation region viewed from the precracked area  
 (a) View from the precracked region, showing the large step associated with the initiation sites of the macro fan-shaped region  
 (b) Tilted view of the stepped region associated with initiation sites, showing the massive inclusion site about 1,3 mm long where there is evidence of type I and type II (rod-like) manganese sulphide inclusions

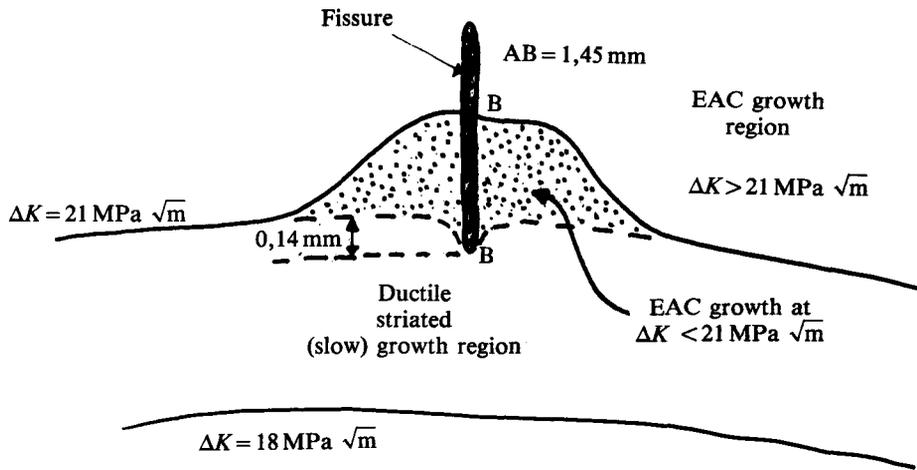
One interesting feature is the occurrence of a region of EAC growth within the  $\Delta K$  steps 18 to 21 MPa  $\sqrt{m}$  (Fig. 37). A schematic diagram of growth events is given in Fig. 44, showing that, if there had been a regular crack front during the ductile striated growth (broken line), the crack in the region of the fissure would have grown a further 0,14 mm if EAC had not occurred. Thus, according to the growth rates in Test C\*2, at  $\Delta K = 20 \text{ MPa } \sqrt{m}$ ,  $da/dN$  would be about  $1 \times 10^{-4}$  mm per cycle for non-EAC growth. This means essentially that the EAC growth facet, 1,45 mm long, was formed in 1400 cycles, yielding a rate for EAC growth of  $1,1 \times 10^{-3}$  mm per cycle. This value approaches the plateau rates where general EAC growth occurred across the total width of a specimen.

Fig. 44—Schematic diagram of the deviation in the step  $\Delta K = 21 \text{ MPa } \sqrt{\text{m}}$  as a result of a semi-circular region of EAC growth within the  $\Delta K$  range  $18 > \Delta K > 21 \text{ MPa } \sqrt{\text{m}}$ . Approximate measurements were taken from Fig. 36. The growth rate in the slow-growth region was about  $1 \times 10^{-4} \text{ mm per cycle}$

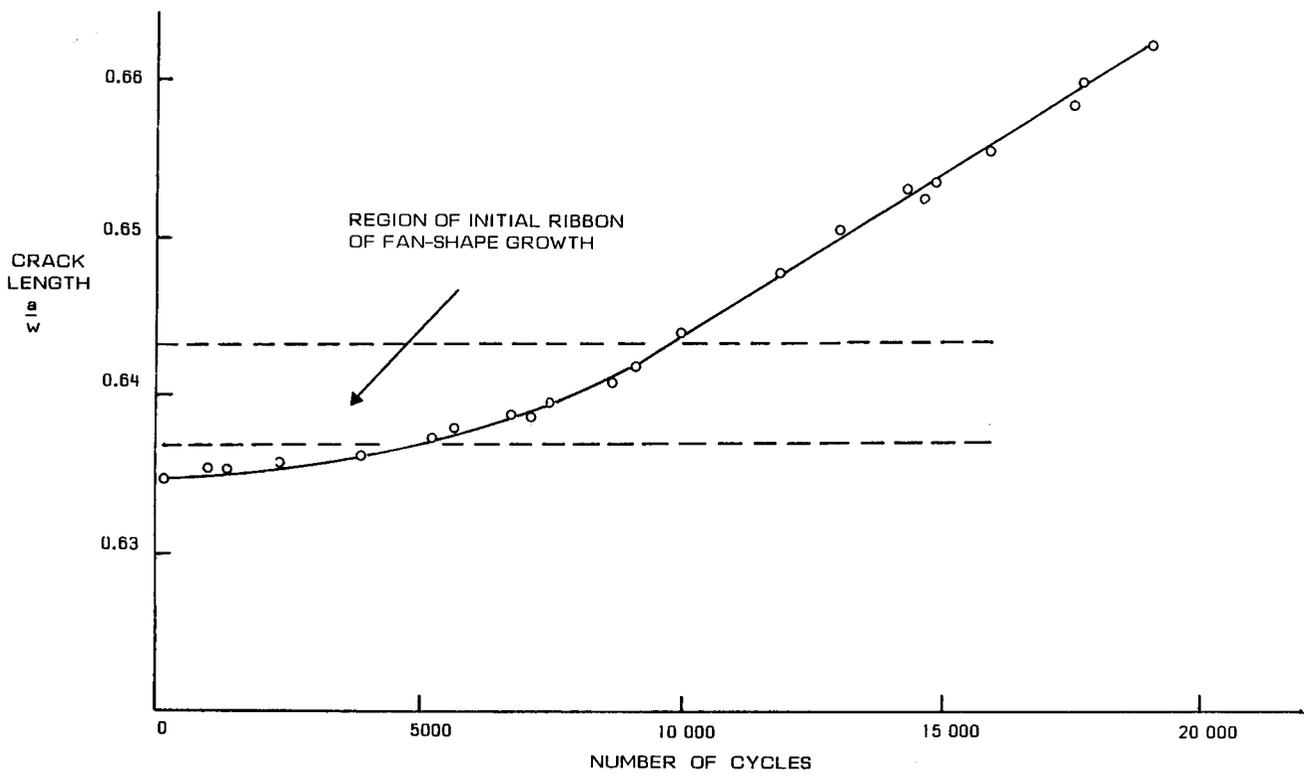
The average length of the initial EAC growth ribbon in test C\*1 was about 0.5 mm. A plot of crack length versus number of cycles is shown in Fig. 45. It is evident that this average distance agrees remarkably well with the

Fig. 45—The length of a raw crack versus the number of cycles in BPL test C\*1, showing that the initial formation of a ribbon of fan-shaped EAC growth coincides with the fastest recorded growth rate

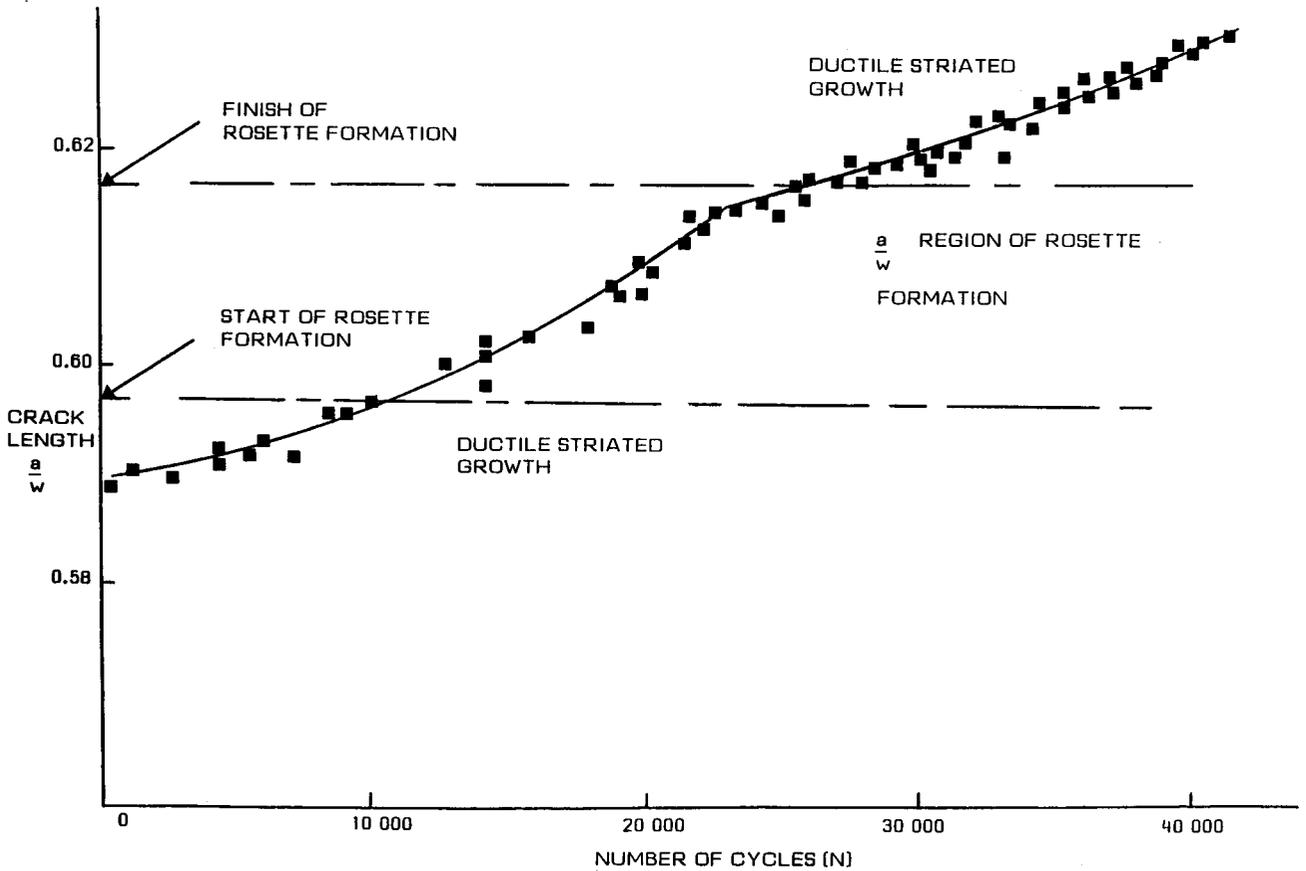
The results of test C\*2 show the existence of a large rosette of region II EAC growth. Outside this feature, the fracture mode was totally of the ductile striated type characterized by fissures at right-angles to the general direction of crack growth. Furthermore, the region at which the macro fan-shaped region initiated has been shown to consist of an elongated cluster of non-metallic inclusions, consisting mainly of type I and type II manganese sulphides that dissolved during testing in a PWR environment. Also evident near the initiation region were areas of intergranular failure with 'yawning' grain boundaries typical of hydrogen-assisted cracking. Fractographic evidence (Fig. 30) shows that fan-shaped growth is initiated ahead of the main crack front and then fans back in the opposite direction to general crack growth, this again pointing to a hydrogen-assisted mechanism. The graph of the length of the raw crack versus the number of cycles in test C\*2 is given in Fig. 46. The curve shows a definite deviation at  $a/w \approx 0.615$ : initially, crack growth typically increased with crack length but, at  $a/w \approx 0.615$  the growth rate abruptly slowed down to the initial rates and then increased again with crack length. Also shown on this graph is the range of crack lengths over which the rosette region developed. The region of fastest growth agrees well with the initial development of the rosette, while the point of abrupt change in crack growth coincided with the outer boundary of the fan-shaped region. Thus, although the macro fan-shaped region of EAC represents only about 17 per cent of the specimen thickness, it appears that the crack-monitoring instruments sensed its development during the test.

Fig. 46—The length of a new crack versus the number of cycles in BPL test C\*2, showing the region of rosette formation
