Pit wall failures on 'unknown' structures

by P.M. Dight*

Synopsis

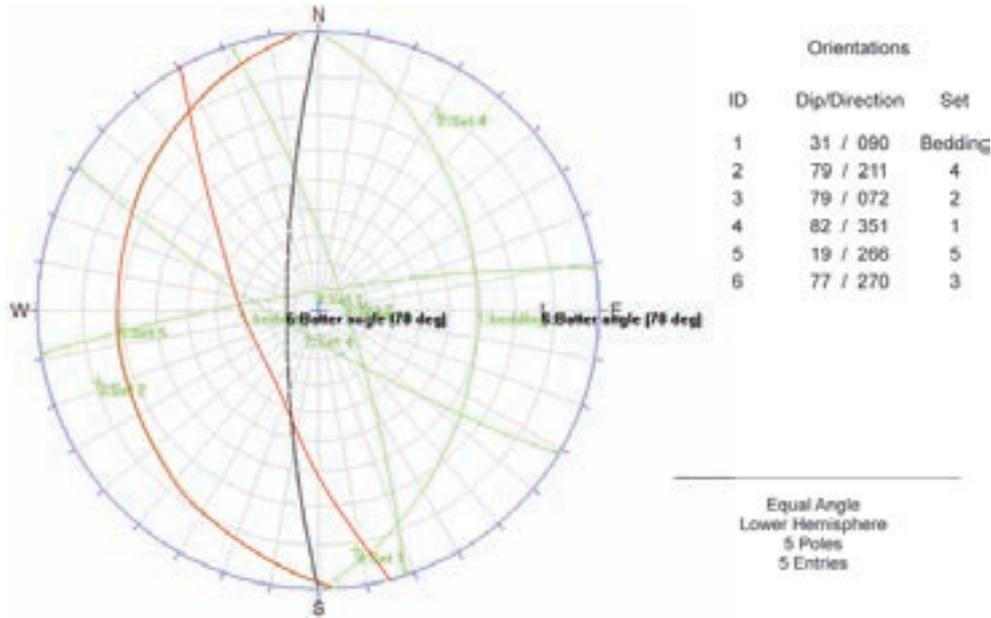
Figure 4—Stereonet showing major defect orientation Mine A

The back scarp followed a step-path comprising structure 5, which was sub-parallel to the thrust line due to oversteepening (Figure 4). This set had an up-dip continuity of 1 to 2 m and terminated on bedding. Note that all the rock mass on the pit side of this line would be totally stress relieved 'in tension'.

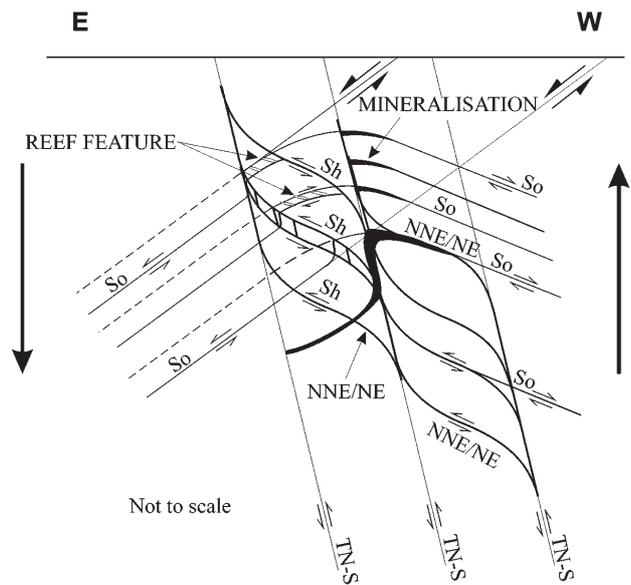
Figure 7—Tectogenetic Model after Bogacz, 1998

Subsequently, a detailed structural model of the mine was developed by Bogacz (1998). Shown on Figure 7 is a schematic 'structural interpretation' as projected onto the south wall of the pit. Of note are the steep 'shears' which traverse obliquely across the bedding. These shears 'parallel' the cross bedding structures (Set 5) identified in the pit wall exposures, but due to the bias in the mapping were not recognized/identified features. The typical spacing on these features is between 20 and 50 m. Structurally they could be considered as part of a fractal set. Use of the structural model in geotechnical design would have warned against steepening the pit wall and as a consequence a probable reduction in the size of the failure.

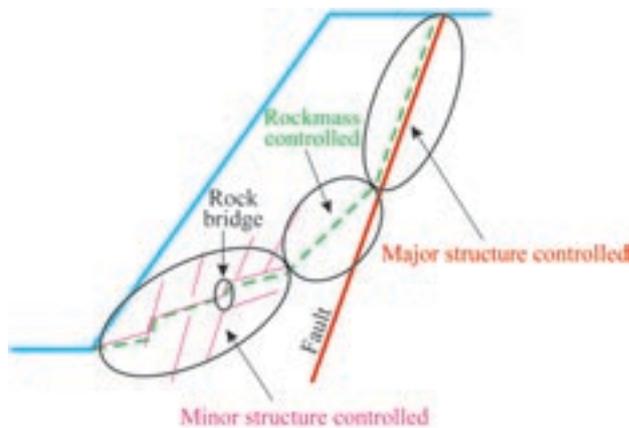
Figure 6—Step path failure after Baczyński, 2000

The failure mechanism therefore could be interpreted using Baczynski's step path model (Baczynski 2000) as shown in Figure 6. However, there is not sufficient explanation of the initiation of shearing at the toe.

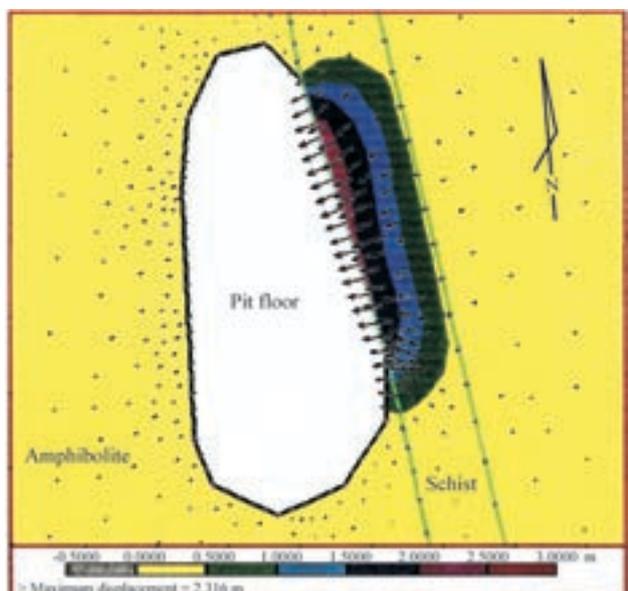
Figure 11—Mine B: showing displacement concentration in schist

This later failure was interpreted to be the result of buckling in the quartz biotite schist, followed by flexural failure and sliding on the 16° plane. Figure 11 shows the stress analysis undertaken at that time. Once the lateral stress was relieved, then the driving force for the failure dissipated and the rock mass reached equilibrium.

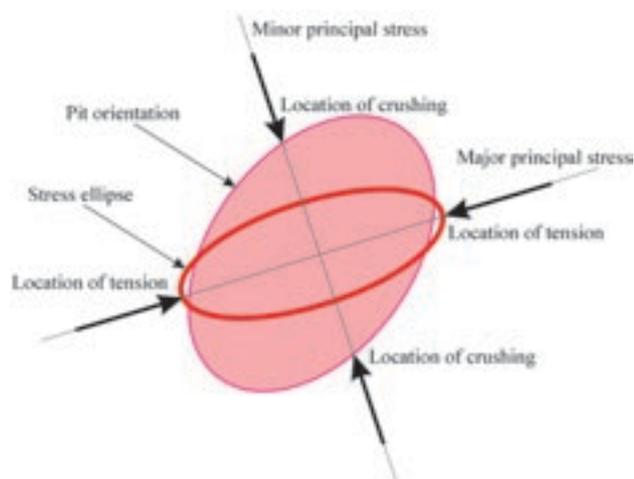
Figure 13—Mine C: showing Kirsch stress interpretation

This item caused the ultramafic to respond in flexure and generate an initial 'tensile' crack at an angle of 20° to 25° resulting in a step-path angle (combining with the 70° foliation in the ultramafic).

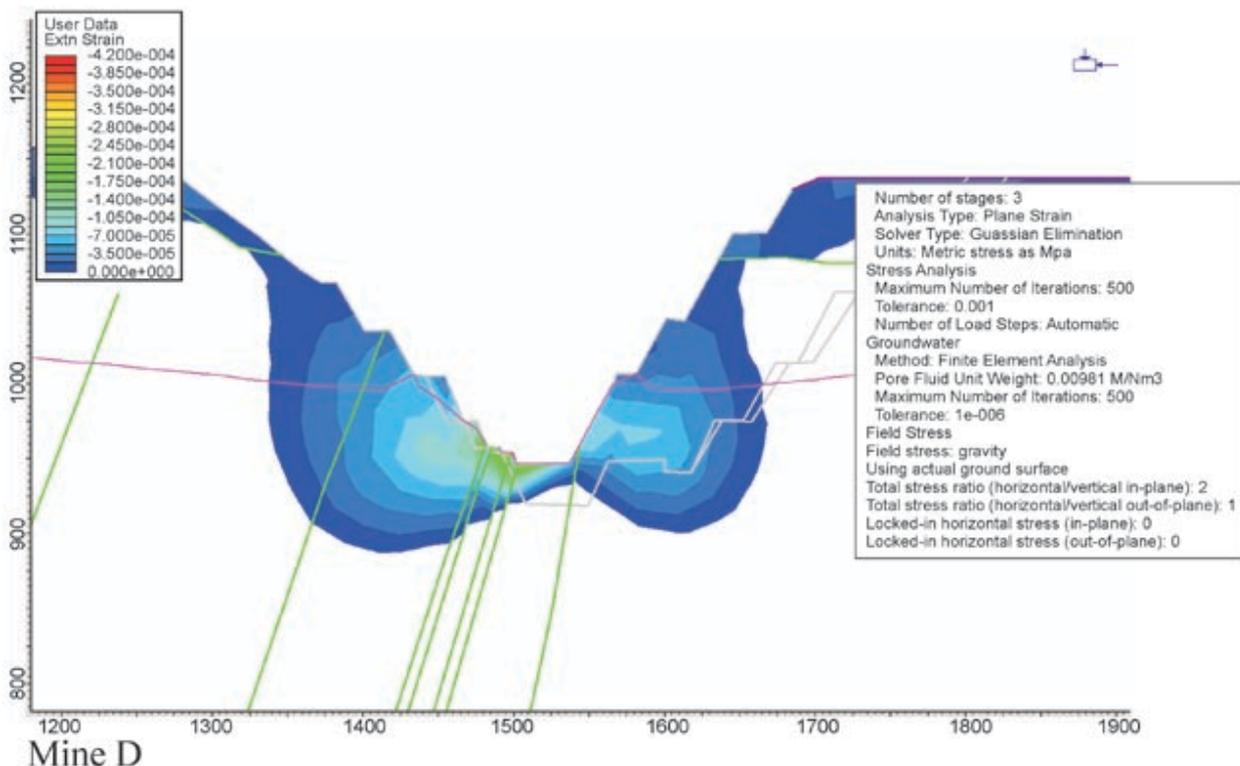
Figure 15—Mine D: showing contours of extension strain. Failure angle is quite shallow

In this study the contours of extensional strain shown in Figure 15 do not comprehensively demonstrate the initiation of a new failure surface as noted by Lynch. This may, in part, be due to the assumptions relating to the local stress field, and the simplifying assumptions which arise from the 2D modelling, which can often ignore major structure effects. In the case of Navachab, the instability apparently occurred

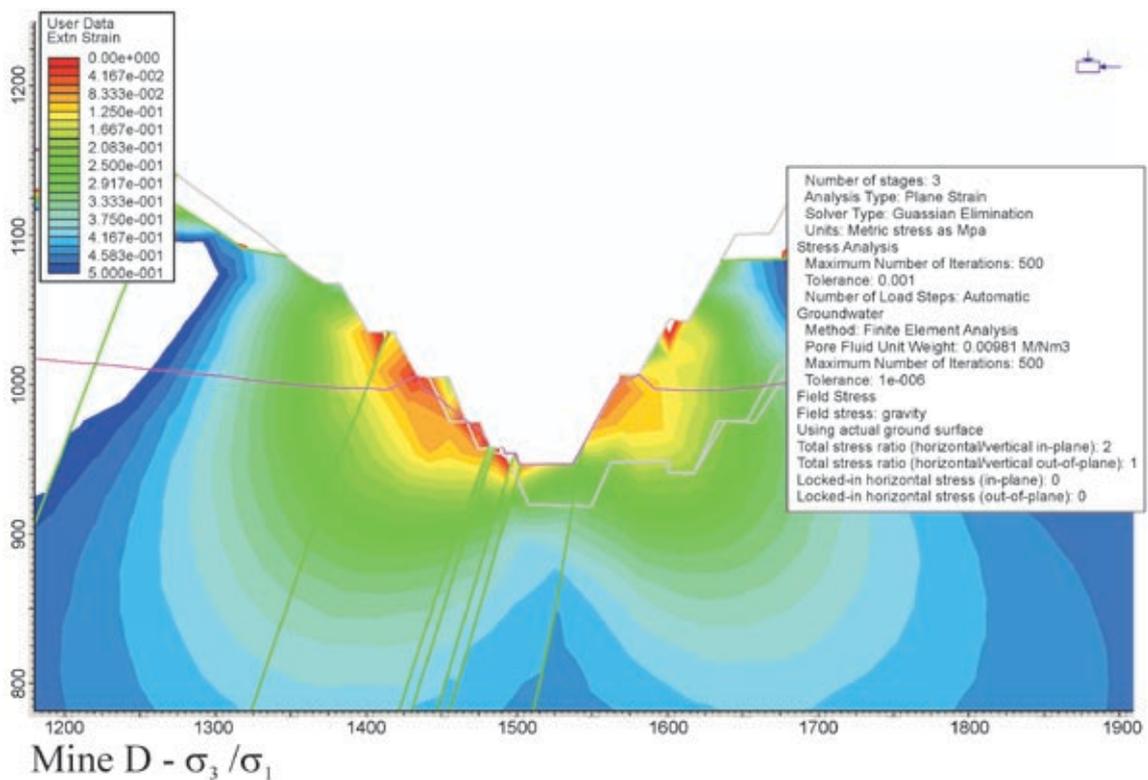
Figure 17—Mine D: shows contours of σ_3/σ_1 ; failure occurs at a shallow angle

Making an allowance for this event, a different model of extensional strain can be interpreted, as shown in Figure 17, which is closer to the expected basal plane.

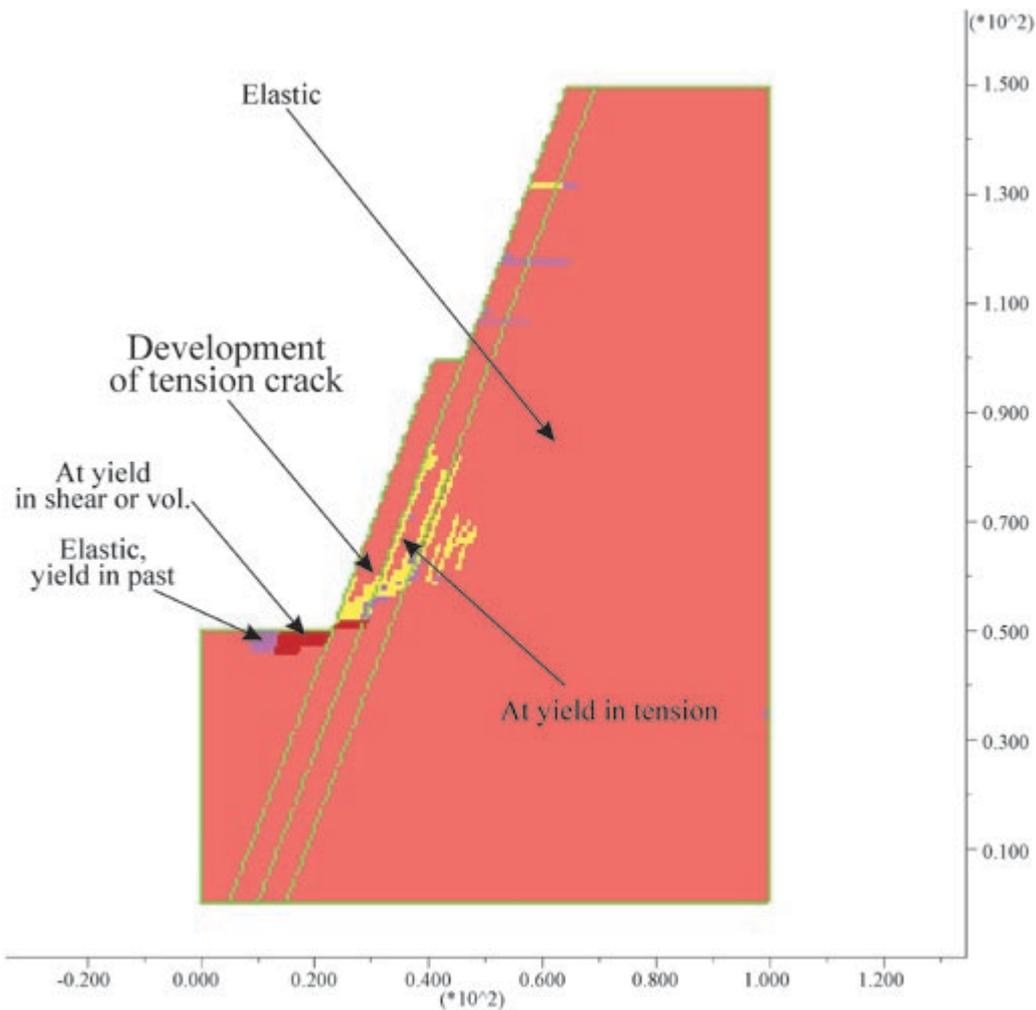
Figure 18—Development of tensile cracks which initiate through flexure

shearing. Figure 18 shows the development of tensile cracking resulting from rock flexure. The angle is surprisingly similar to that generated by σ_3/σ_1 and extensional strain.
