Ground control at Leinster Nickel Operations

by J. Cahill* and M. Lee*

Leinster Nickel Operations, located in Western Australia, consists of an underground and three open pit mines in relatively adverse ground conditions. This paper reviews our ground control practices in the open pits, covering aspects of ground support, wall control and monitoring. These methods have been effective in allowing mining operations to continue beneath unstable slopes. In particular, the use of Groundprobe's slope stability radar has enabled the Harmony open pit to safely operate for months following indication of failure from traditional methods. This case study highlights the benefits of investing in appropriate slope stability monitoring systems.

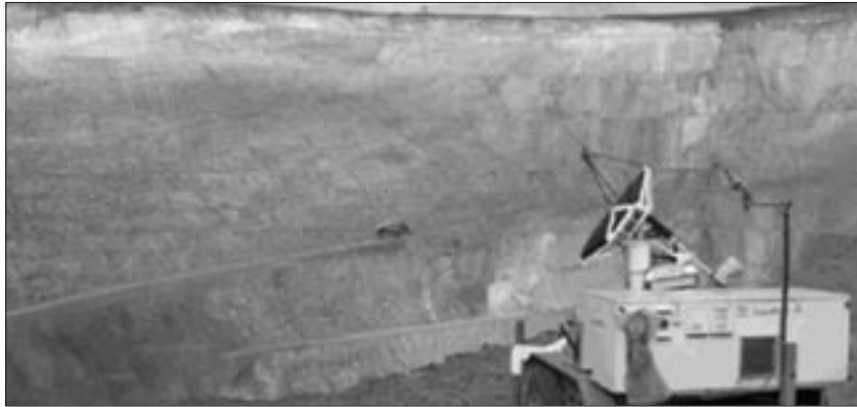
Groundprobe's slope stability radar (Figure 5) has been in use since 2002 at Leinster. The radar continuously monitored the wall and was focused on areas where there was a low confidence level on the ability of prisms and visual

inspections to predict failure with adequate time to remove all personnel and equipment. Scan times were generally 10–15 minutes, with the data being sent via radio link to the monitoring office. Audible alarm tolerance settings were based on previous failures in similar ground conditions.

Figure 5—Groundprobe's slope stability radar, monitoring the south east wall at Harmony
