The influence of mining sequence and ground support practice on the frequency and severity of rockbursts in seismically active mines of the Sudbury Basin

by P. Morissette*, J. Hadjigeorgiou*, A.R. Punkkinen⁺, D.R. Chinnasane⁺, and A. Sampson-Forsythe⁺

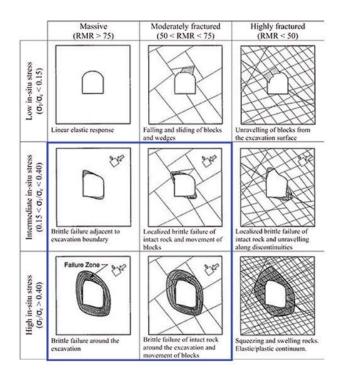
Morissette *et al.* (2014) have presented a comprehensive review of the geology and rock mass properties at Creighton, Copper Cliff, and Coleman mines. Ranges of rock mass quality and stress conditions typical for the three mines are represented in Figure 3. In this conceptual diagram, the observed conditions suggest the potential for brittle rock mass failure and movement of blocks. The stress gradient for Creighton mine is provided in Table I. Stress gradients at Copper Cliff and Coleman mines are similar to that at Creighton, given the proximity of the mines.

Figure 3–Potential for tunnel instability and brittle rock mass failure at Creighton, Copper Cliff, and Coleman mines based on the classification proposed by Martin *et al.* (1999)

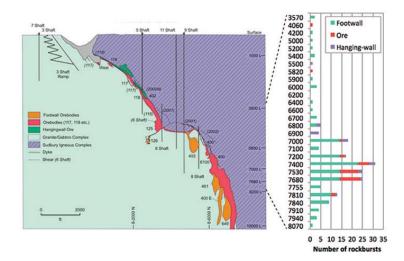
At Creighton mine, the occurrence of rockbursts appears to be influenced by the depth and maturity of mine levels (Figure 5). A noticeable increase in the total number of rockbursts is observed as the mine depth approaches the 7400 level (2255 m). Open stopes varying from 53 to 60 m in height were mined at levels above 2255 m depth in the 400 orebody. Below the 7400 level, the spacing between top and bottom sills was reduced to 40 m in anticipation of higher stress conditions at greater depths and to better delineate the mineable reserves. Since 2005, the majority of stopes were mined below the 7400 level in Creighton Deep. Mining in the 461 orebody began in 2006. Recognizing the unfavourable orientation of the orebody with respect to the major principal stress, reflected by seismic activity in the area over the last few years, the mine employed stopes with a design height of 26 m. Fine-tuning of stope design is an ongoing process at Creighton mine.

Figure 5-Influence of depth and maturity of mine levels on the occurrence of rockbursts at Creighton mine

The reduction in the stope height at Creighton has likely contributed to preventing an escalation of seismic activity as the mine progressed to greater depths. This is reflected by the evolution of the rate of seismicity, which was assessed from January 2000 to September 2013 using the magnitude-time history analysis technique (Figure 6). This technique is described in detail by Hudyma and Potvin (2010).

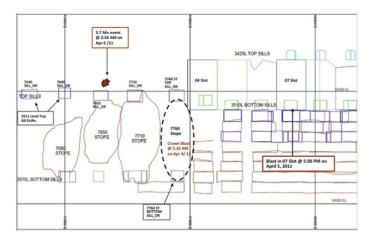
Figure 18-Chronology of events associated with the 6 April 2011 rockburst (Sampson-Forsythe, 2011)
