The clean-up of the plant at Bracken Gold Mine

by M.A. de Ruijter*

Synopsis

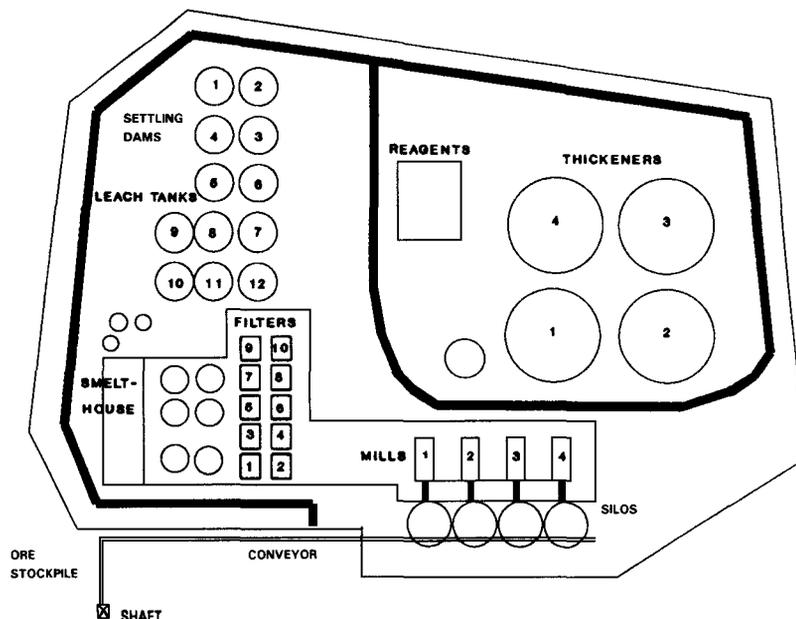
Figure 1—Layout of the Bracken metallurgical plant

It should be noted that certain samples could not be taken for reasons of inaccessibility. The assay results given in Table III show that the mill and filter buildings, the smelthouse, and the surrounding areas constituted the
