The tailings dam at Consolidated Murchison Limited

by H. J. N. WINHOFF*, Ing. Grad. (Visitor)

The history of tailings dam operations at Consolidated Murchison Limited is briefly recounted, and a mechanical method of dam-wall construction is described and illustrated in some detail.

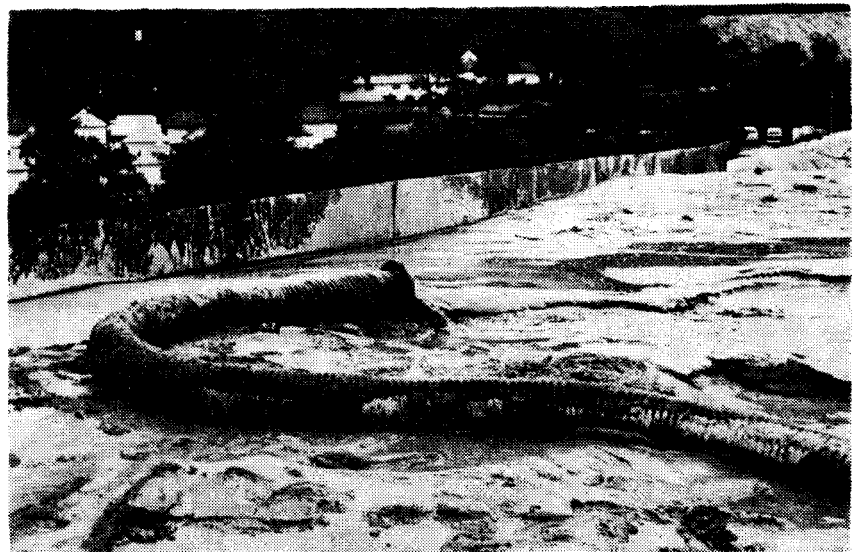
Plate III—Deposition of slimes against the steel plates

thus ensuring a dam-wall slope of 33°. These steel plates are shown in Plates III and IV.

to be unfounded, since the unclassified tailings settled very well and did not leak out between the plates. The plates thus proved to be better than hand-built walls.
