A risk evaluation model for support design in Bushveld Complex underground mines: Part II—Model validation and case studies

by W.C. Joughin*, A. Jager†, E. Nezomba‡, and L. Rwodzi‡

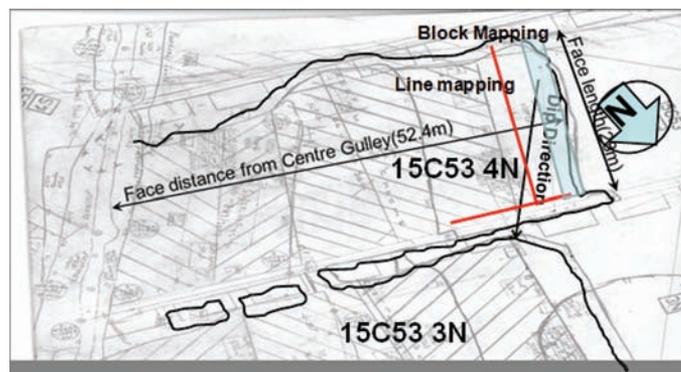
One of the UG2 stope panels is shown in Figure 1. The UG2 stopes are supported with mine poles, and the Merensky stopes are supported with mine poles and hydrabолts, due to the blocky nature of the reef.

Figure 1 – UG2 Reef stope panel showing line and rockfall mapping

Geotechnical Line mapping was carried out in the dip and strike directions as indicated by the red lines in Figure 1. The following information was collected:

The rockfalls were mapped on the face during each shift, on a daily basis (Monday to Friday), in the area indicated by the pale blue shading in Figure 1. The mapping team started by marking all the rockfalls that had occurred after the blast on the previous shift during the early morning examination. The boundaries of the rockfall moulds in the hangingwall were painted. The following characteristics of each rockfall were captured:

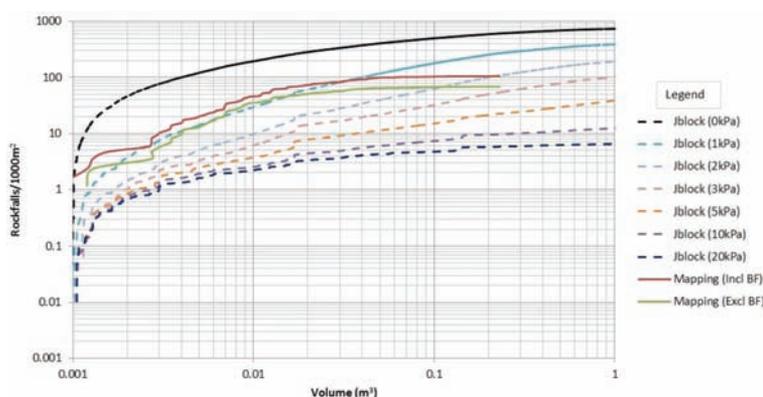
The objective of this investigation was to determine whether JBlock reliably simulates the actual rockfall frequency and size distributions that occur underground. A JBlock analysis was done to simulate a set of rockfalls for comparison with mapped rockfall data. The joint set data from underground mapping presented in Table II was used to statistically simulate keyblocks in JBlock for both the UG2 and Merensky reefs. The correlation of Merensky mapped data with JBlock simulated data is presented in Figure 2.

Figure 2—Merensky Reef mapped rockfall volume and JBlock distributions for clamping stresses from 0 kPa to 20 kPa

The curve for the mapped rockfall data for the Merensky Reef has a good correlation at low clamping stresses for rockfalls between 0.003 m³ and 0.03 m³, but for larger rockfalls, the curve crosses several clamping stress curves as the size increases. This trend indicates that JBlock needs to be modified to allow increasing clamping stresses for increasing rockfall size or in fact rockfall height.

The mapped rockfall data set includes very small rockfalls, but is limited to maximum rockfall size of 0.46 m³. It is clear that applying some low value of clamping stress to this range of block sizes greatly improves the correlation between mapped and simulated results. However, it is quite apparent that the JBlock program needs to be modified further to improve the correlation. The actual clamping stress in the hangingwall increases with increasing height above the stope, and the results show that a low clamping stress is appropriate for small rockfalls, while a higher clamping stress is appropriate for larger rockfalls. A longer and more extensive rockfall data collection exercise will be required to collate the full range of rockfall sizes.
