Laser surface melting of 304 stainless steel for pitting corrosion resistance improvement

by T.S. Seleka* and S.L. Pityana*

Synopsis

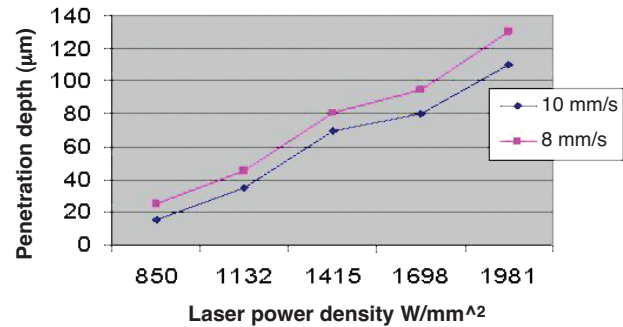
Figure 1—Relationship between laser power density and penetration depth

Stainless steel 304L, of 6 mm thickness, was used for this study. The chemical composition of 304 SS is given in Table I. All the experimental samples for LSM were used as received without any surface processing. LSM was carried out using a 4.4 kW Nd: YAG laser with a top hat profile beam source. LSM processing parameters were optimized to favour all factors that manipulate pitting corrosion resistance. Figure 1 shows the relationships between

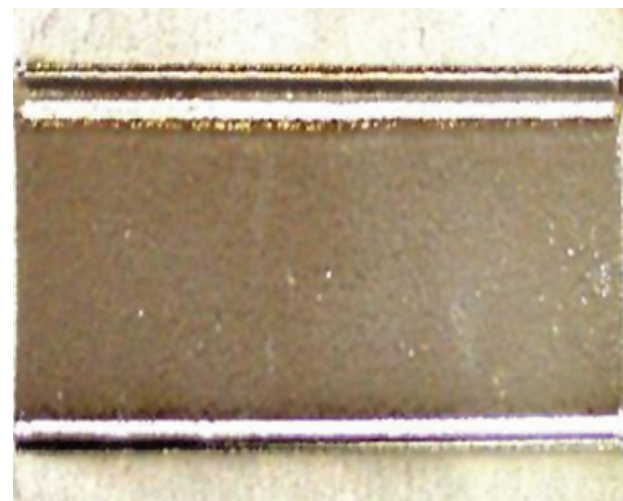
Figure 3—Laser processed surface under argon atmosphere

After LSM, the surfaces were silver in colour, signifying that the surfaces were smooth and reasonably protected by argon gas. Figure 3 shows this phenomenon.

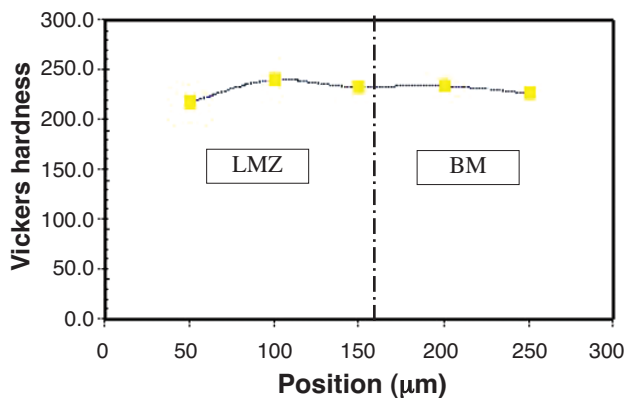
Figure 6—Microhardness across the transverse section of the sample submitted to laser surface melting

Hardness test were performed and there was no change in the hardness value as compared to the base metal. Even though the structure refinement at the surface could lead to an increase on the yield strength, the hardness measured is

not expected to change much, particularly in a high strain hardening rate material like this 304 SS. Figure 6 shows a microhardness profile and the difference in the untreated and laser treated regions.

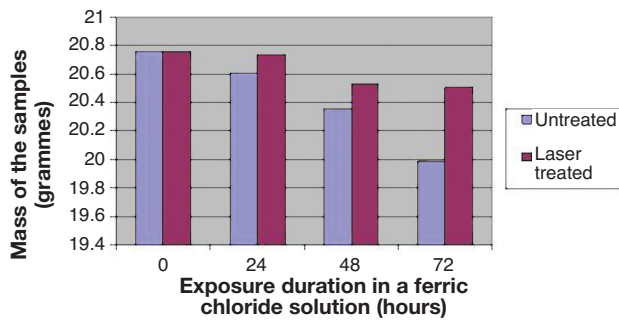
Figure 9—The tendency to lose mass of the untreated and laser treated samples

After 48 hours, it was apparent that laser-melted sample resisted pitting. On the other hand, the untreated sample showed randomly dispersed pits, which are deep in geometry. Figure 9 illustrates mass loss for both samples exposed for 72 hours.

Both samples started the test with the same mass, which gives this comparative study more sense. It is clear from the illustration that after 48 hours, a laser treated sample has lost only a few milligrams. In this stage the passive layer on the surface was still strong as compared to the untreated sample. This is because during LSM, chromium tends to react with oxygen to form a passive chromium oxide layer. The removal and dissolution of inclusions and precipitates contribute a lot. After 72 hours, a laser treated sample started to corrode at an accelerated rate. This sample showed smaller and shallower pits in clusters.

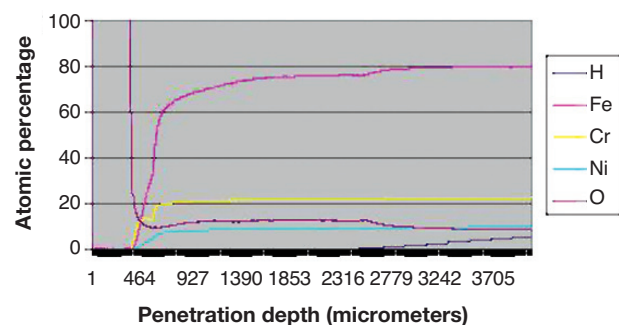
Figure 10—Glow discharge optical emission spectroscopy

GDOES utilizes a low-pressure, non-thermal process in which materials are uniformly sputtered from the sample surface by a stream of argon ions from plasma. The cathodic sputtering removes the material layer by layer, without any changes in sample chemistry caused by melting. Therefore the light emitted from this excitation is analysed using an optical emission spectrometer.

The percentage of chromium and nickel shows a uniform distribution from the surface penetrating the sample.

An oxide layer represented by a percentage of oxygen at the near surface layer.
