# Characterization of surface roughness and subsurface pores and their effect on corrosion in 3D-printed AlSi10Mg

\*Paper written on project work carried out in partial fulfilment of B.Eng (Metallurgical Engineering)

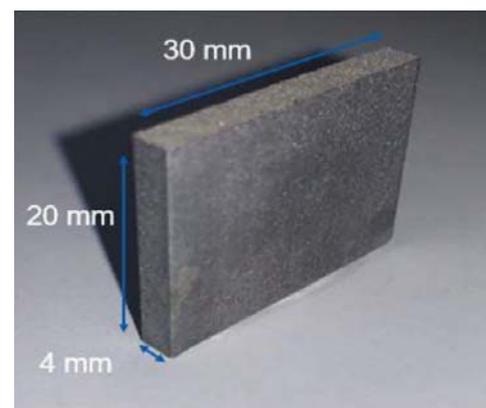
Figure 1 – Schematic representation of sample dimensions

Tests were carried out on 40 L-PBF AlSi10Mg samples obtained using a SLM250 metal 3D printer (Wiiibox, China). The built-direction of the samples was in the X-Y plane. Half of the printed samples were received as 'rough' ( $7.3 \mu\text{m } Ra$ ) and the other as 'smooth' ( $3.7 \mu\text{m } Ra$ ) in surface. The smooth samples were placed closer to the gas outlet, which is believed to have caused the difference in the surface roughness. The laser, scan, powder, and temperature parameters were kept constant. All the samples were  $30 \text{ mm} \times 20 \text{ mm} \times 4 \text{ mm}$  in size, as shown in Figure 1.

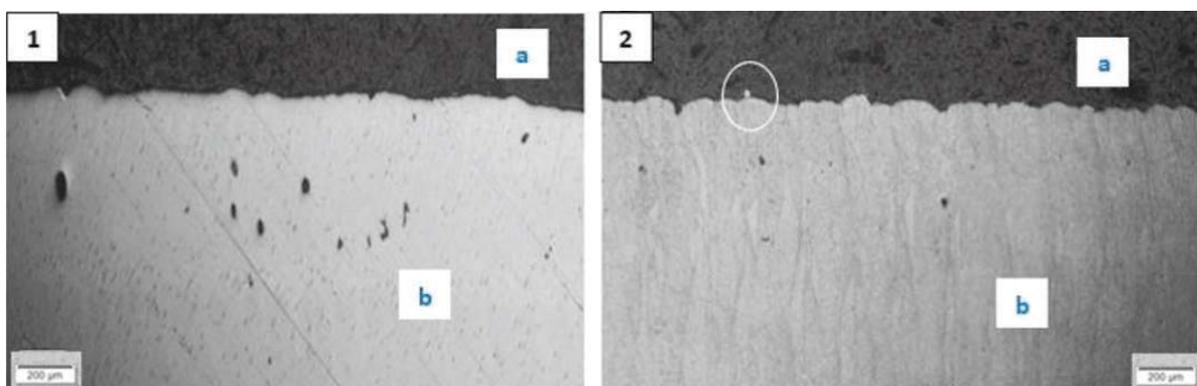
Figure 2 – Cross-sections of smooth (1) and rough (2) AlSi10Mg samples

Figure 2 shows cross-sections of smooth and rough as-received samples from the Y-Z plane. The top black part (a) is Bakelite resin and the grey part (b) is the sample (all cross-sections in this report show the resin as black). In both the samples, 'valleys and peaks' were observed, with those in the rough sample being more prominent.

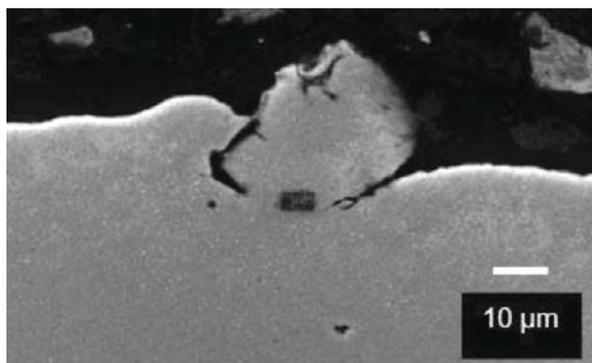
Figure 3—Partially melted powder identified on a rough sample surface

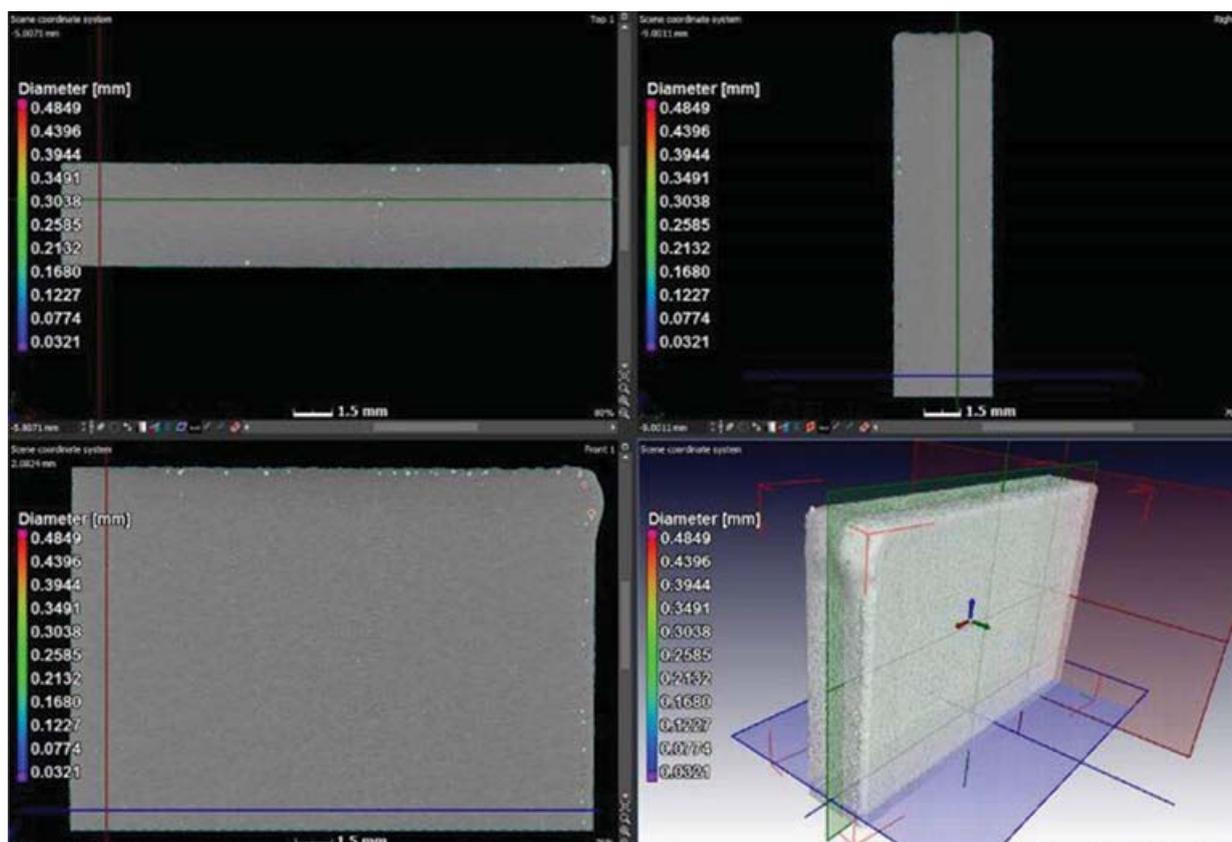
Figure 4—Nano-CT scan image showing subsurface contour porosity on smooth sample with a XY built-direction

Nano-CT scans were used for the 3D quantification of porosity. Figure 4 is a nano-CT image of one of the ‘smooth’ samples that shows characteristics of both the smooth and rough samples. The size range of the pores and the porosity volume percentage for both types of sample are given in Table I. The porosity volume percentage of the smooth samples were observed to be slightly higher (by 0.02%) than for the rough samples. The pores for the X-Y plane built-direction samples were identified as subsurface, contour pores (du Plessis and le Roux, 2018). Figure 5 depicts both a nano-CT scan and an optical microscope image to show that the pores mainly line up to form a porous layer. Large pores can be found outside the layer at the corners of the samples. The

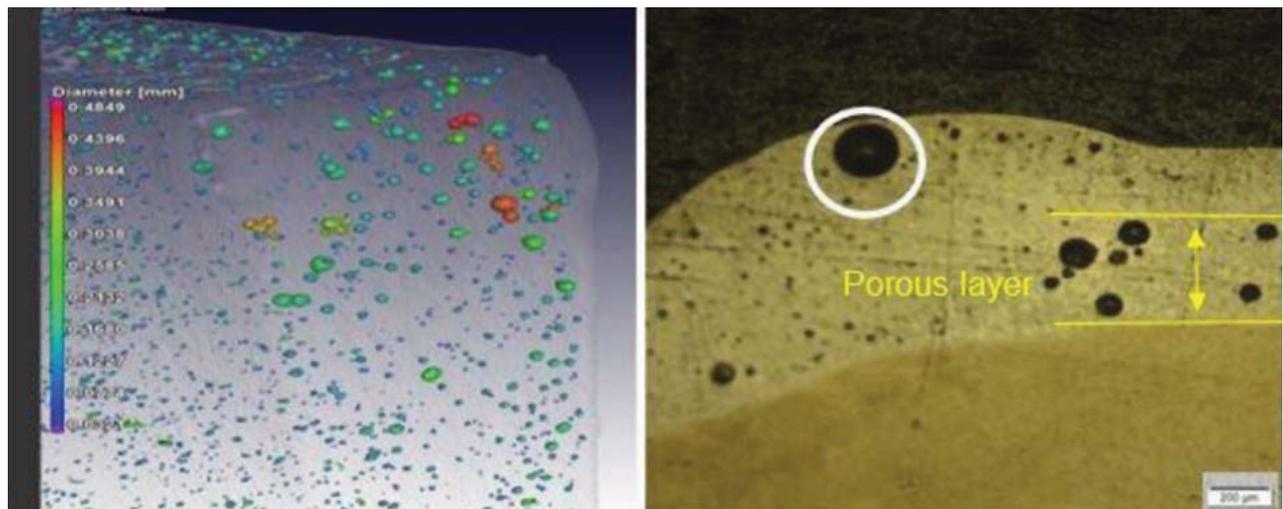
Figure 5—Nano-CT scan (a) and optical microscope (b) images showing the subsurface contour porosity

encircled pore in Figure 5b presents a high risk for decreasing corrosion resistance as it is very close to the surface, and if exposed would act as an initiation site for localized corrosion.

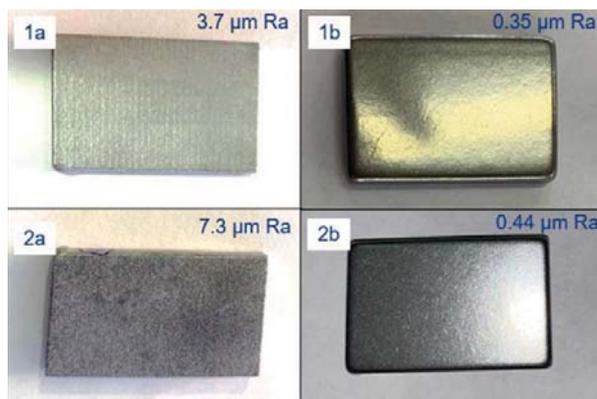
Figure 6—Smooth (1) and rough (2) L-PBF AlSi10Mg before (a) and after (b) CBF

Images of the L-PBF AlSi10Mg samples before and after CBF are shown in Figure 6. From visual inspection, it is apparent that CBF improves the poor surface finish; however, upon further analysis it is seen that a new problem may be introduced. The porous layers of the smooth and rough samples, as well as the layers removed during CBF, were characterized using optical and dimensional analysis. Assuming uniform removal of material, the removed layer described in Table III represents half the material removed per plane.

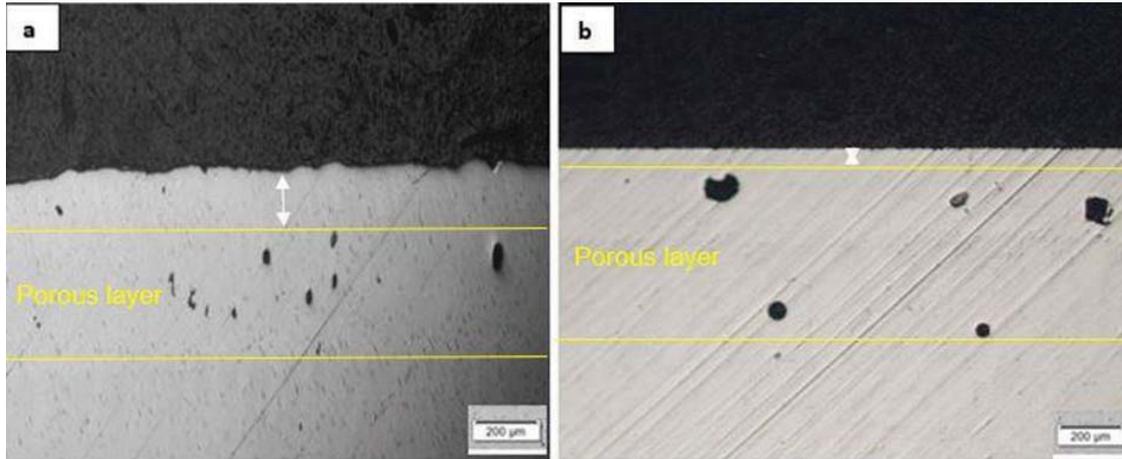
Figure 7—Optical microscopy images of before (a) and after (b) centrifugal barrel finishing of the smooth AISi10Mg samples

Table III reveals how the subsurface pores in the smooth samples were at risk of being exposed on the surface. To investigate this, cross-sections of the smooth samples were analysed using optical microscopy and nano-CT scans. Due to CBF, some surface material was removed, bringing the surface closer to the (initially) subsurface pores as shown in Figure 7.

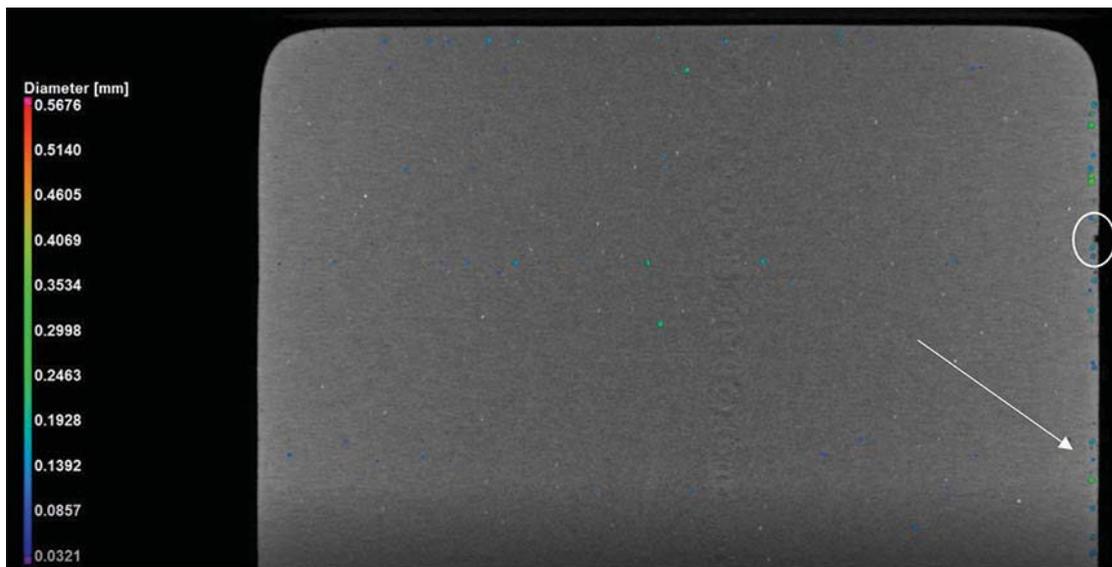
Figure 8—Nano-CT scan image showing the exposure of a pore within the porous layer of a smooth sample

The nano-CT scans showed that the porous layer remains in the subsurface for some samples, and on the surface for others. Some scans, such as the one in Figure 8, revealed some subsurface pore exposure on the surface. The porous layer can be seen on the right-hand side of the sample, with an encircled exposed pore.

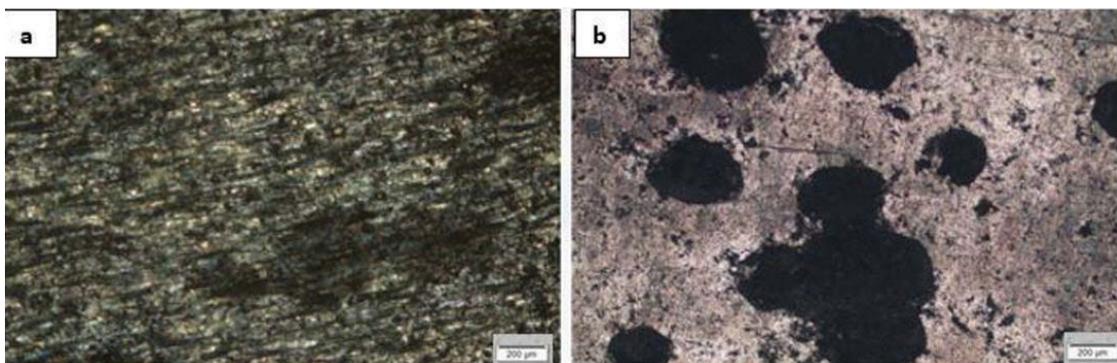
Figure 9—Corroded surface of unpolished (a) and polished (b) smooth L-PBF AISi10Mg

To investigate whether the porous layer after CBF affects the corrosion resistance, smooth polished and unpolished samples were corroded using potentiodynamic tests. The visual results from optical microscopy revealed that the polished samples experienced more corrosion, with more prominent pits than the unpolished samples. This can be seen in Figure 9.
